**Placer County Water Agency Middle Fork
American River Project
(FERC No. 2079)**

**LAND 1 – TRANSPORTATION SYSTEM
TECHNICAL STUDY REPORT – 2008**

August 2009

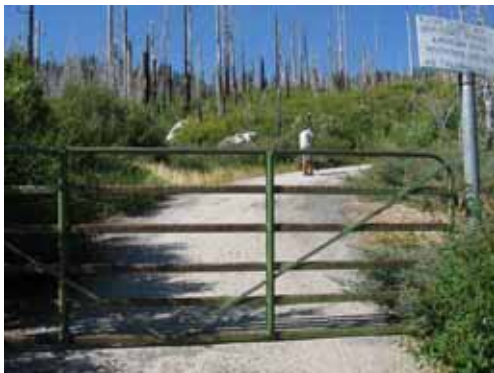
DCMFTPR02-A - Duncan Creek–Middle Fork Tunnel Portal Road (gate not located on Project road, but restricts access to Project road)

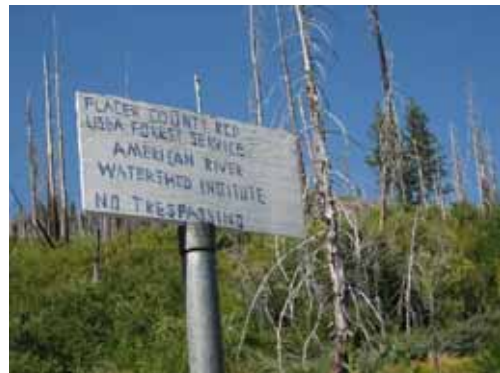
DCMFTPR02-B - Duncan Creek–Middle Fork Tunnel Portal Road (sign not located on Project road but restricts access to Project road)

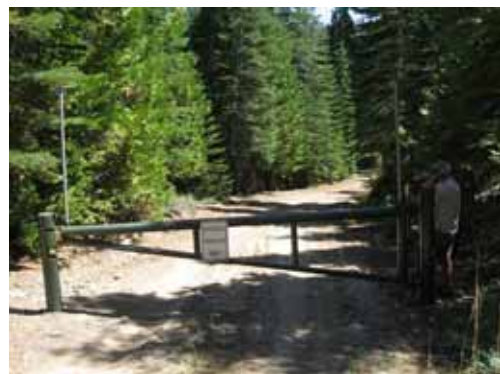
FMHHTPR02 - French Meadows–Hell Hole Tunnel Portal Road at Road Mile 0.004

French Meadows - Hell Hole Tunnel Portal Road		71	Steel Gate	0.004	-120.414372	39.073280	Good	FMHHTPR02	Gate closed, in good condition
French Meadows Powerhouse Road		71	Steel Gate	1.218	-120.407316	39.077415	Good	FMPR48	Gate open and in good condition.
		66	Warning, Right	1.212	-120.407316	39.077415	Good	FMPR53	Warning sign on the right before powerhouse. In good condition.
Hell Hole–Middle Fork Tunnel Gatehouse Road		71	Steel Gate	0.034	-120.416357	39.060818	Good	HMFHTGR05	Steel Gate closure on road, open and in good condition.
Dormitory Facility Road		71	Steel Gate	0.127	-120.415461	39.058875	Good	DFR06	Gate at dormitory
Middle Fork Interbay Area									
Middle Fork Powerhouse Penstock and Butterfly Valve House Road		71	Steel Gate	0.000	-120.596847	39.024439	Good	MFIDPRIAP166B	Gate next to the powerhouse, off of Middle Fork Interbay Dam and Powerhouse Road and Interbay Access Points.
		95-3	Underground Powerline	1.434	-120.586797	39.018926	Fair	MFPPBVHR44	Underground powerline. The marker is in fair condition and is peeling. Made of aluminum.

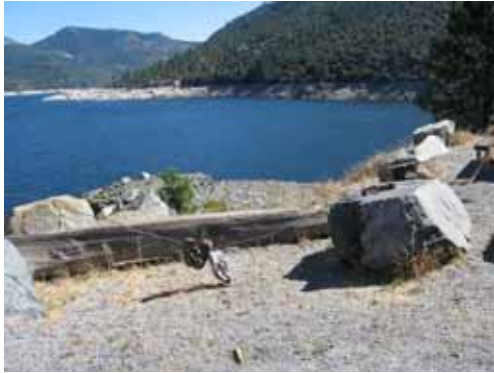
HHDSNAP01 – Hell Hole Dam Spillway and Northern Access Point at Road Mile 0.000

French Meadows–Hell Hole Tunnel Gatehouse Road		71	Steel Gate	0.009	-120.434768	39.107265	Good	FMHHTGR02	Road closed. Gate in good condition.
French Meadows Dam Outlet Works and Leakage Weirs Road		71	Steel Gate	0.008	-120.470541	39.107696	Good	FMDOWLWR02	Road closed with steel gate off of FR 96. In good condition.
Middle Fork American River Gage and Weir below French Meadows Dam Road^b		71	Steel Gate	0.264	-120.477968	39.105814	Fair	MFARGWBEMDR03	Road Closed by a steel gate. In good condition, although slightly rusted.
Hell Hole Area									
Hell Hole Dam and Powerhouse Road and Spillway Southern Access Point		71	Steel Gate	0.048	-120.413635	39.059744	Good	HHDPRSSAP02	Gate on road to spillway closed and slightly rusted.
Hell Hole Dam Spillway and Northern Access Point		74	Cable and Log Barrier	0.000	-120.413360	39.061188	Fair	HHDSNAP01	Road closed by log and cable (rocks). Road closure in fair condition.

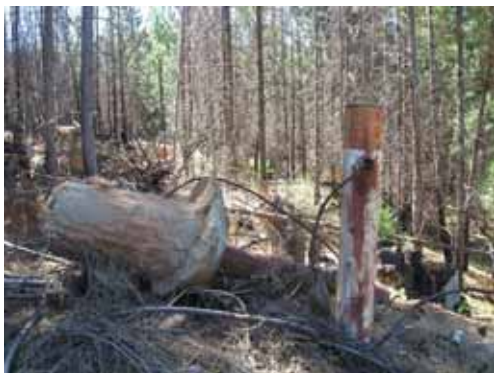
BCAR02 – Brushy Canyon Adit Road at Road Mile 0.059

- During 2008, surveys were performed at all the Project roads and trails with two exceptions. Brushy Canyon Adit Road was not surveyed because large sections of the road are either washed out or covered by a landslide precluding safe access. Hell Hole Dam Leakage Weir Road was not surveyed due to the road being overgrown and not well defined.
