**Placer County Water Agency  
Middle Fork American River Project  
(FERC No. 2079)**

**REC 1 – RECREATION USE AND FACILITIES  
TECHNICAL STUDY REPORT**

Placer County Water Agency  
P.O. Box 6570  
Auburn, CA 95604

May 2010

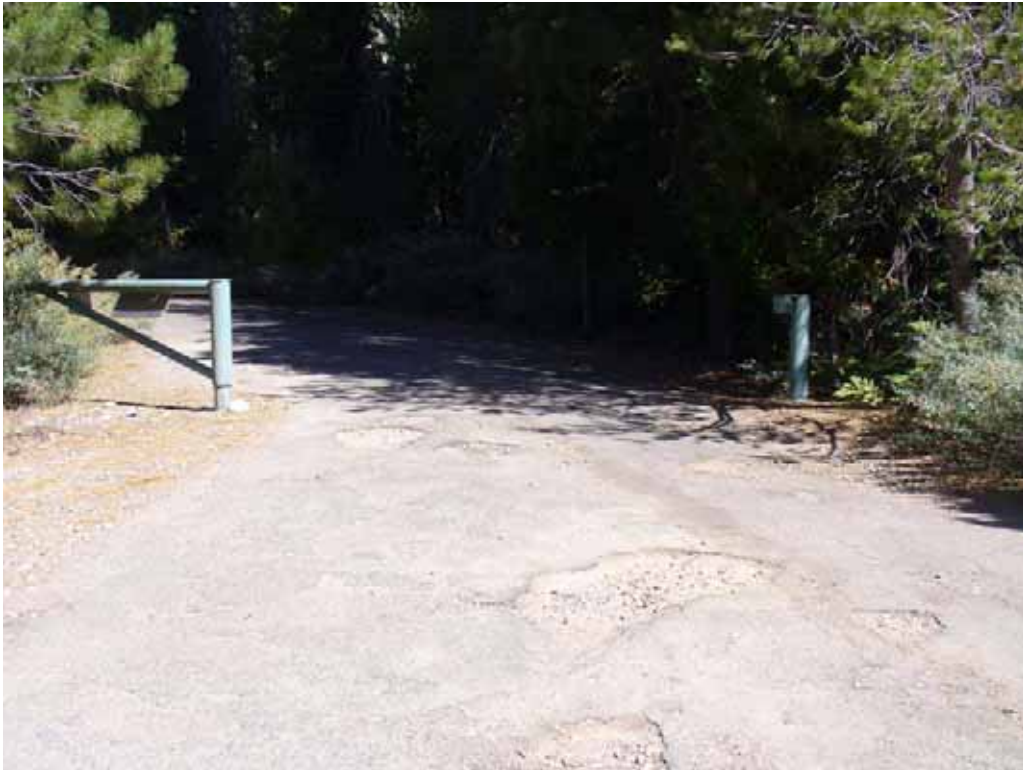
**Photo D-2-3. Poor condition road surface at entrance to Big Meadows Campground.  
(8/21/08)**

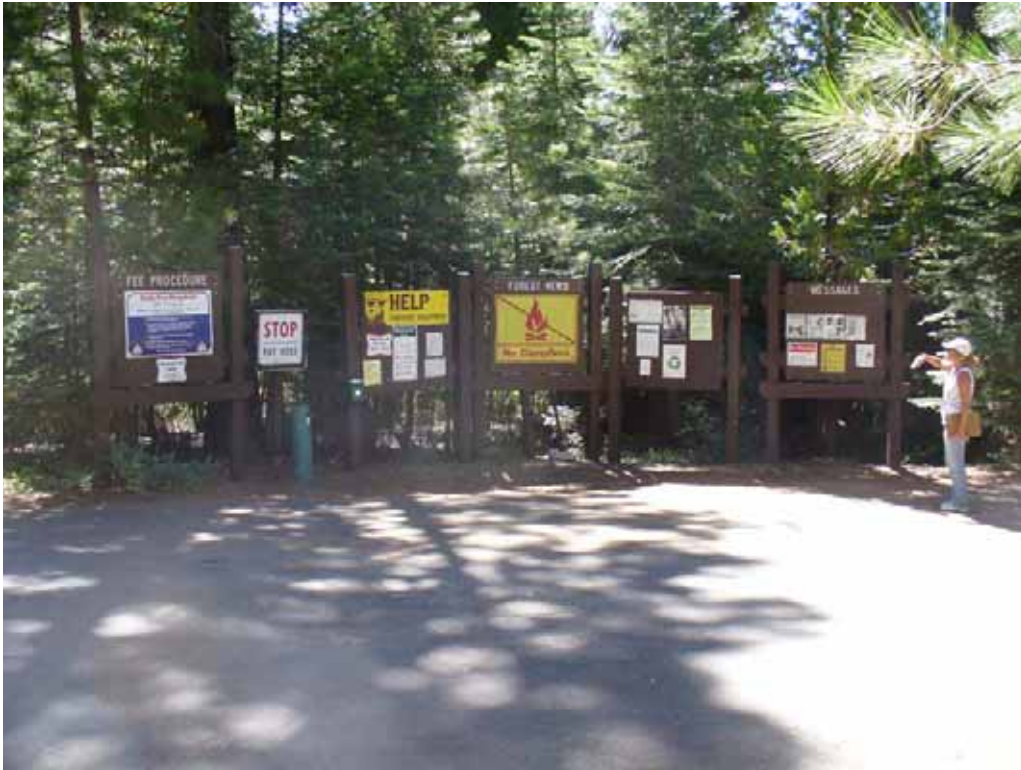
**Photo D-2-7. Turn out and fee station at edge of Hell Hole Campground Parking Area. (8/21/08)**

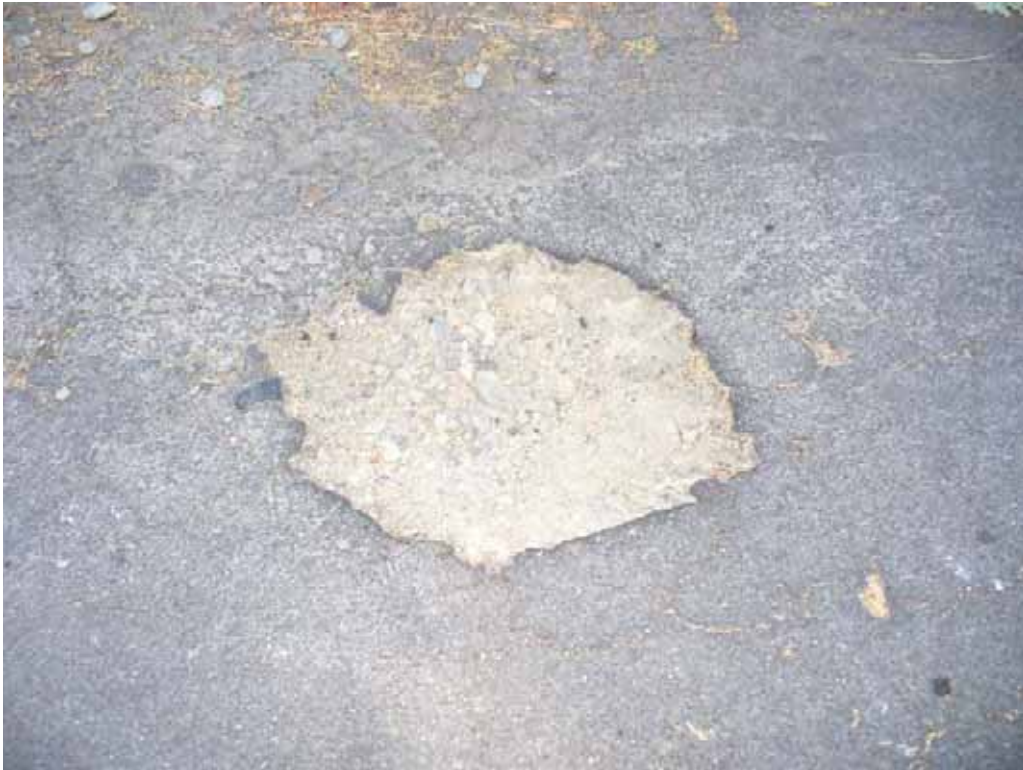
**Photo E-2-5. Pothole in road near turn-out. (8/21/08)**

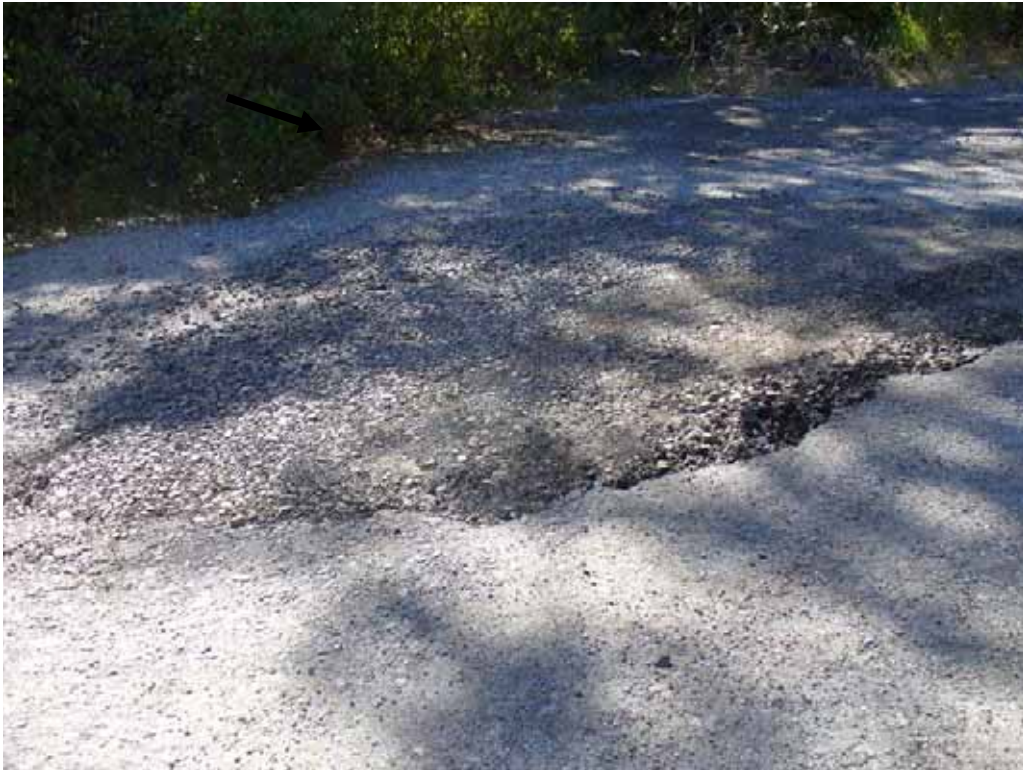
**Photo G-2-3. Example of damaged pavement surface in Hell Hole Vista Parking area. (8/20/08)**

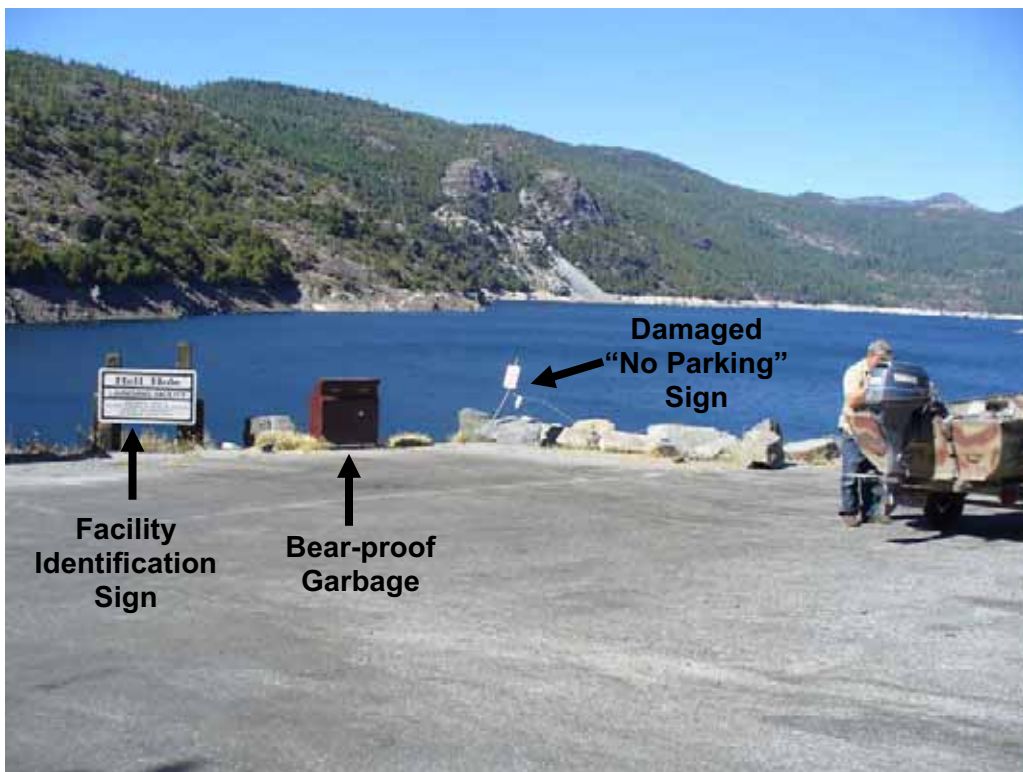
**Photo H-2-8. Hell Hole Boat Ramp Parking Area, lower lot. Surface is in good condition but striping has faded. Note facility identification sign, bear-proof garbage container, and damaged "no parking" sign. (8/4/08)**

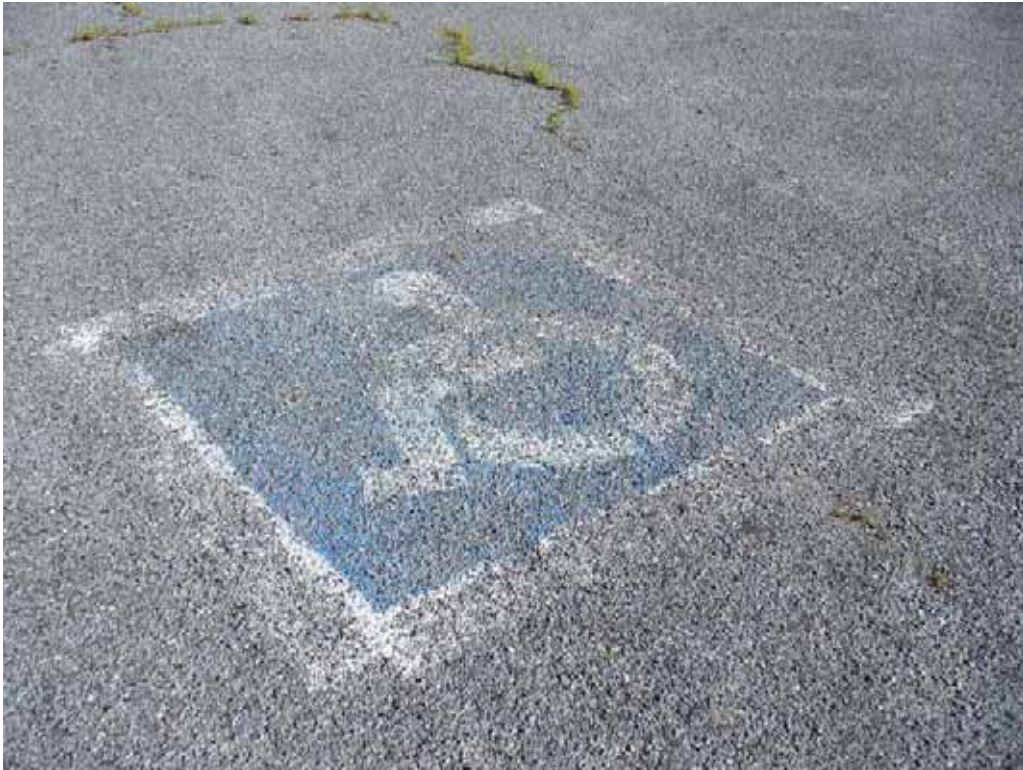
**Photo H-2-25. Example of faded handicap parking area marking painted on asphalt with chip seal. (8/4/08)**

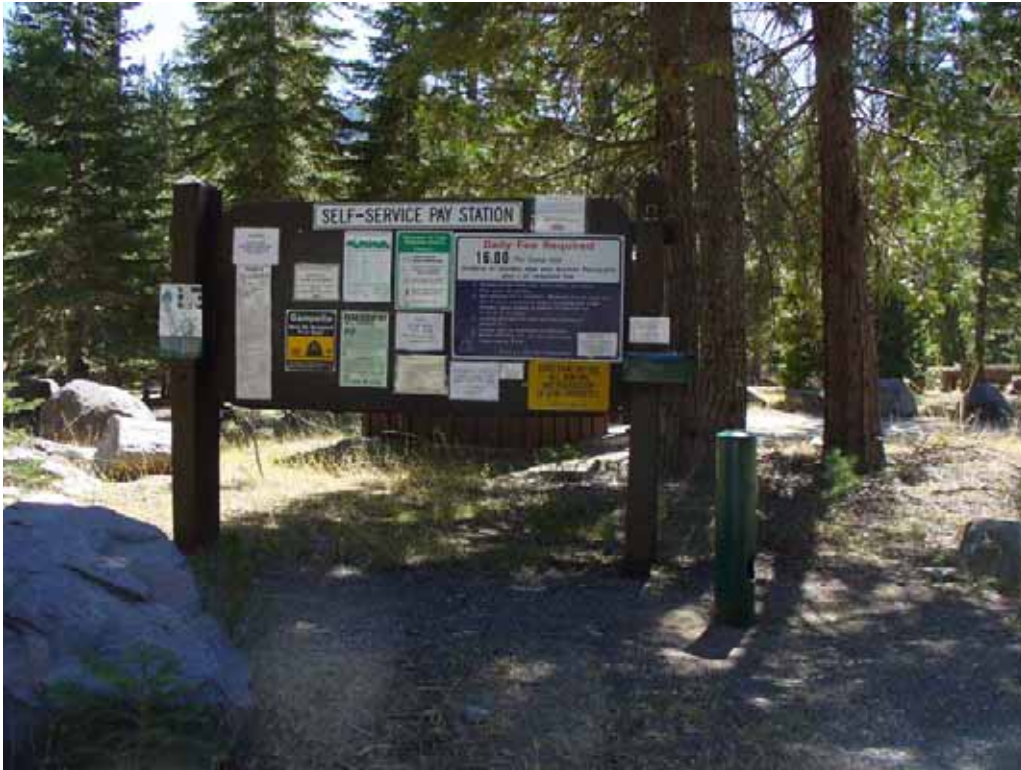
**Photo I-2-2. Site identification sign at entrance to Ahart Campground. This site is in fair condition due to the large crack. (9/04/08)**

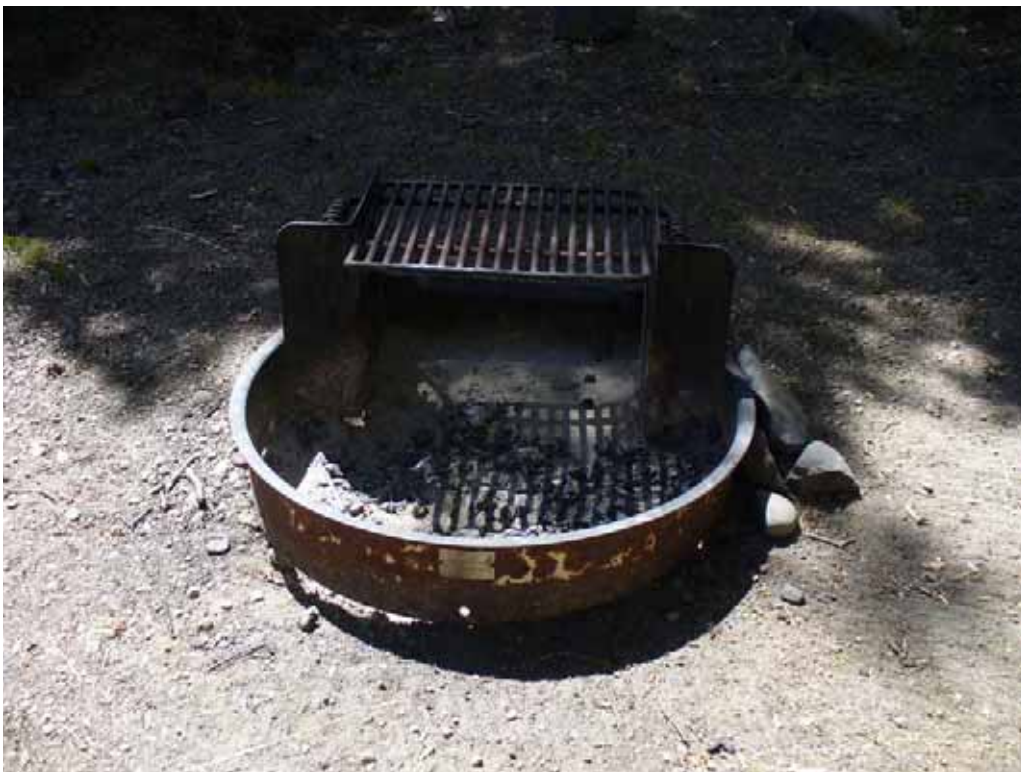
**Photo I-2-7. Concrete and steel stove at site 1, poor condition. (9/04/08)**

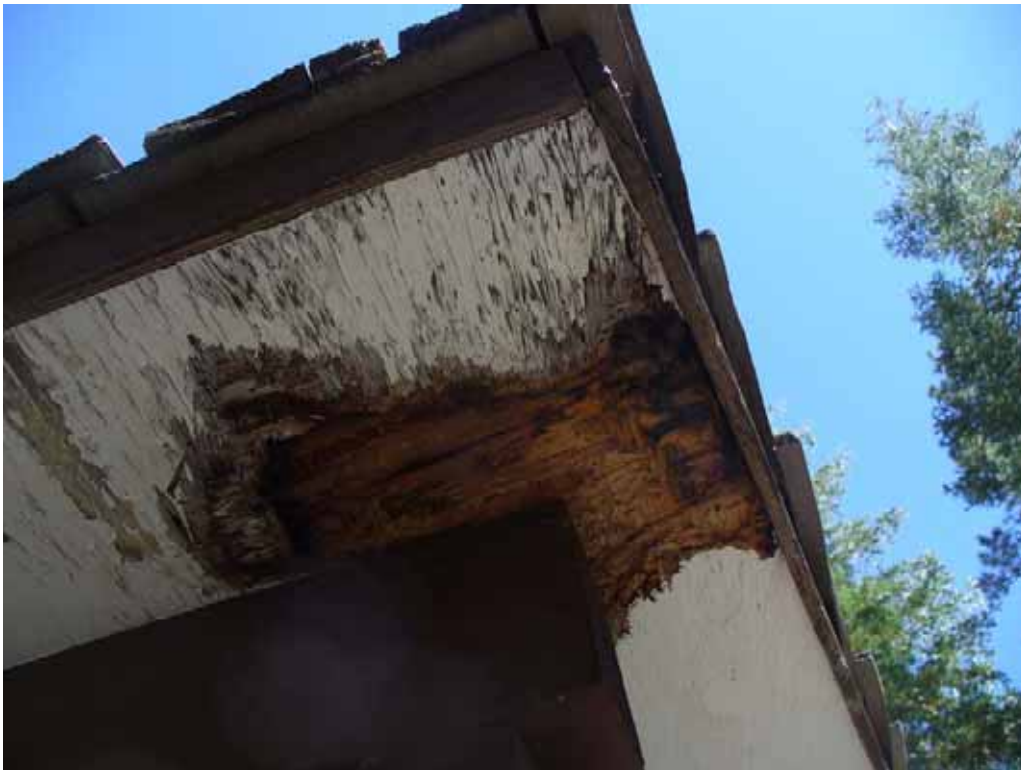
**Photo I-2-14. Dry rot on roof and frame of toilet building No. 1. (9/0408)**

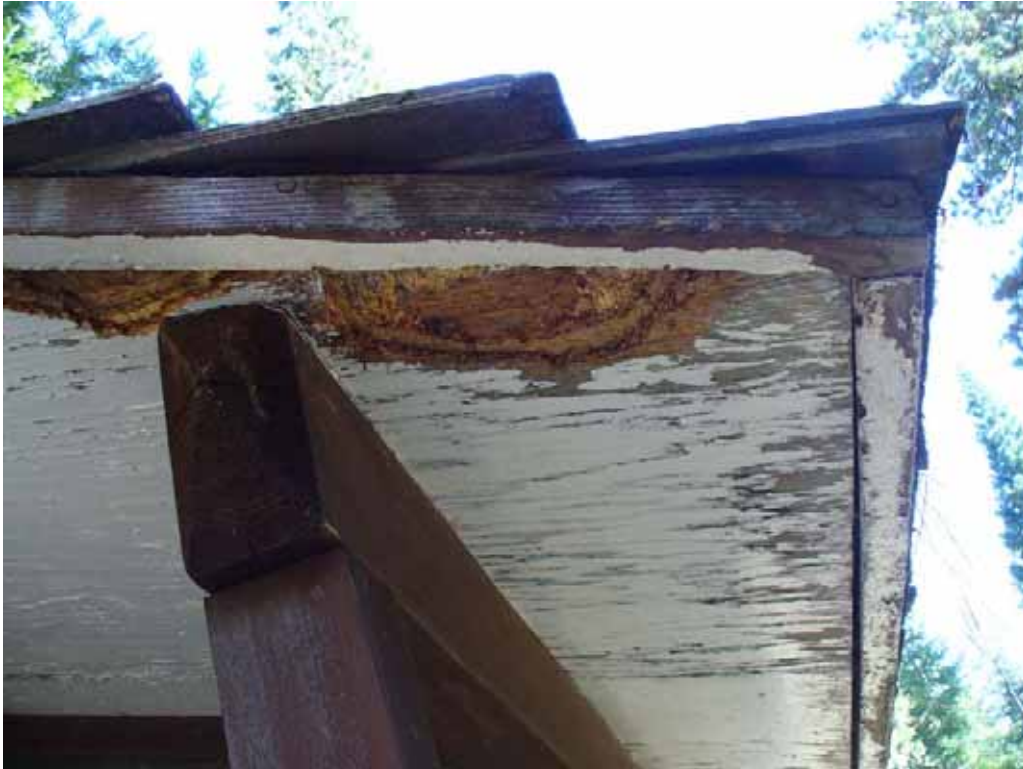
**Photo K-2-11. Dry rot on bathroom structure No. 2. (9/04/08)**

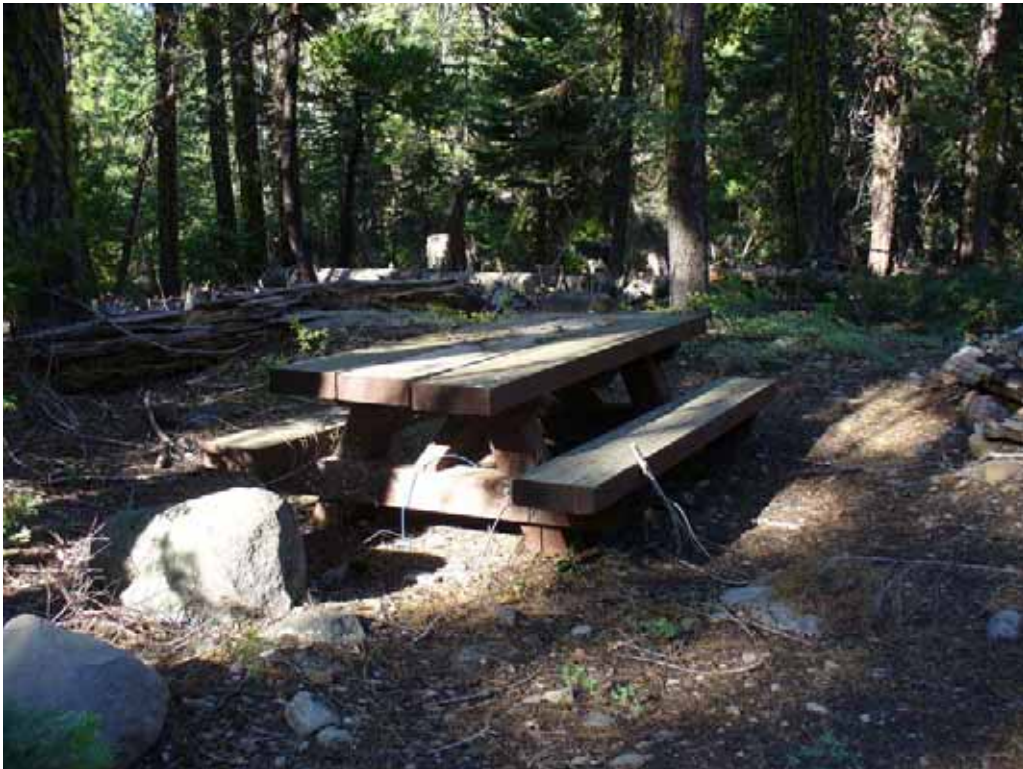
**Photo L-2-22. Site 9. Note excessive debris and obstacles. (7/24/08)**

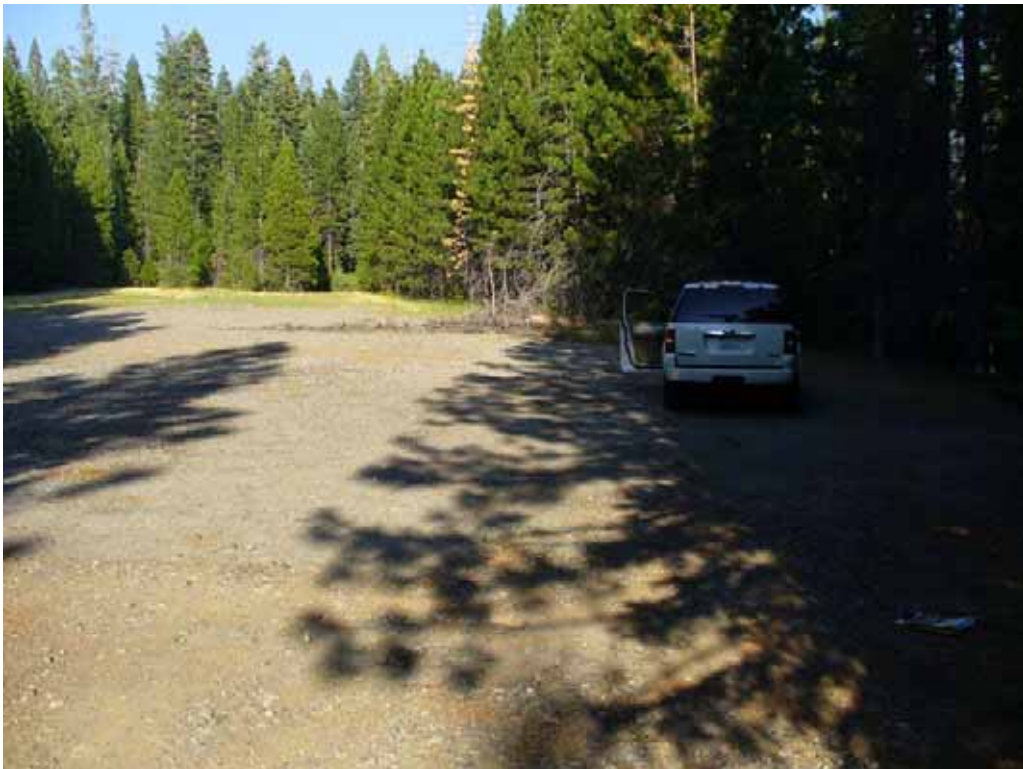
**Photo P-2-6. McGuire Boat Ramp Parking Area – southeast lot. Surface has deteriorated to base rock and is in poor condition. (7/23/08)**

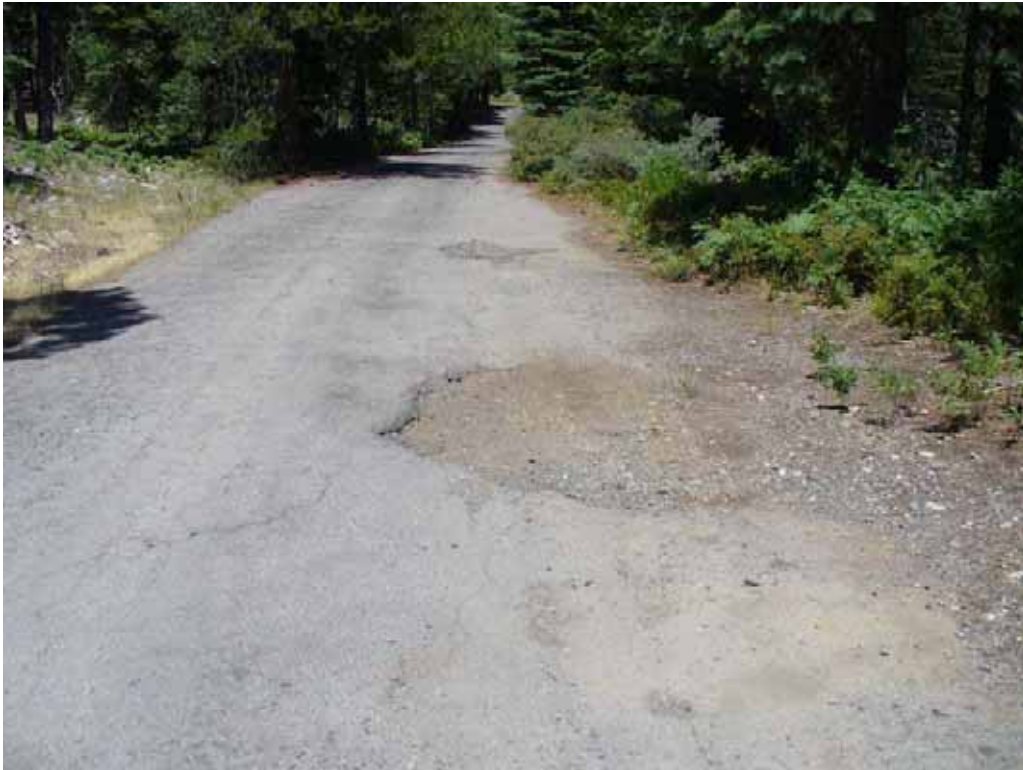
**Photo Q-2-3. Potholes and damaged pavement along access road to McGuire Picnic Area, beach, and parking area. (7/24/08)**

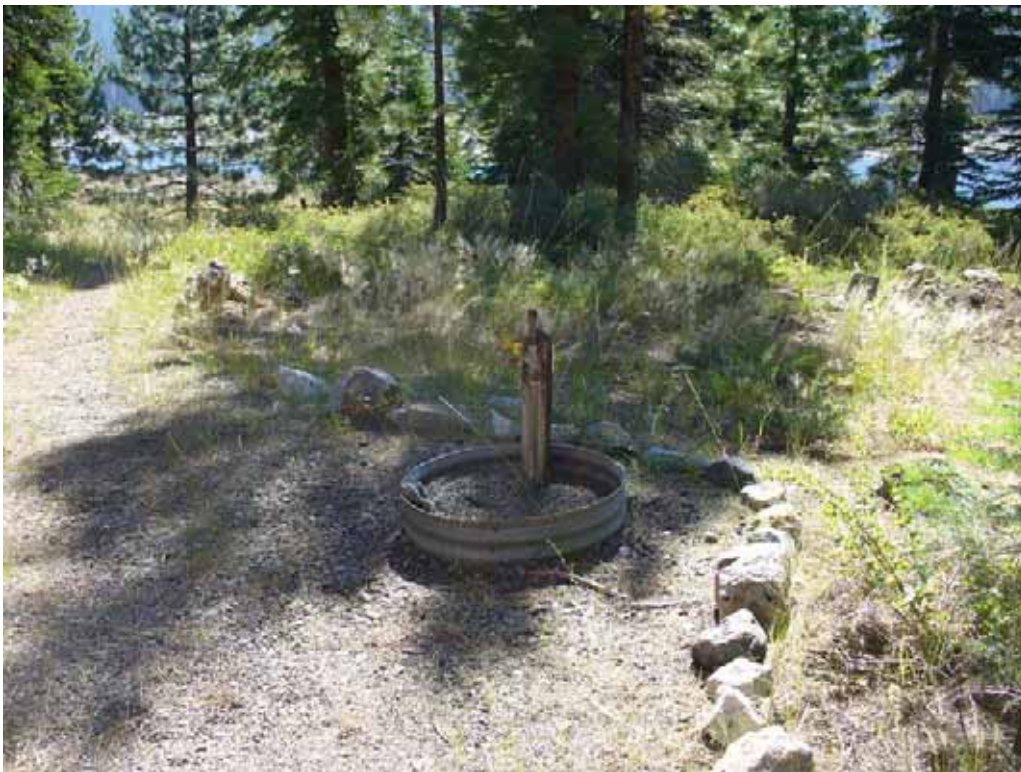
**Photo Q-2-12. Water faucet located along path to McGuire Beach, near bathroom. Handle is accessible but approach is not because the sump/drain is set above grade. (7/24/08)**

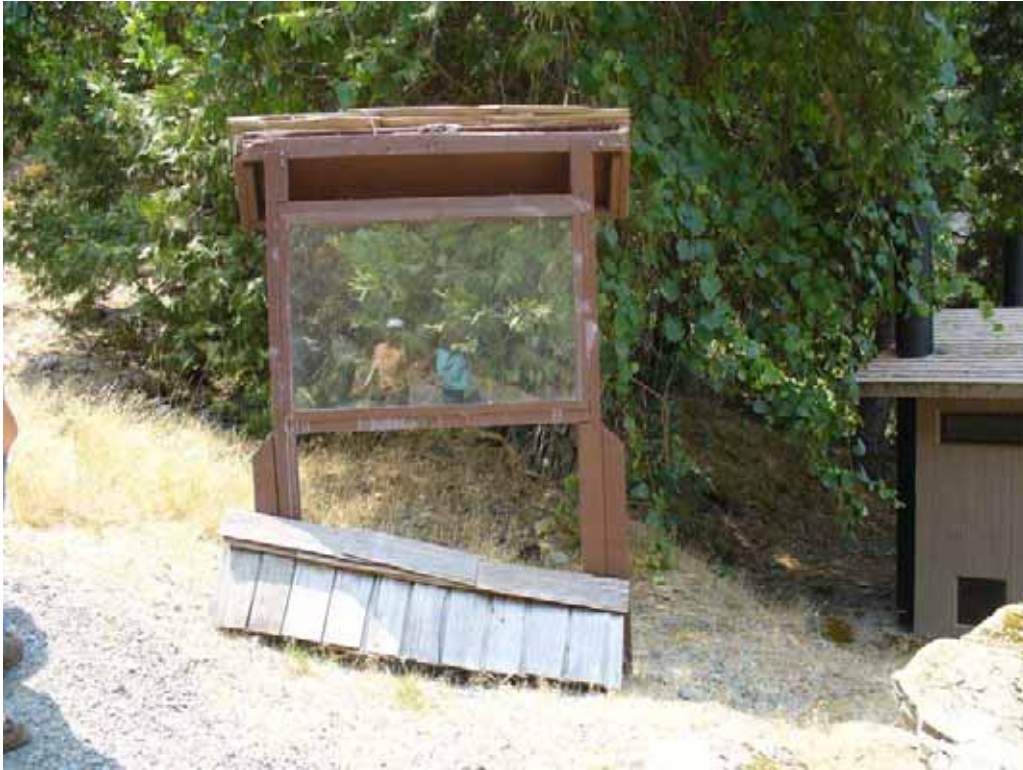
**Photo T-2-9. Damaged information board adjacent to CXT upslope from parking area. (7/23/08)**

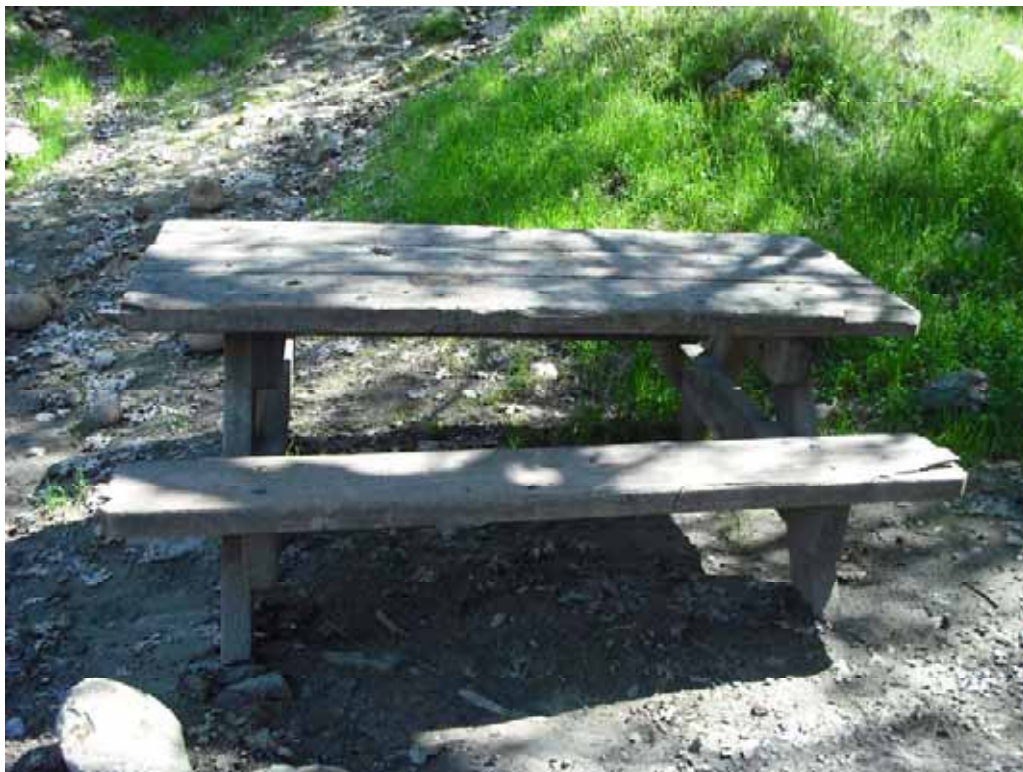
**Photo V-2-24. Example of heavy wood picnic table in Campsite 4. Campsite 4 includes two tables. Both are damaged and are in poor condition. (3/12/09)**

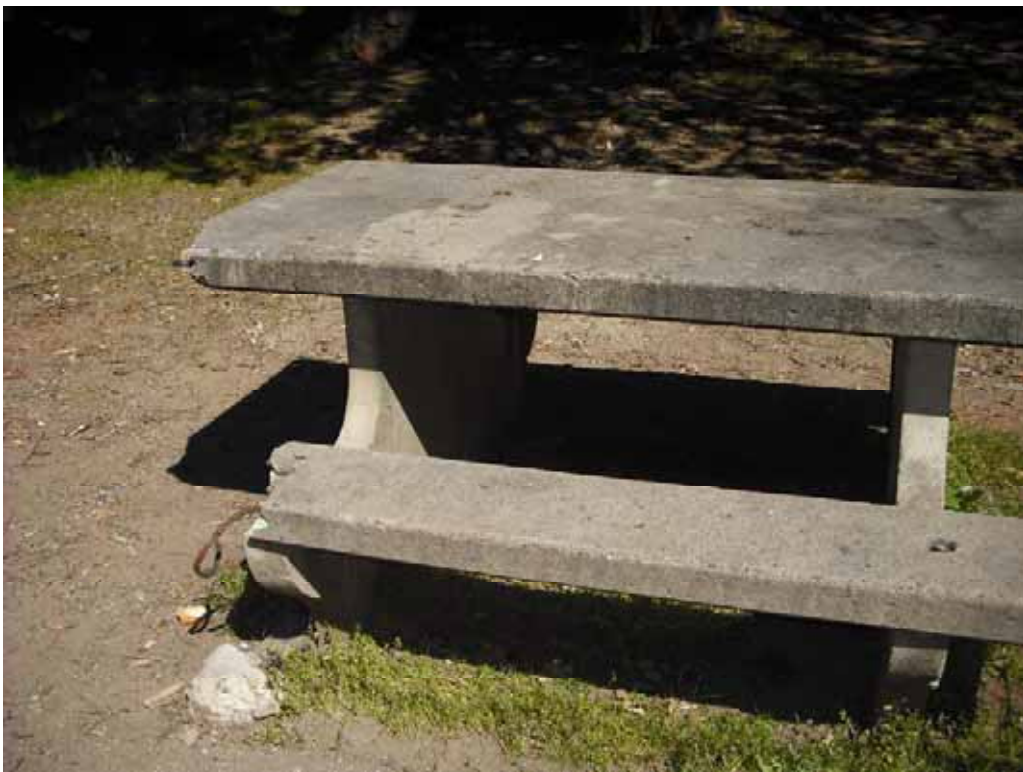
**Photo V-2-26. Concrete table located in Campsite 5. Table is damaged and in poor condition. (3/12/09)**
