**Placer County Water Agency  
Middle Fork American River Project  
(FERC No. 2079)**

**REC 1 – RECREATION USE AND FACILITIES  
TECHNICAL STUDY REPORT**

Placer County Water Agency  
P.O. Box 6570  
Auburn, CA 95604

May 2010

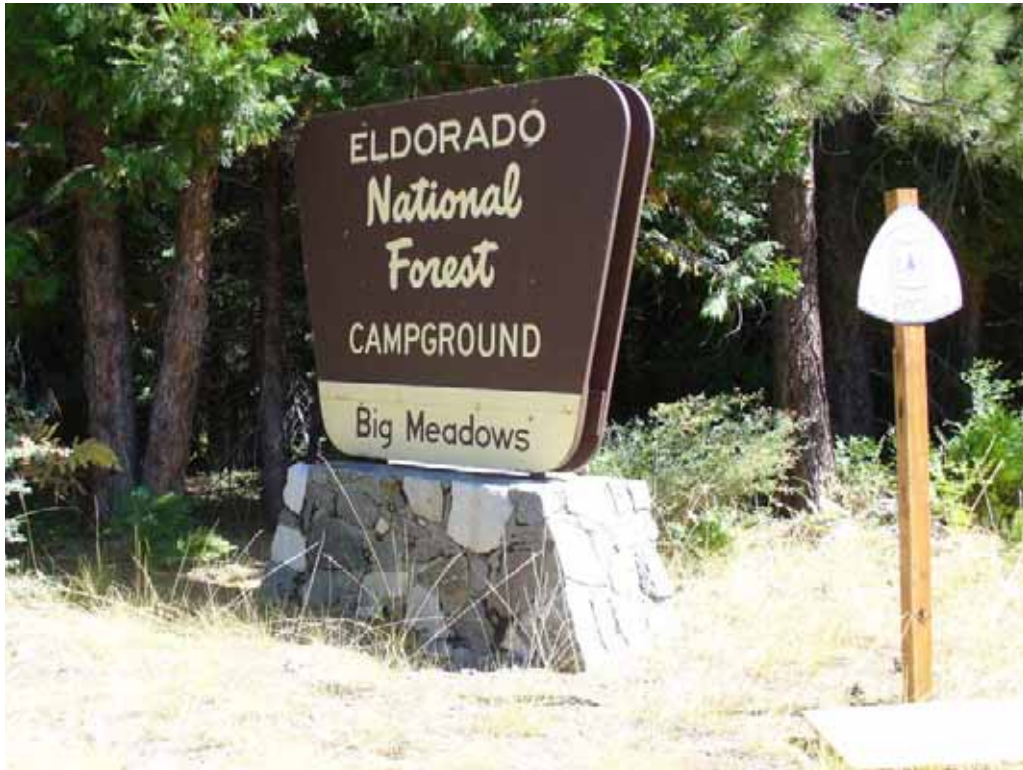
**Photo D-2-1. Site identification sign at entrance to Big Meadows Campground. (8/21/08)**

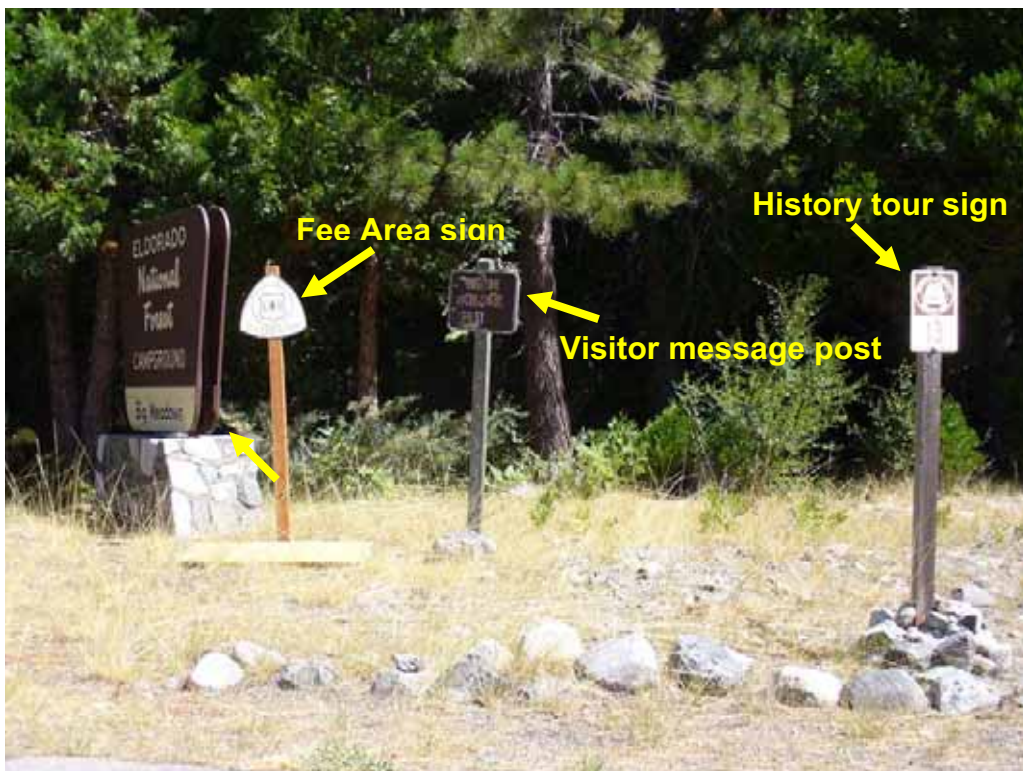
**Photo D-2-2. Other signage at entrance to Big Meadows Campground. (8/21/08)**

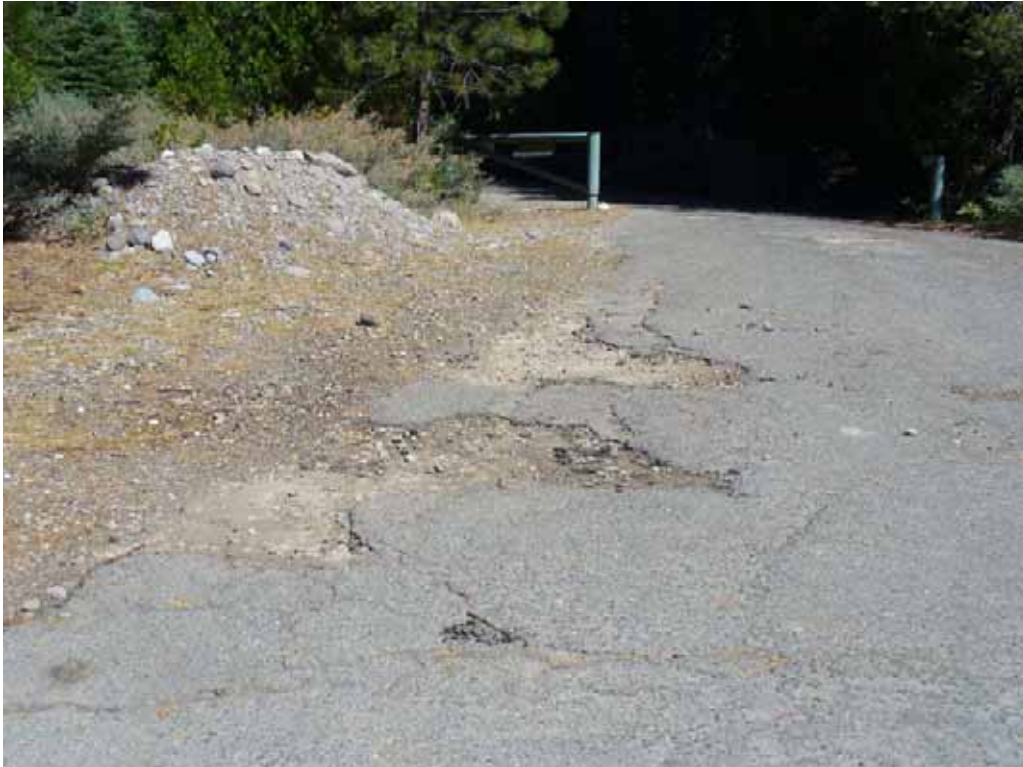
**Photo D-2-4. Poor condition road surface at entrance to Big Meadows Campground.  
(8/21/08)**

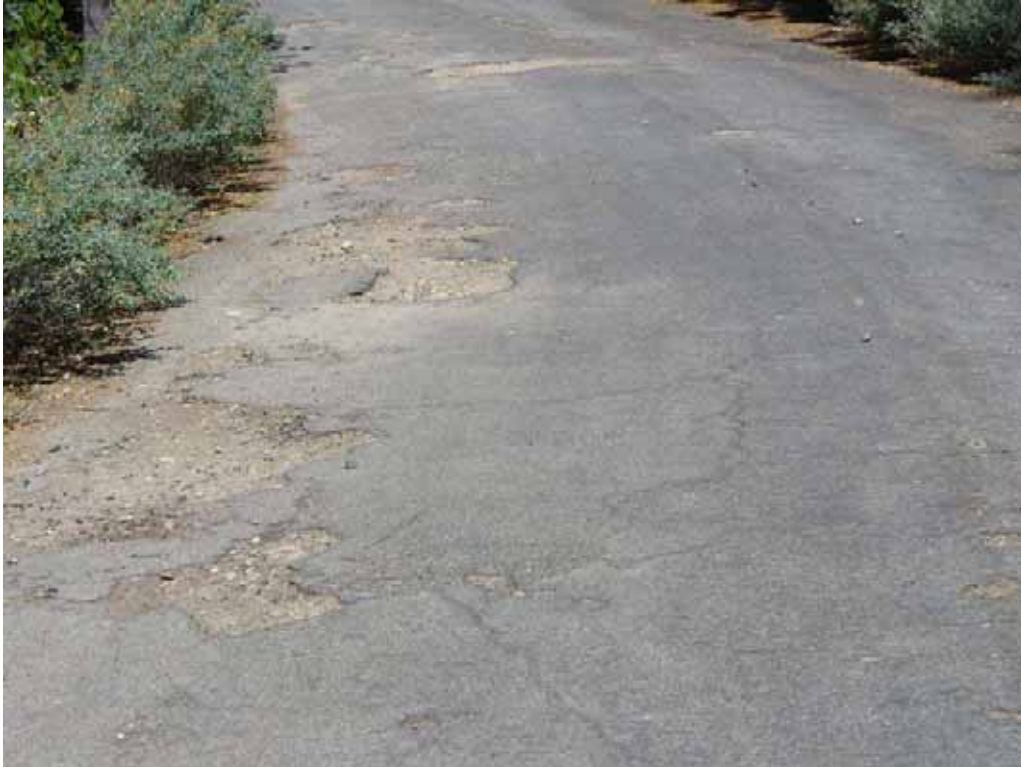
**Photo D-2-6. Poor condition pavement along 14N43, the access road to Big Meadows Campground (8/21/08).**

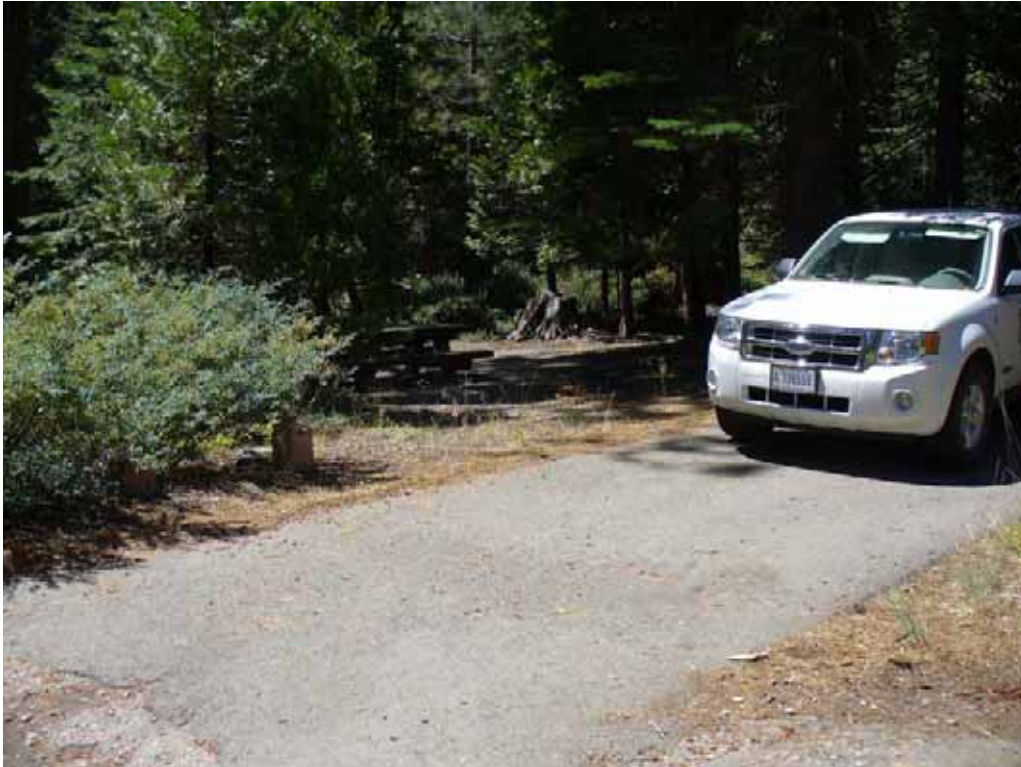
**Photo D-2-8. Example campsite parking spur (Site 1). This spur is a “trailer spur”, 40’ long x 10’ wide. (8/21/08)**

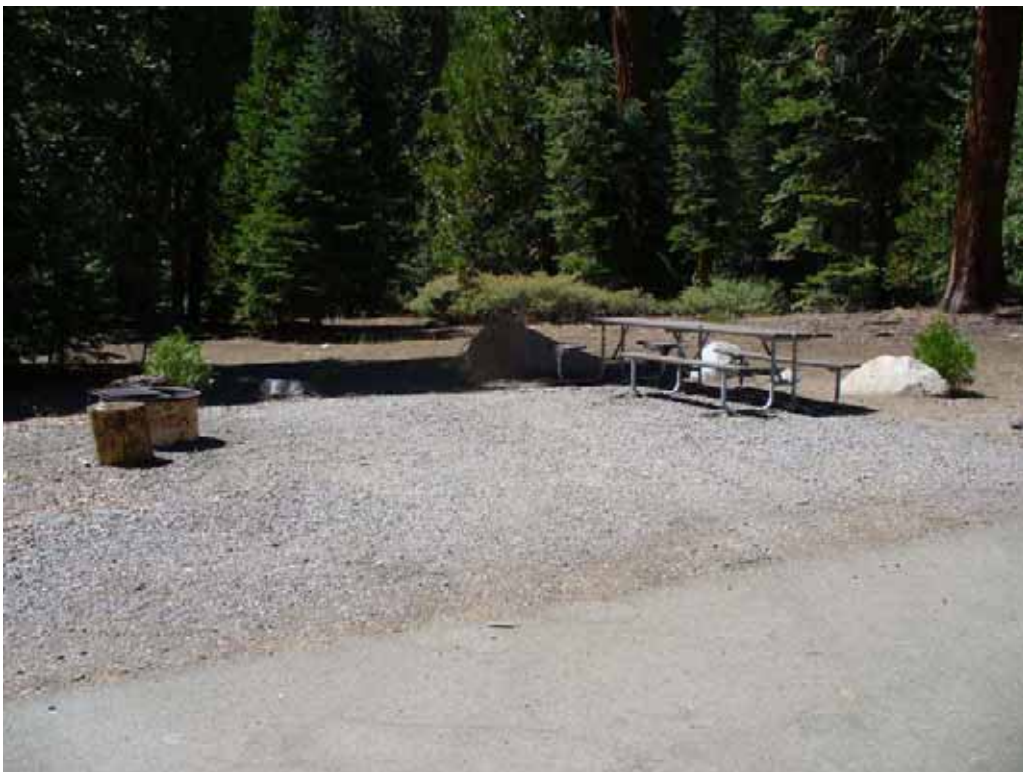
**Photo D-2-10. Fully accessible site – Site 52. (8/21/08)**

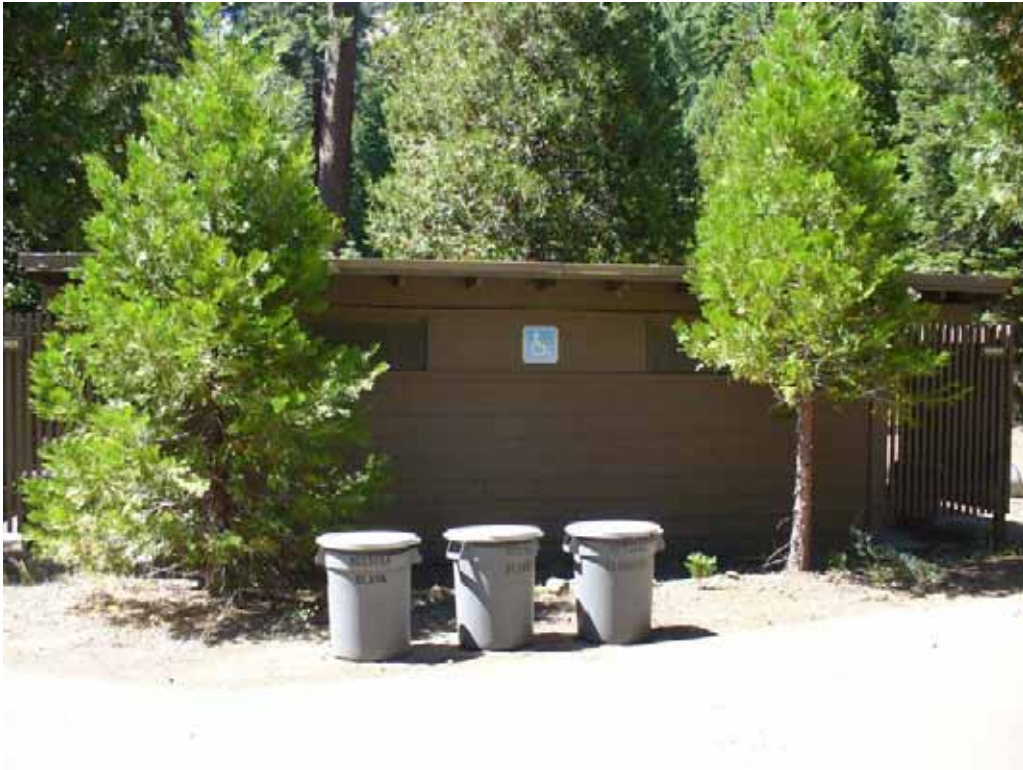
**Photo D-2-11. Bathroom with flush toilets located near Site 52. This bathroom was converted to be accessible by PCWA in 1995. (8/21/08)**

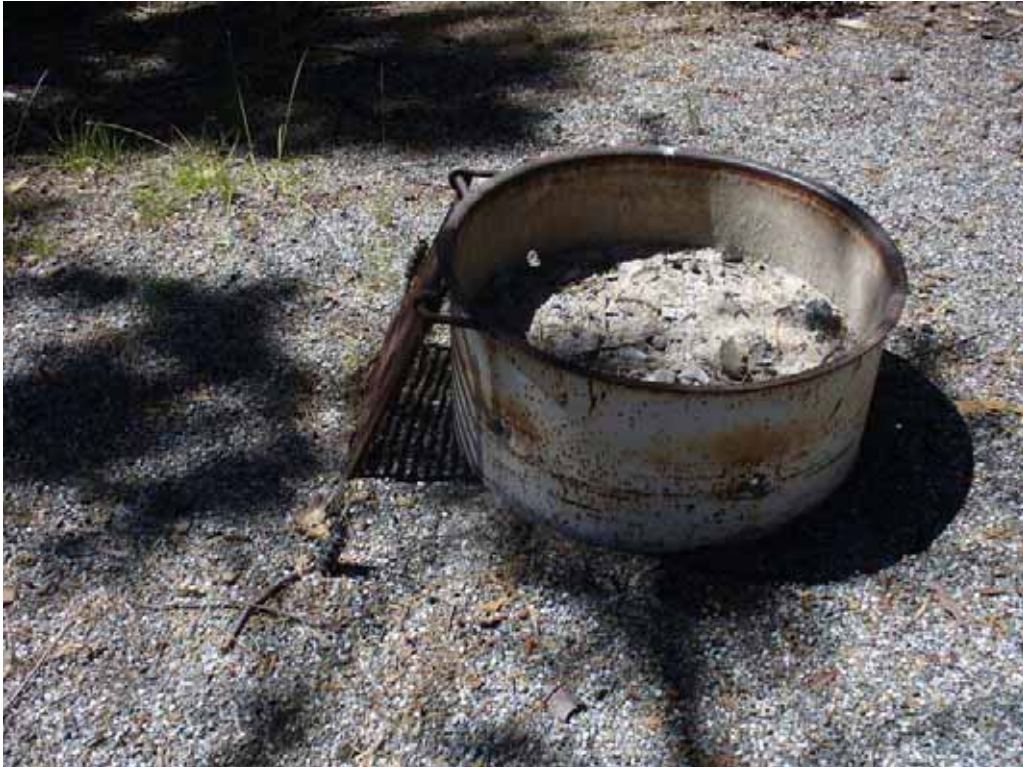
**Photo D-2-12. Accessible fire rings with grills like this one are available at all of the sites in Big Meadows Campground. (8/21/09)**

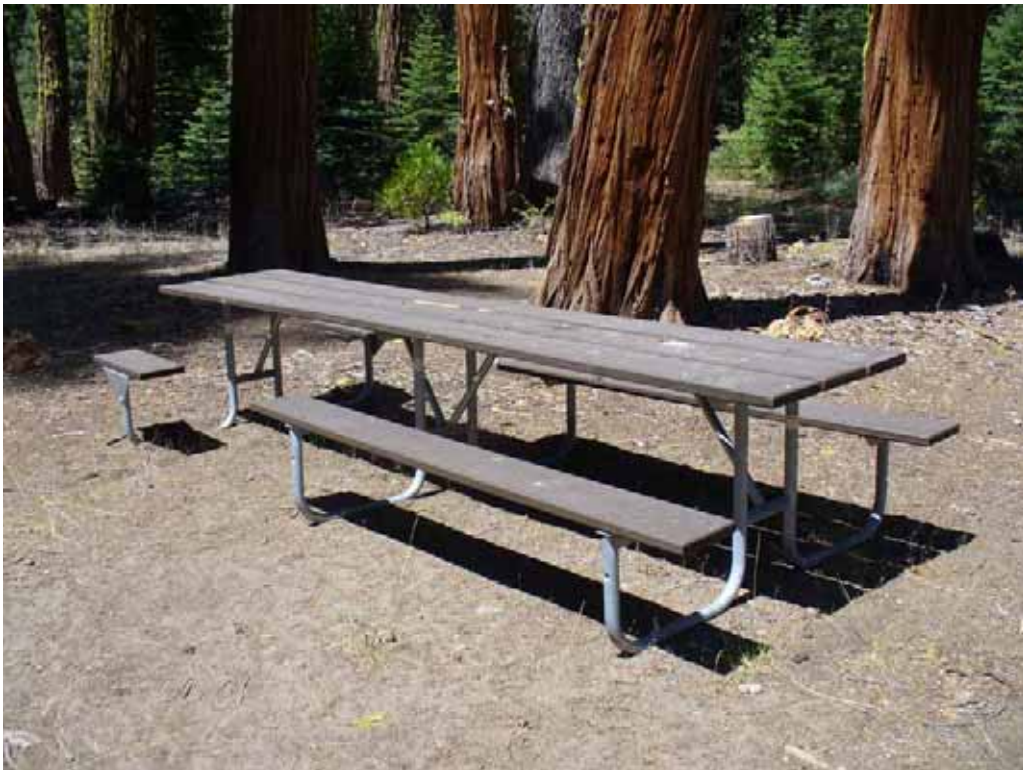
**Photo D-2-14. Example of a double accessible table in good condition. (8/21/08)**

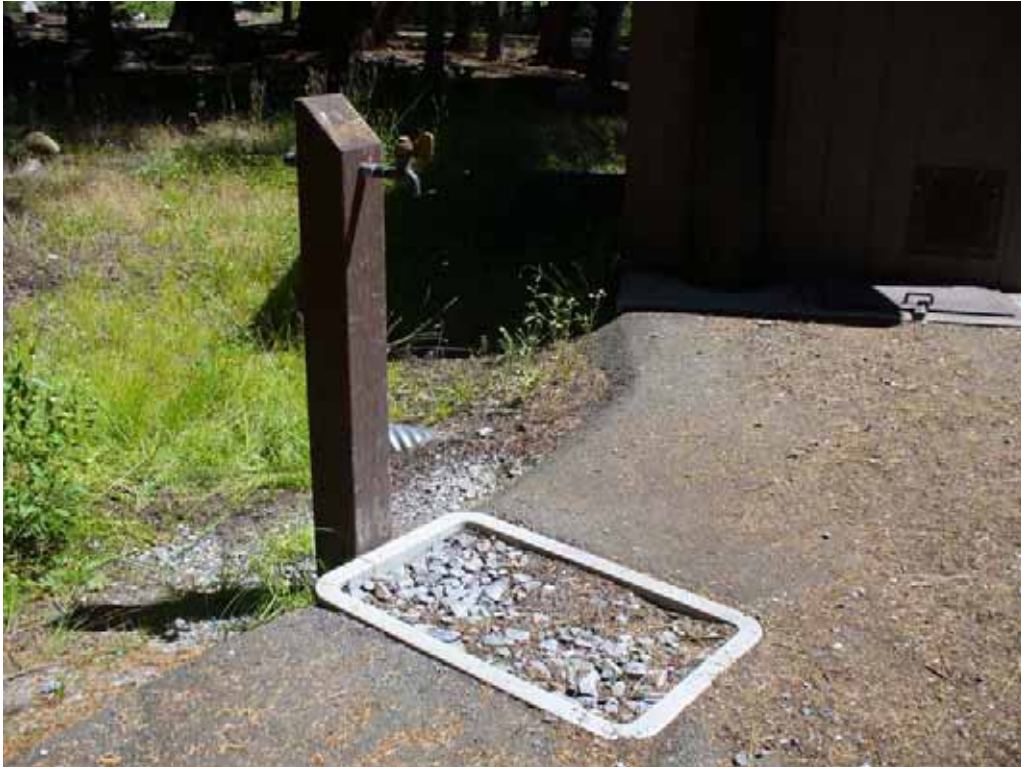
**Photo D-2-16. Example water faucet - accessible (8/21/08)**

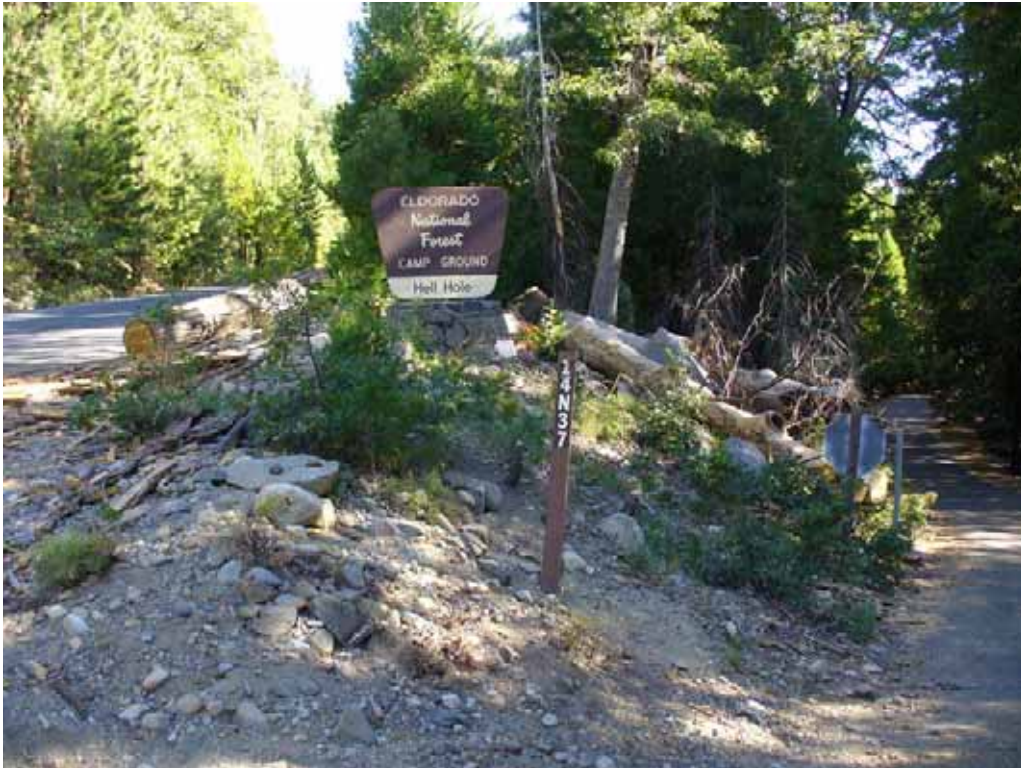
**Photo E-2-1. Site identification sign and carsonite road marker at entrance to Hell Hole Campground. The road on the left side of the photograph is FR-2. (8/21/08)**

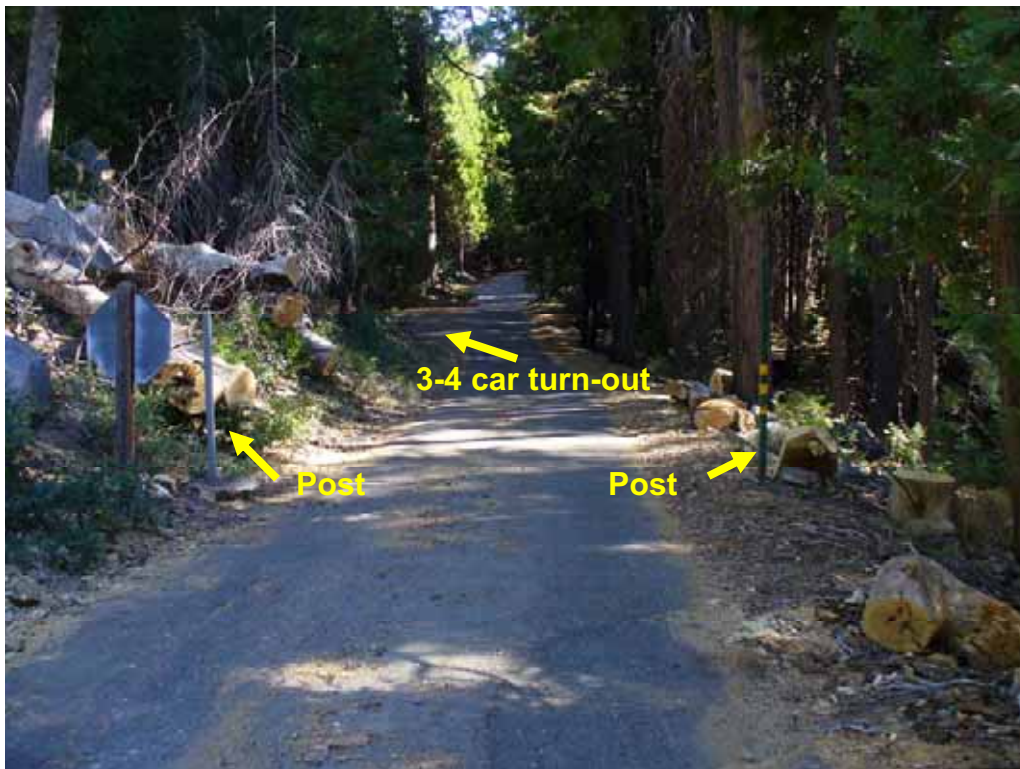
**Photo E-2-2. Road to Hell Hole Campground near entrance. This road is identified by the Forest Service as 14N37. (8/21/08)**

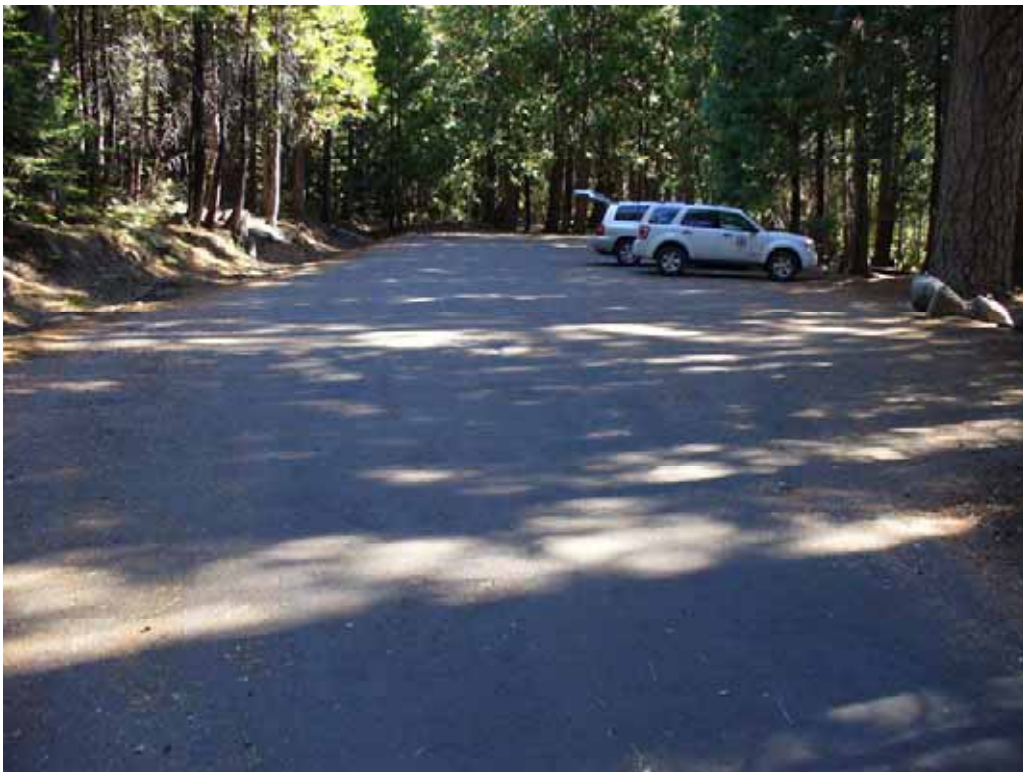
**Photo E-2-6. Hell Hole Campground Parking Area. (8/21/08)**

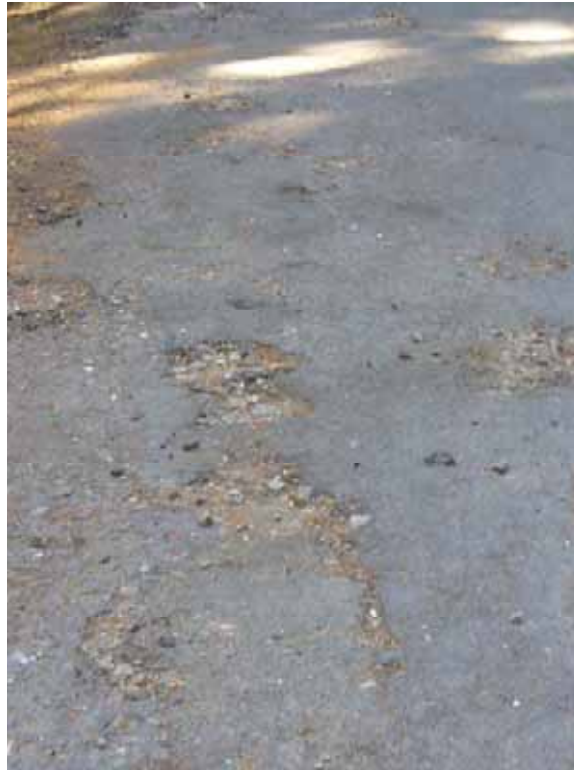
**Photo E-2-7. Poor condition pavement at edge of Hell Hole Campground Parking Area. (8/21/08)**

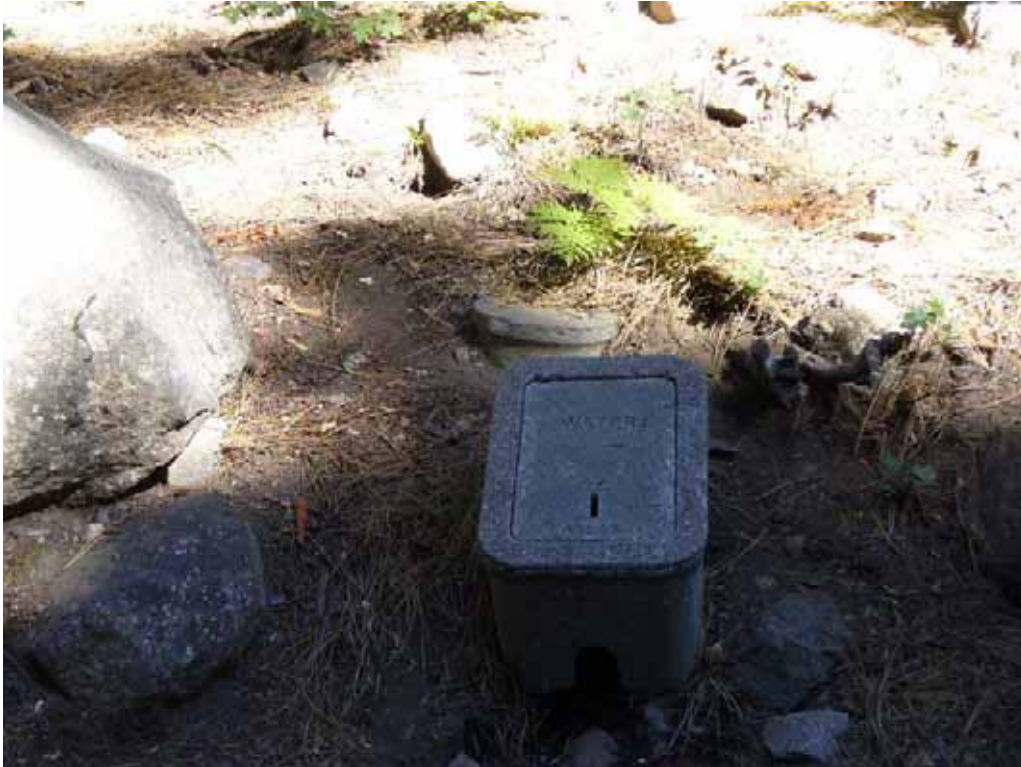
**Photo E-2-8. Water valve box on northwest side of parking area. (8/21/08)**

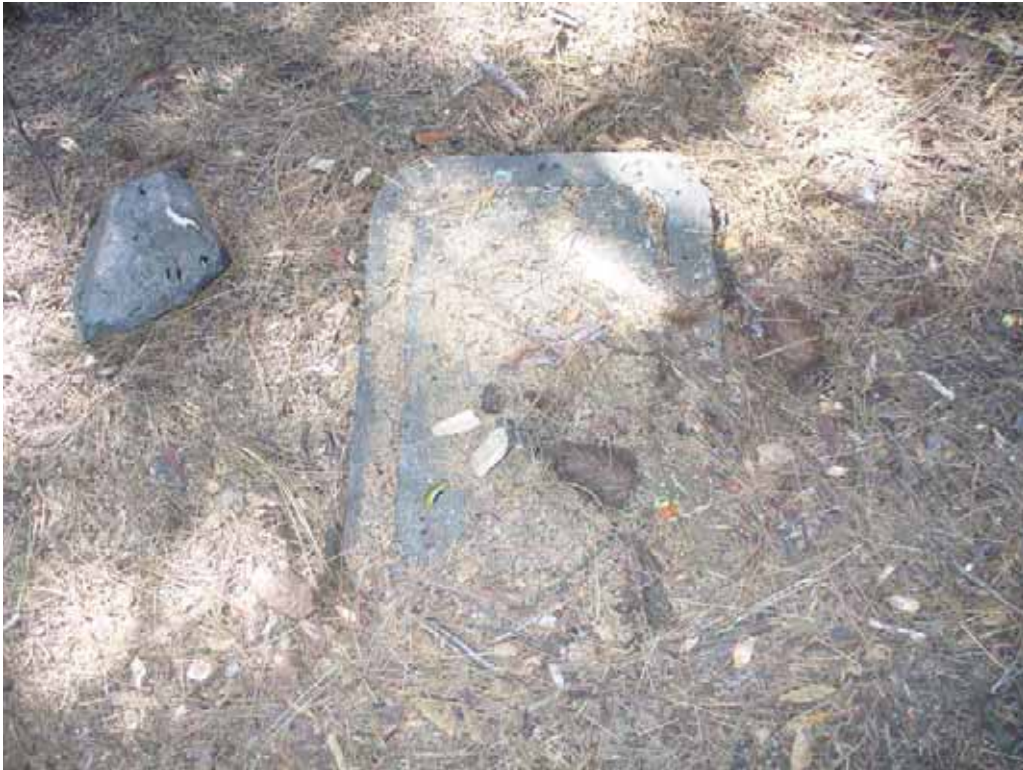
**Photo E-2-9. Water valve box on southeast side of parking area. (8/21/08)**

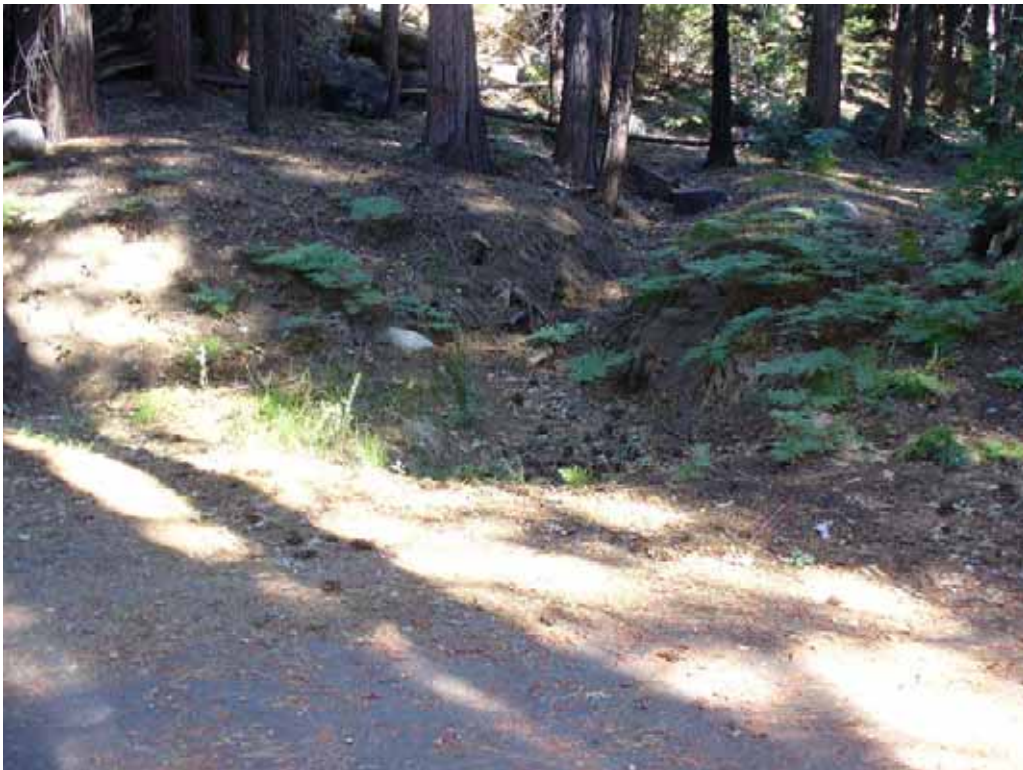
**Photo E-2-10. Drainage into parking area. (8/21/08)**

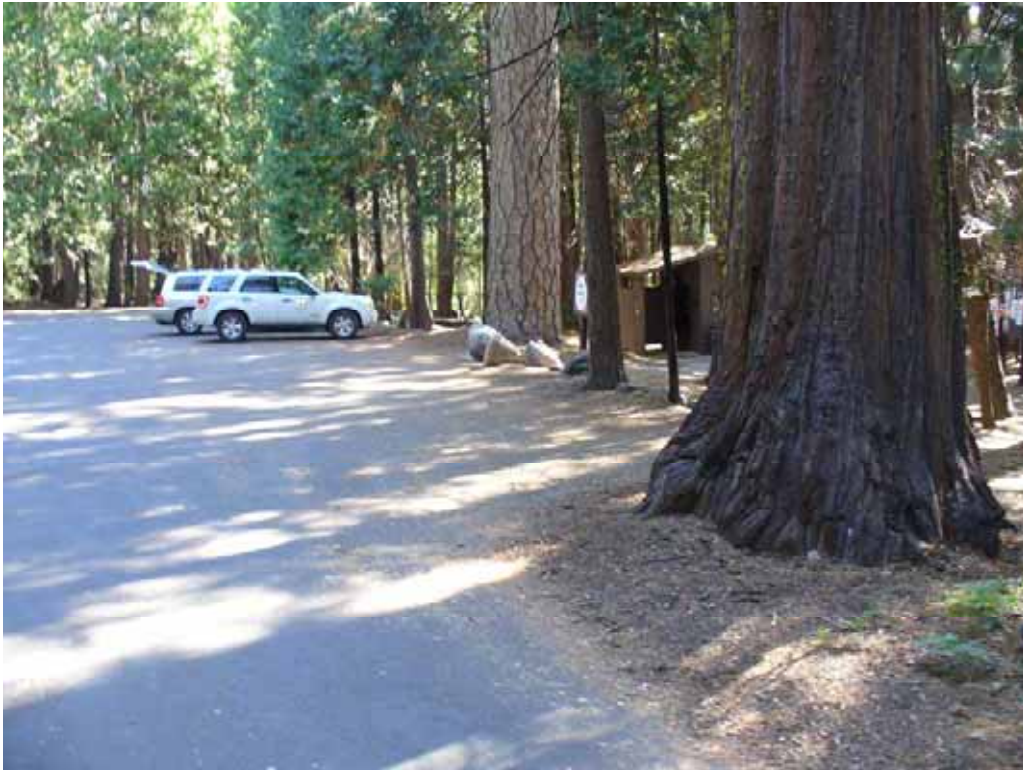
**Photo E-2-11. Hell Hole Campground parking area with bathroom and fee station are in background. (8/21/08)**

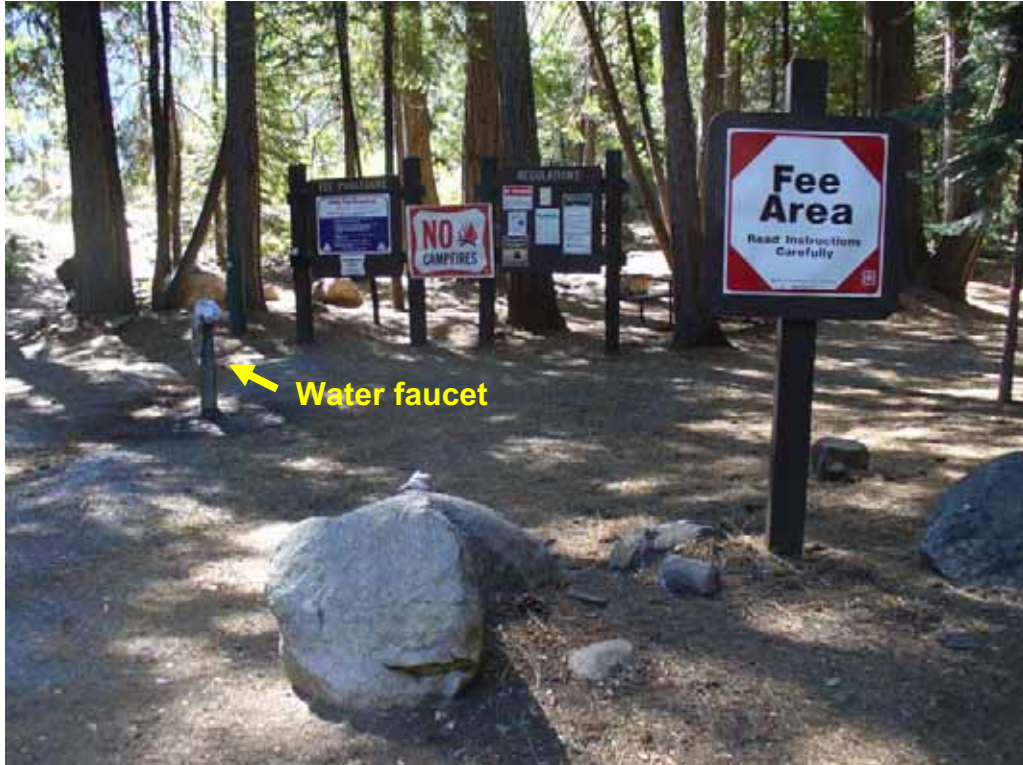
**Photo E-2-12. Fee station between parking area and campground. Note water faucet on left side of photograph. (8/21/09)**

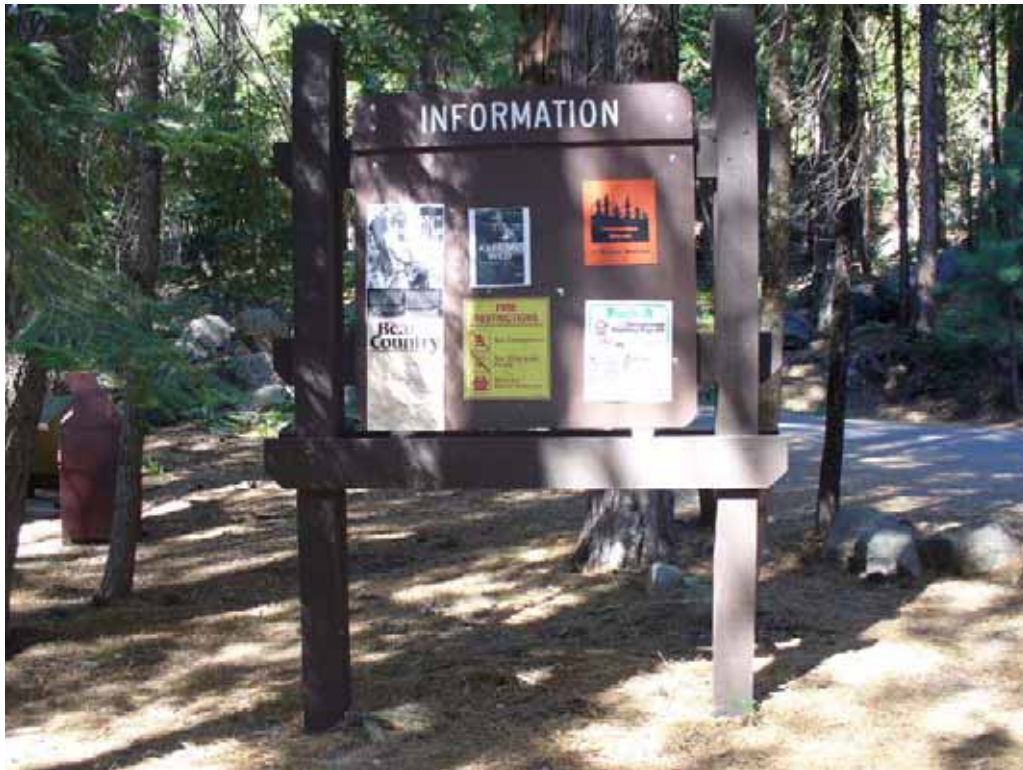
**Photo E-2-13. Information board adjacent to fee station. (8/21/08)**

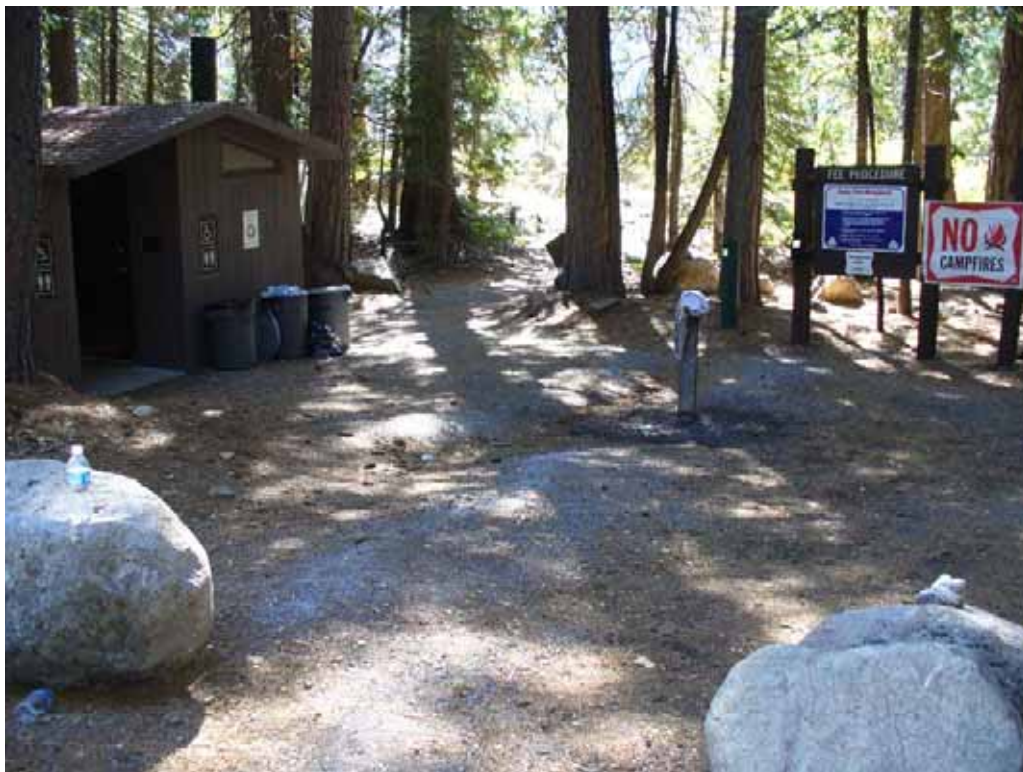
**Photo E-2-14. Single unit, accessible, vault toilet adjacent to fee station. Note poor drainage conditions between water faucet and toilet. (8/21/08)**

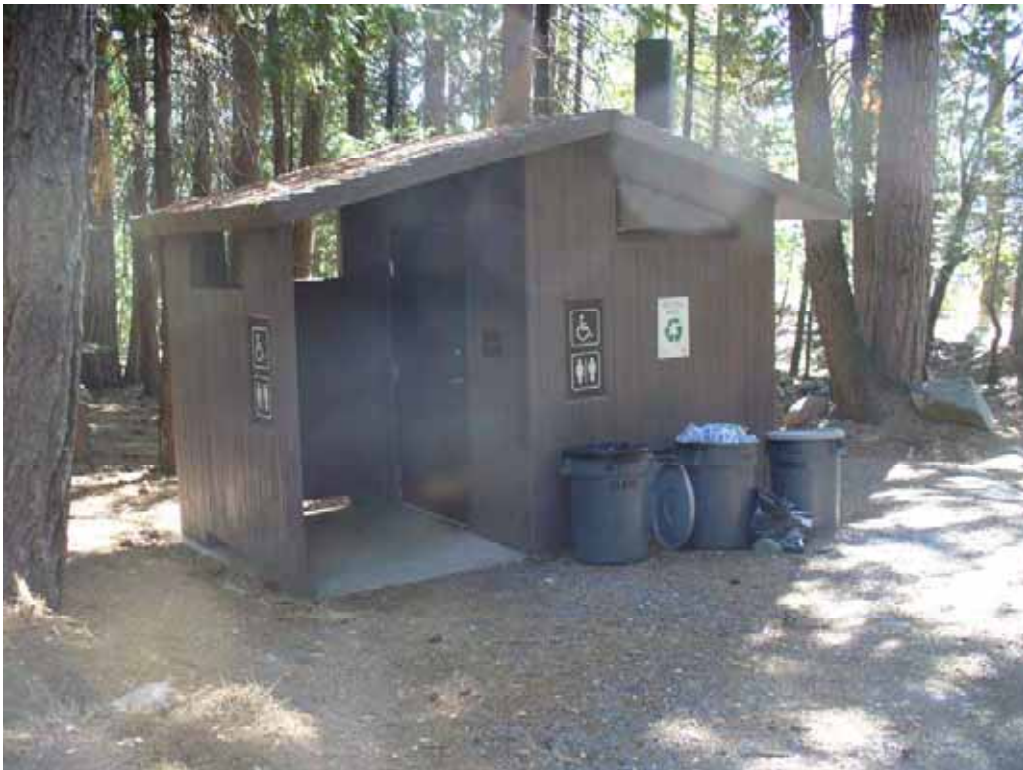
**Photo E-2-16. Single-unit, accessible, vault toilet and recycling bins. (8/21/08)**

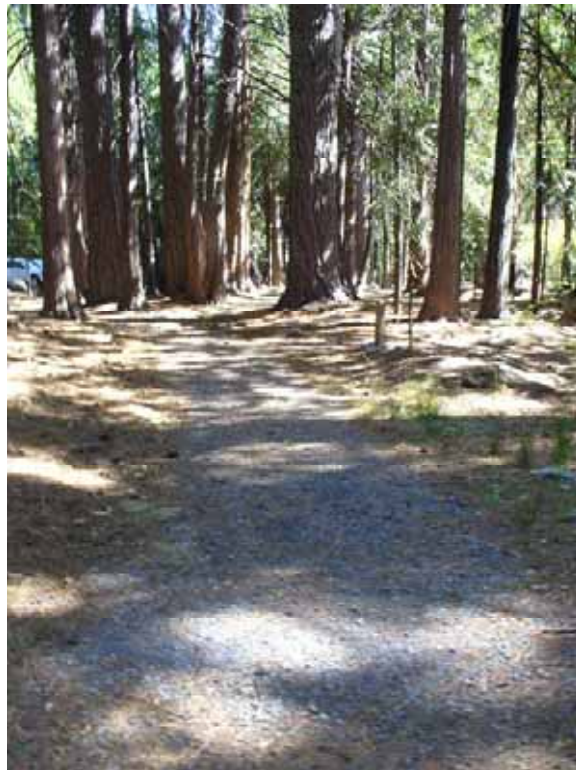
**Photo E-2-18. Accessible path between parking area and Sites 1 and 2. (8/21/08)**

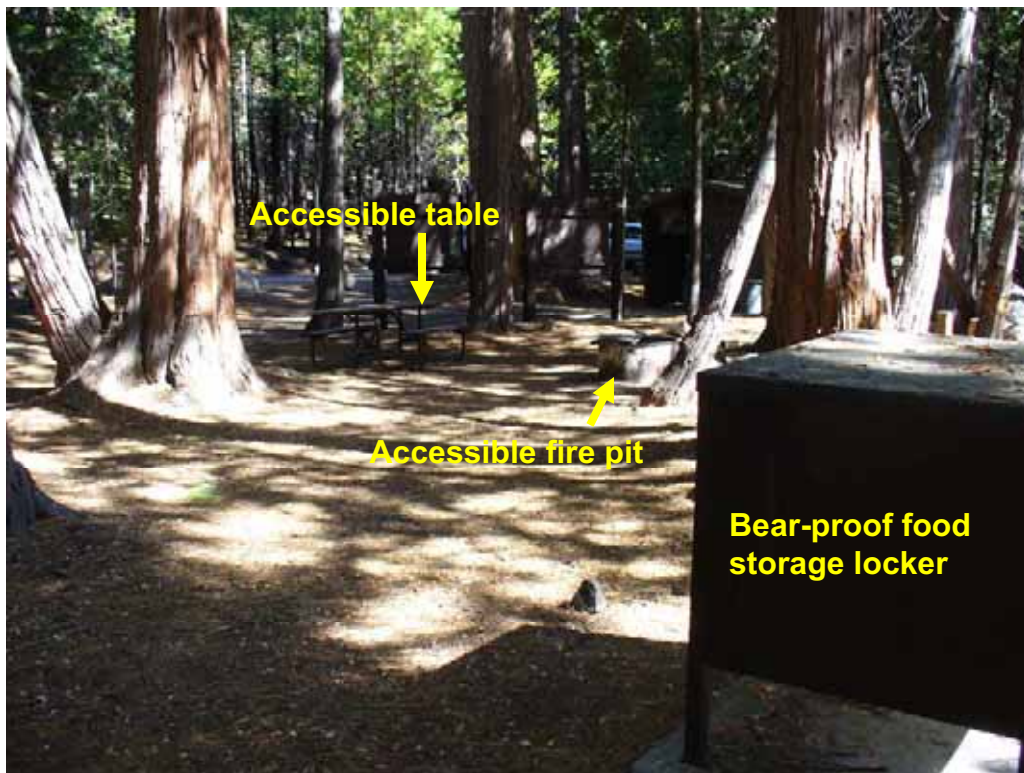
**Photo E-2-19. Site 1 with level surface, ample clear space, accessible table and accessible fire pit. (8/21/09)**

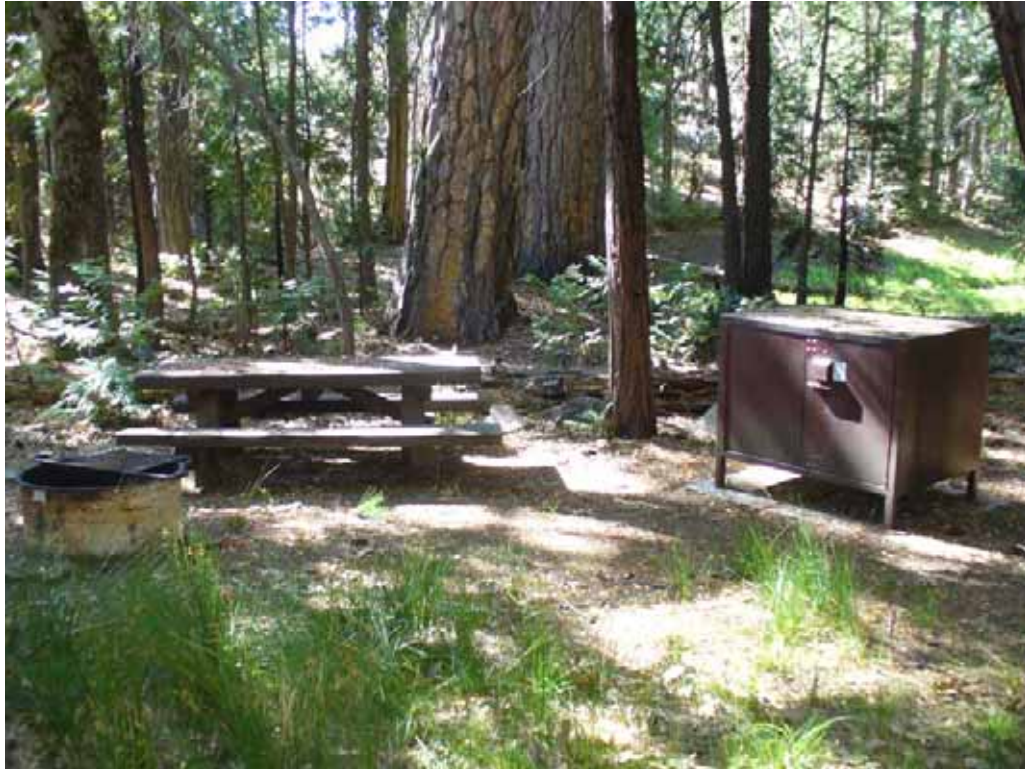
**Photo E-2-20. Example site – Site 2. (8/21/08)**

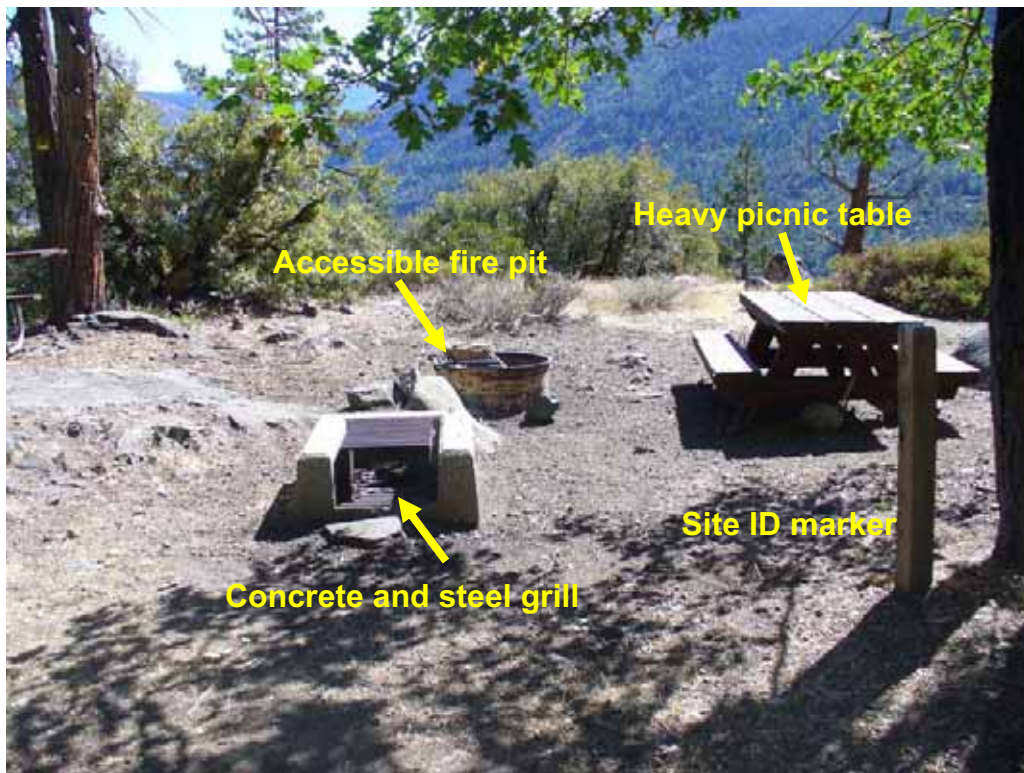
**Photo E-2-23. Example site – Site 6. This site overlooks Hell Hole Reservoir. (8/21/09)**

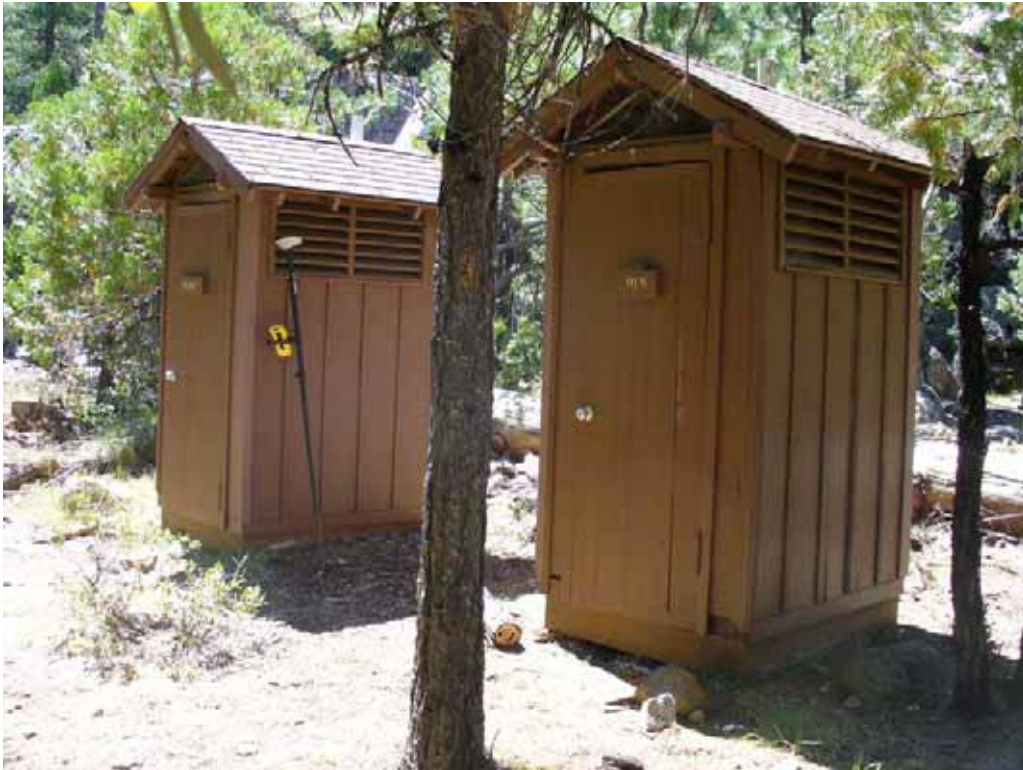
**Photo F-2-1. Pit toilets 1 and 2. (8/4/08)**

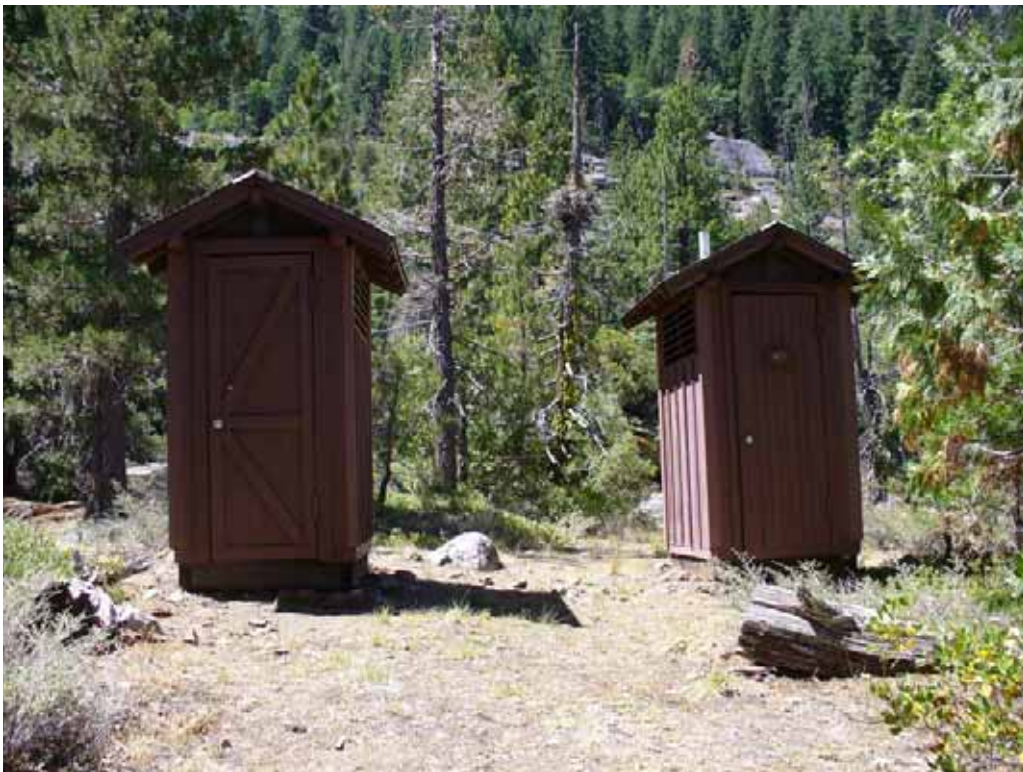
**Photo F-2-2. Pit toilets 3 and 4. (8/4/08)**

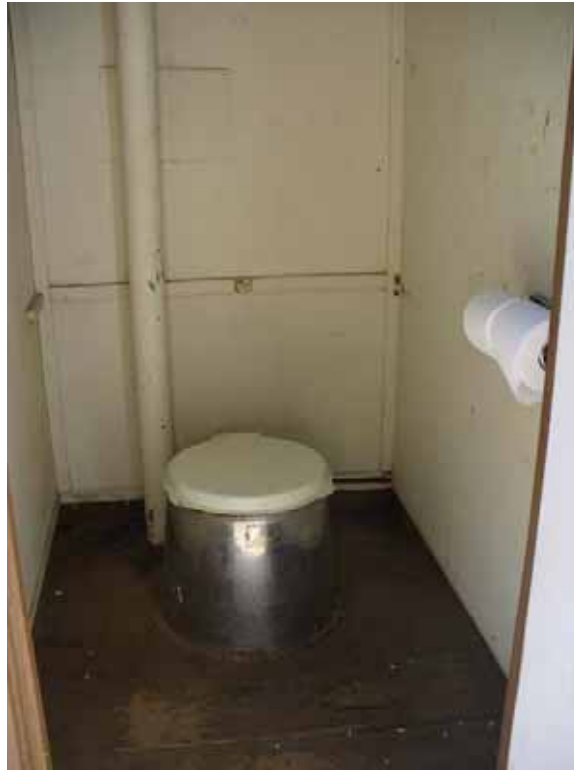
**Photo F-2-3. Example of inside of pit toilet. (8/4/08)**

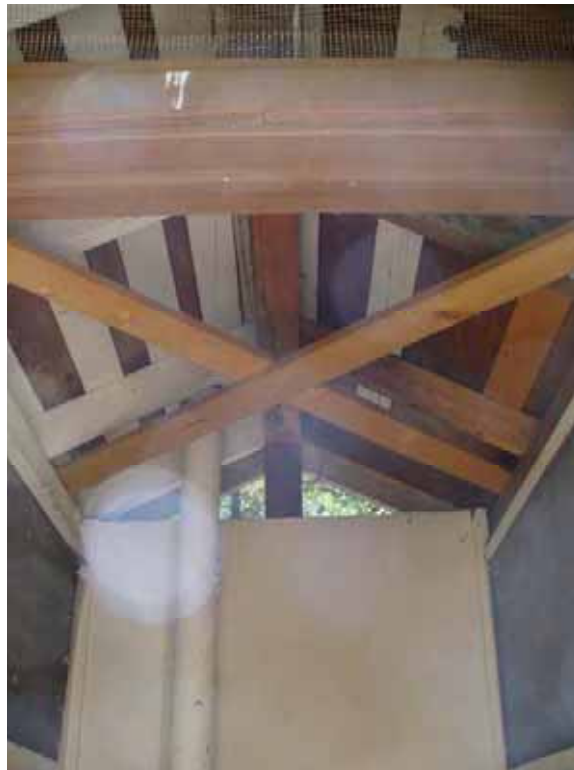
**Photo F-2-4. Example of inside of pit toilet. (8/4/08)**
