**Placer County Water Agency  
Middle Fork American River Project  
(FERC No. 2079)**

**REC 1 – RECREATION USE AND FACILITIES  
TECHNICAL STUDY REPORT**

Placer County Water Agency  
P.O. Box 6570  
Auburn, CA 95604

May 2010

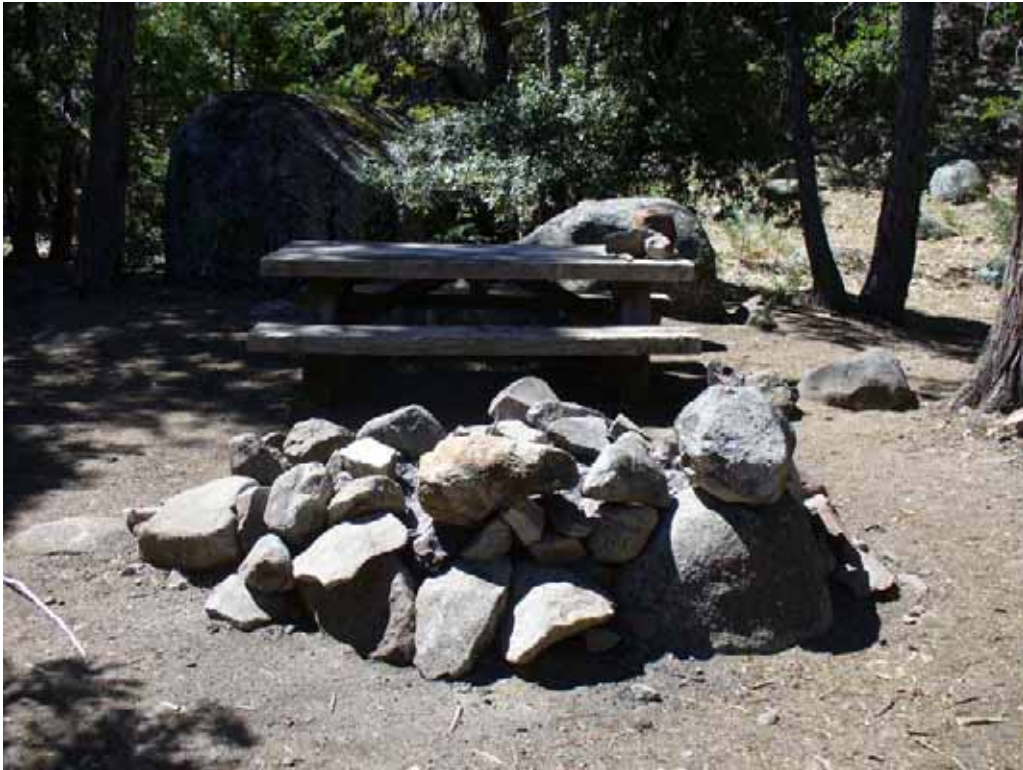
**Photo F-2-5. Heavy wood table and rock fire ring at site 2. (8/4/08)**

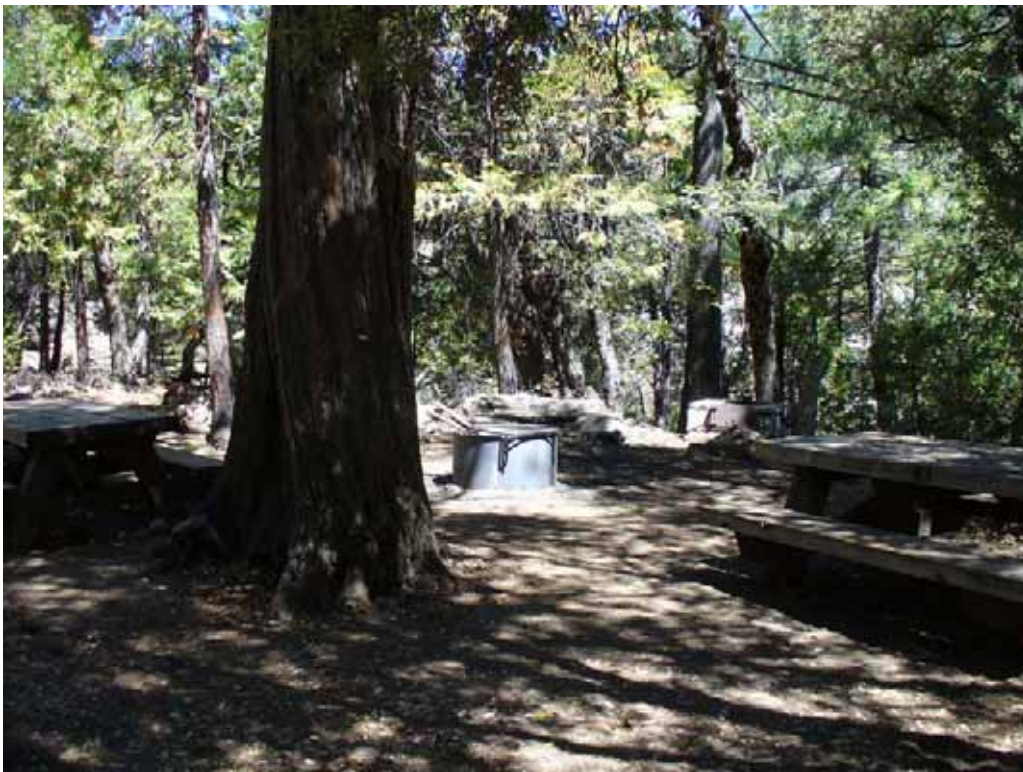
**Photo F-2-6. Site 3 with two heavy wood tables and one accessible fire ring. (8/4/08)**

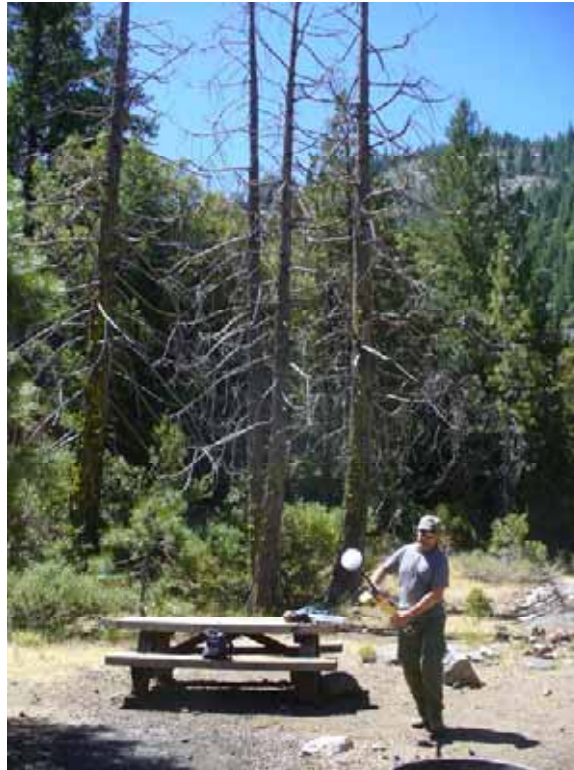
**Photo F-2-9. Picnic table at Site 6. Note hazard trees in middle ground. (8/4/08)**

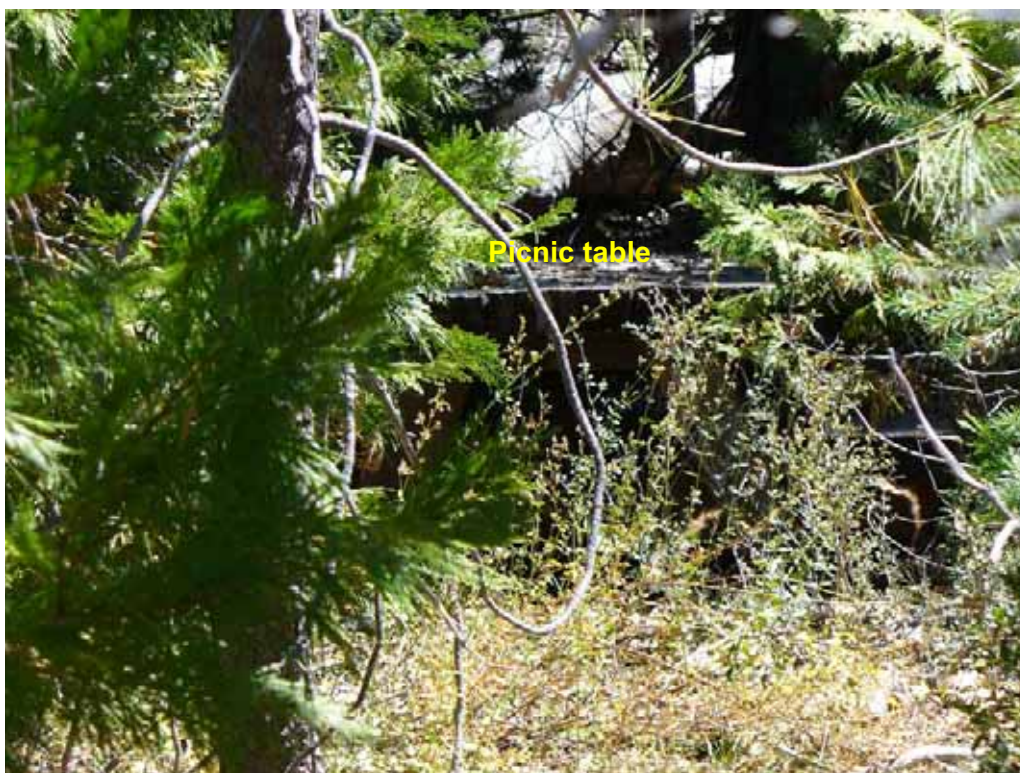
**Photo F-2-19. Overgrown table at Site 13. (8/4/08)**

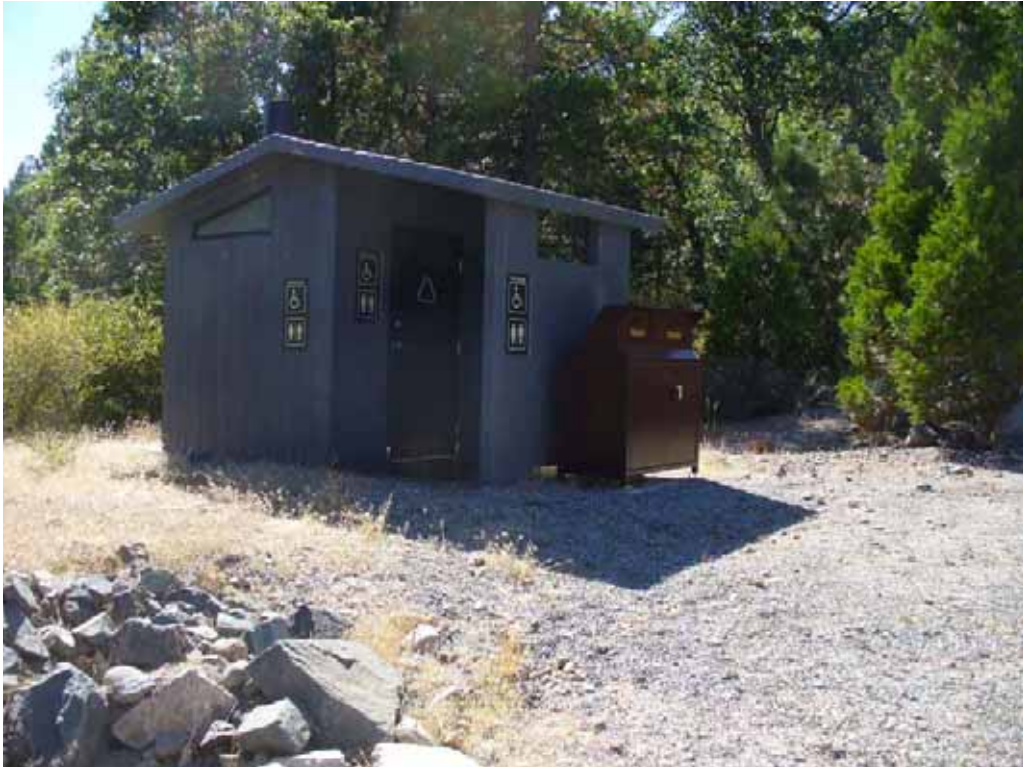
| Feature | Quantity or Dimensions | Location or Description | Material | Type | Cond | Accessibility | | | | | | Comments |
|---|---|---|---|---|---|---|---|---|---|---|---|---|
| <b>Bathroom</b> | Single-unit CXT | Near southwest end of parking area | Pre-cast concrete | Vault | Good | Y | | | | | | CXT is in good condition. Entrance path to CXT is wide and clear of obstacles but surface is not firm. |
| <b>Garbage Containers</b> | 1<br>(2-bin) | Adjacent to CXT. | Steel | Bear-proof 32-gallon | Good | N | | | | | X | This garbage container is in good condition but is not considered accessible due to the design of the handles. |

**Photo G-2-4. Single-unit vault pre-cast concrete toilet (CXT) and double-bin bear-proof garbage container located in Hell Hole Vista parking area. (8/4/08)**

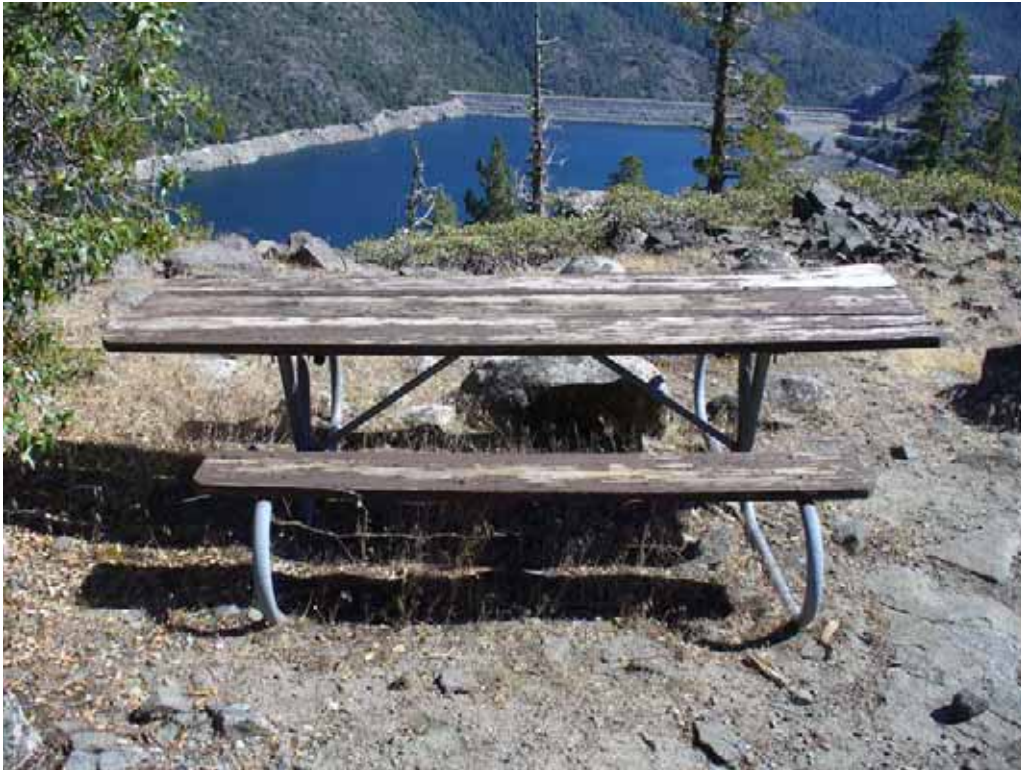
| Feature | Quantity or Dimensions | Location or Description | Material | Type | Cond | Accessibility | | | | | | Comments |
|---|---|---|---|---|---|---|---|---|---|---|---|---|
| <b>Tables</b> | 1 | Located along trail at the top of the ridge halfway to the overlook. | Painted wood on galvanized steel frame | Light | Poor | N | X | X | X | X | X | The table is in poor condition and should be replaced or removed. The area surrounding the table is not accessible due to rocky level changes and obstacles, including rocks and vegetation. |

**Photo G-2-7. Picnic table located along trail to Hell Hole Vista. Hell Hole Reservoir and Dam in background. (8/20/08)**

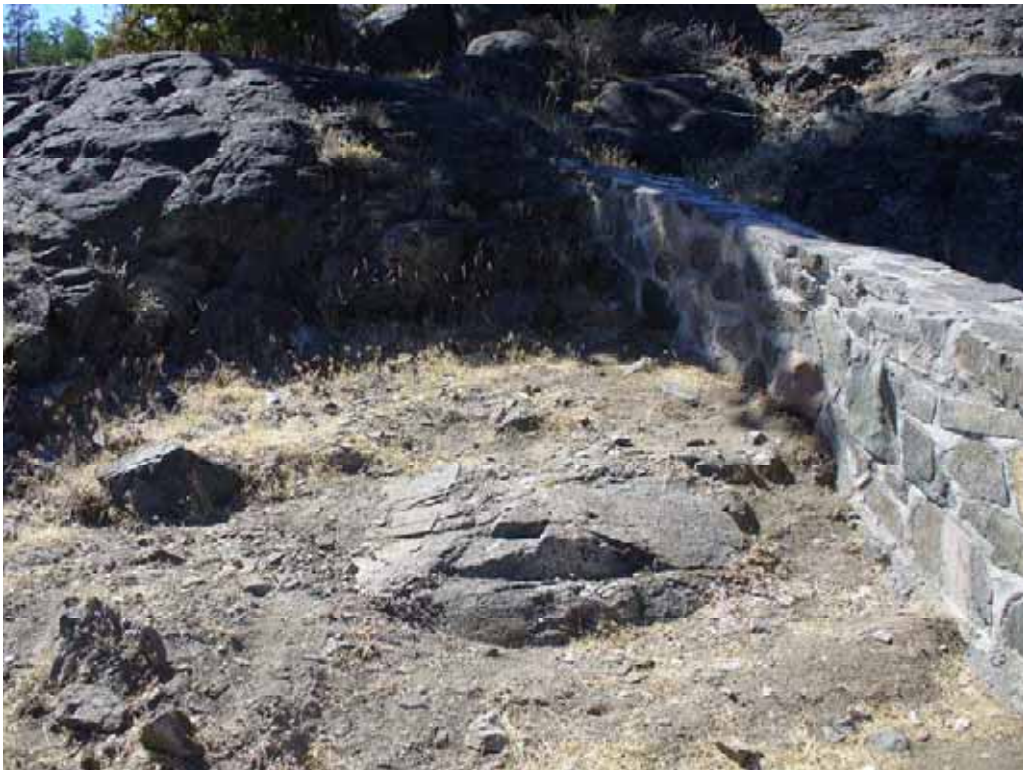
**Accessibility Conditions:** The parking area does not include any designated handicap parking areas. The surface does not meet accessibility standards in some areas due to potholes, level changes, and poor surface conditions. The CXT in the parking area is accessible. However, the surface area surrounding the CXT is not well consolidated. The picnic table does not have sufficient clear space. The trail traverses relatively steep terrain and is not accessible due to level changes, obstacles (e.g. stairs), and excessive running and cross slopes. The vista is not accessible due to level changes and obstacles.

**Photo G-2-10. Unlevel surface in Hell Hole Vista. (8/20/08)**

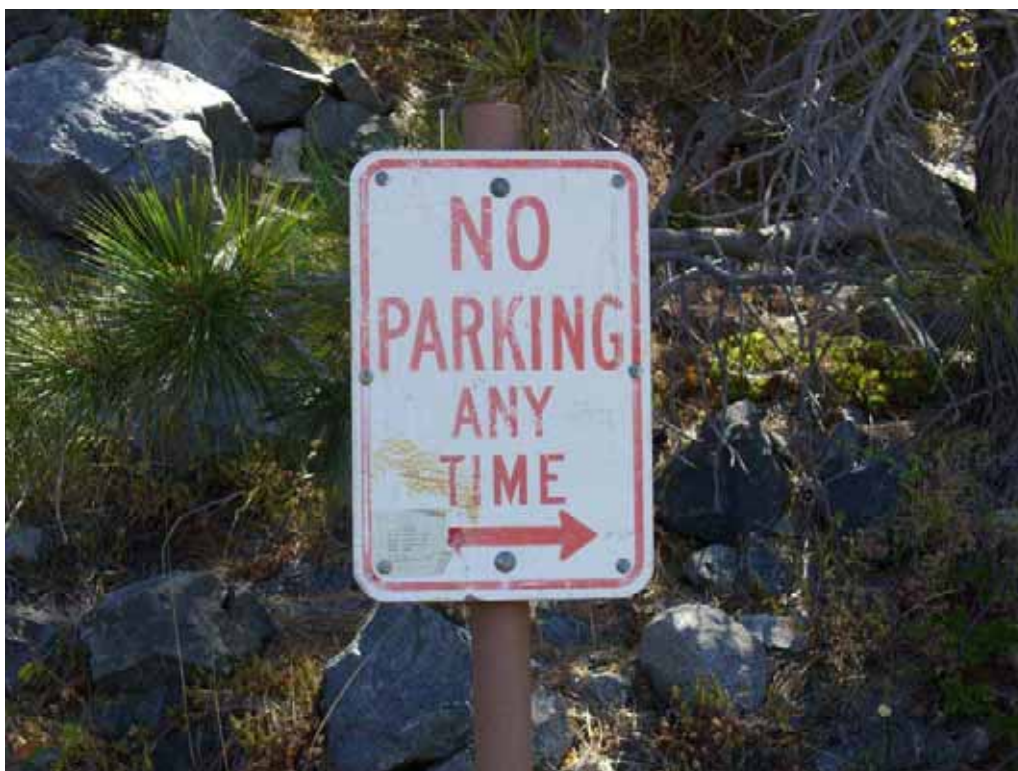
| Type of Sign | Location | Qt | Material | Cond | Wording/Graphics | Remarks | Accessibility Notes |
|---|---|---|---|---|---|---|---|
| Traffic | Near top of boat ramp (west side) | 1 | Aluminum sign (12"x18") on steel post | Fair | NO PARKING<br>ANY TIME | Faded, rusted | Faded. Poor contrast. |

**Photo H-2-2. Example of “no parking” sign located along Hell Hole Boat Ramp. Condition is “fair” due to faded lettering. (8/4/08)**

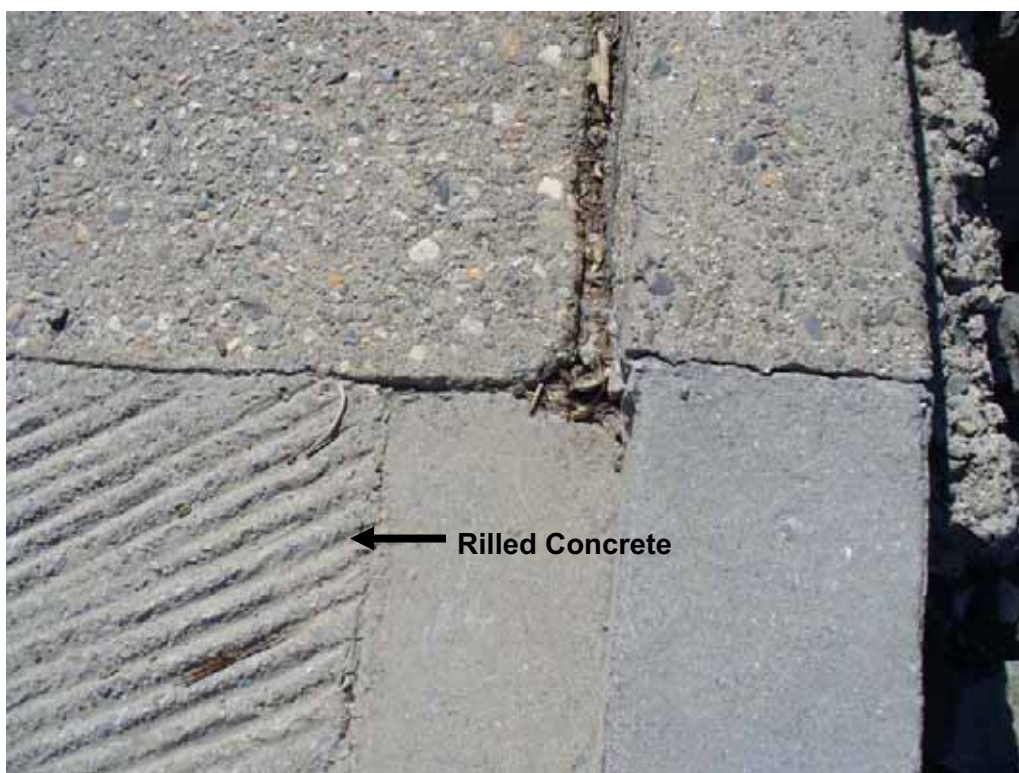
| <b>Accessibility Conditions:</b> The boat ramp is not considered disabled accessible due to the steep grade and the presence of obstacle and rills in the concrete. Also, there is no flat area for entering or exiting a boat. |

**Photo H-2-5. Example of rilled concrete at lower end of ramp. (8/4/08)**

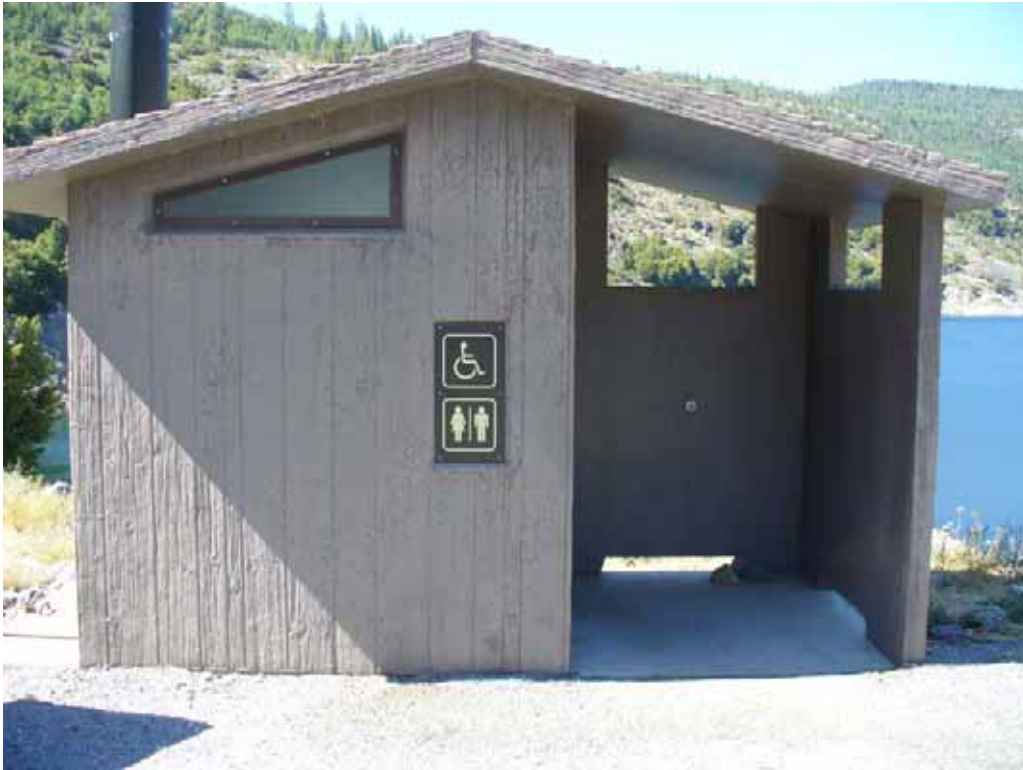
| Feature | Quantity or Dimensions | Location or Description | Material | Type | Cond | Accessibility | | | | | | Comments |
|---|---|---|---|---|---|---|---|---|---|---|---|---|
| <b>Bathroom</b> | Single-unit CXT | Adjacent to parking area, at top of ramp. | Pre-cast concrete | Vault | Good | Y | | | | | | In good condition. However, ceiling is sagging and should be repaired. |

**Photo H-2-9. Single unit pre-cast concrete toilet (CXT). Disabled accessible and in good condition. (8/4/08)**

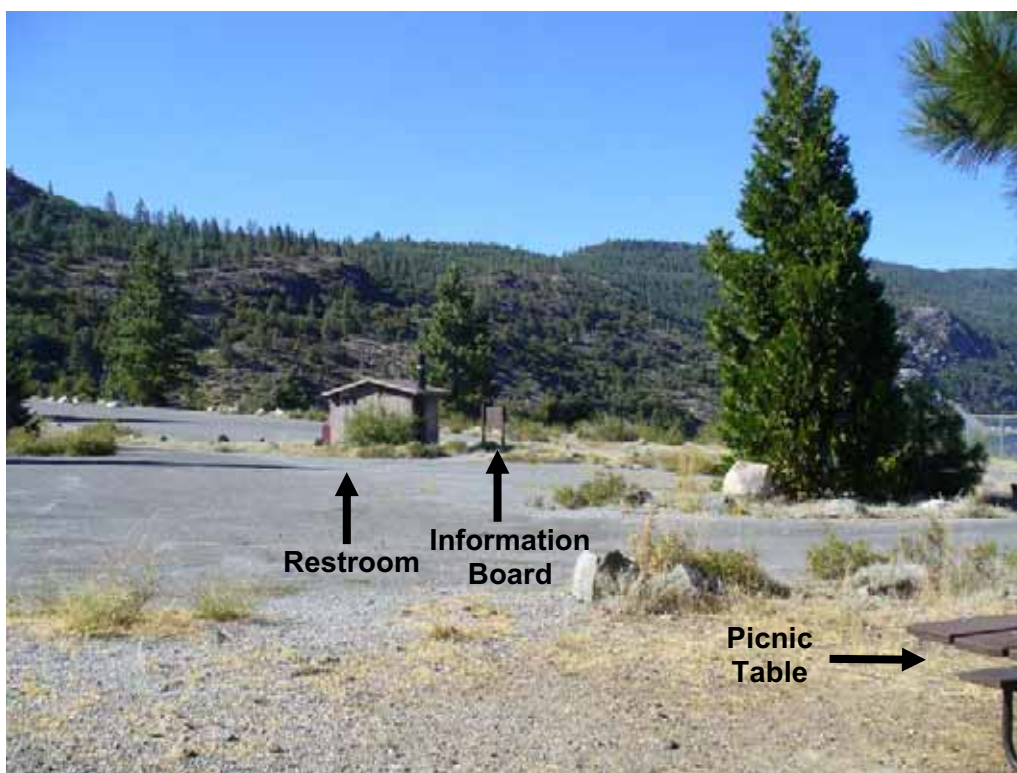
**Photo H-2-21. Hell Hole Boat Ramp General Parking Area (southeastern portion). Surface is asphalt with chip seal in poor condition. Note restroom and information board in middleground and picnic table in foreground (right). (8/4/08)**

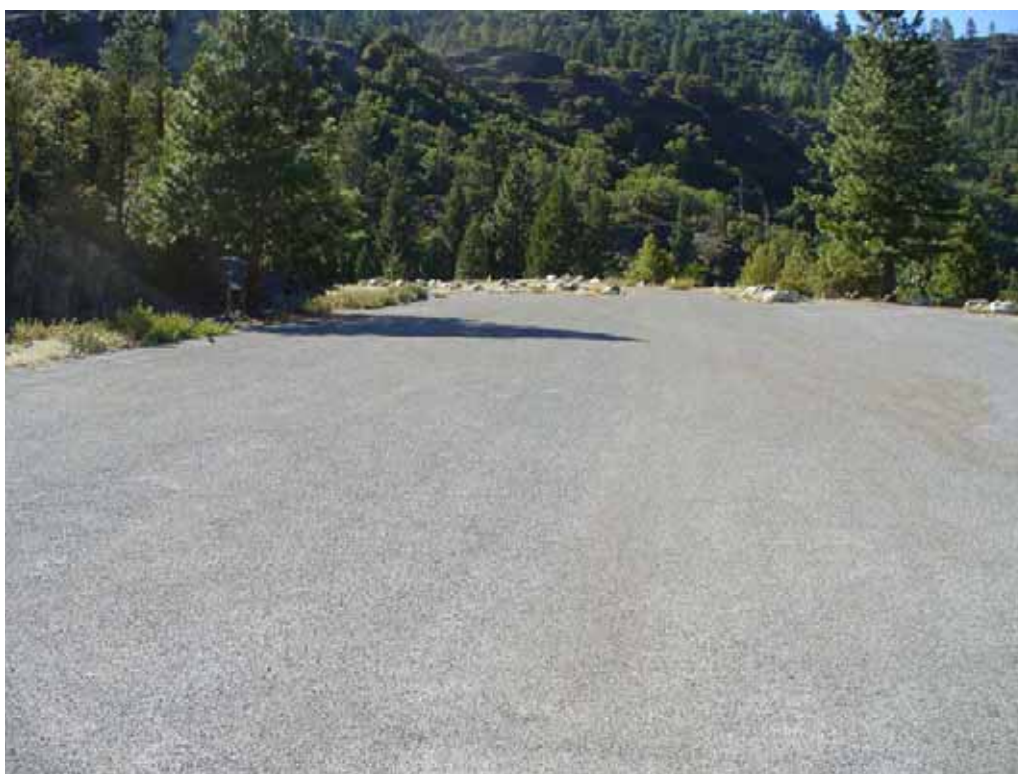
**Photo H-2-22. Hell Hole Boat Ramp General Parking Area (northern portion). Surface is asphalt with chip seal in good condition. (8/4/08)**

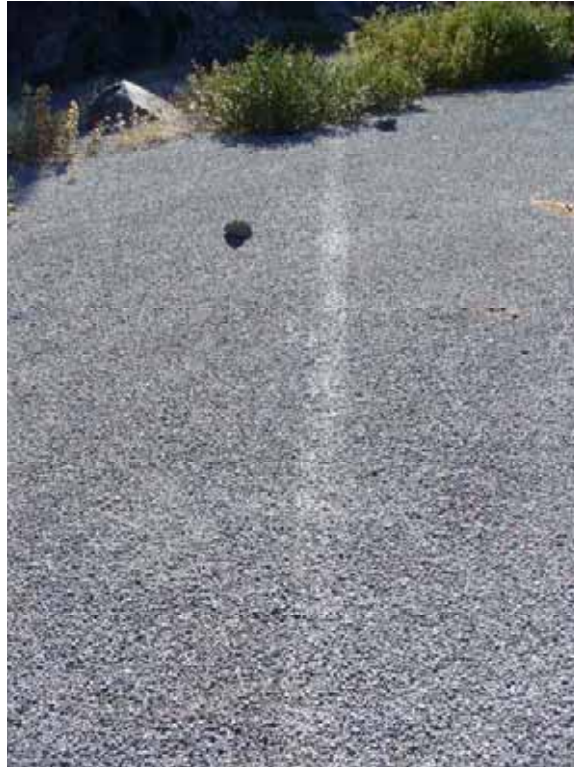
**Photo H-2-26. Example of faded parking stall striping on asphalt with chip seal. (8/4/08)**

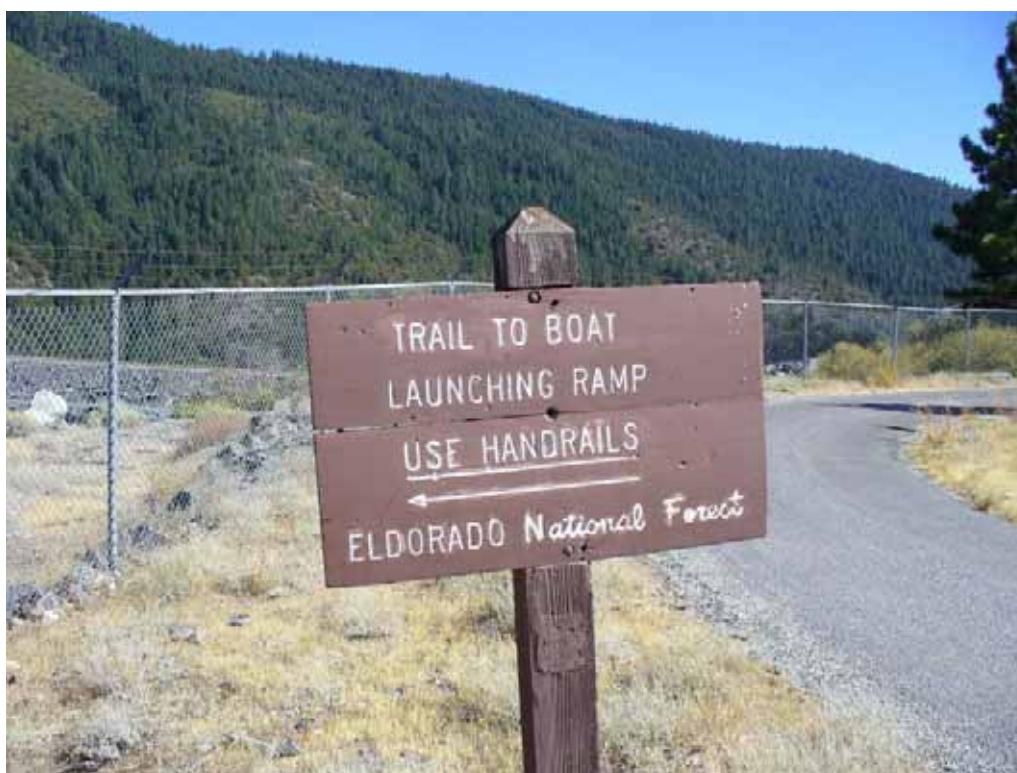
**Photo H-2-30. Directional sign at entrance to trail/stairway to Hell Hole Boat Ramp. Sign is constructed of painted wood on wood post. Sign is in fair condition due to split boards and faded lettering. (8/4/08)**

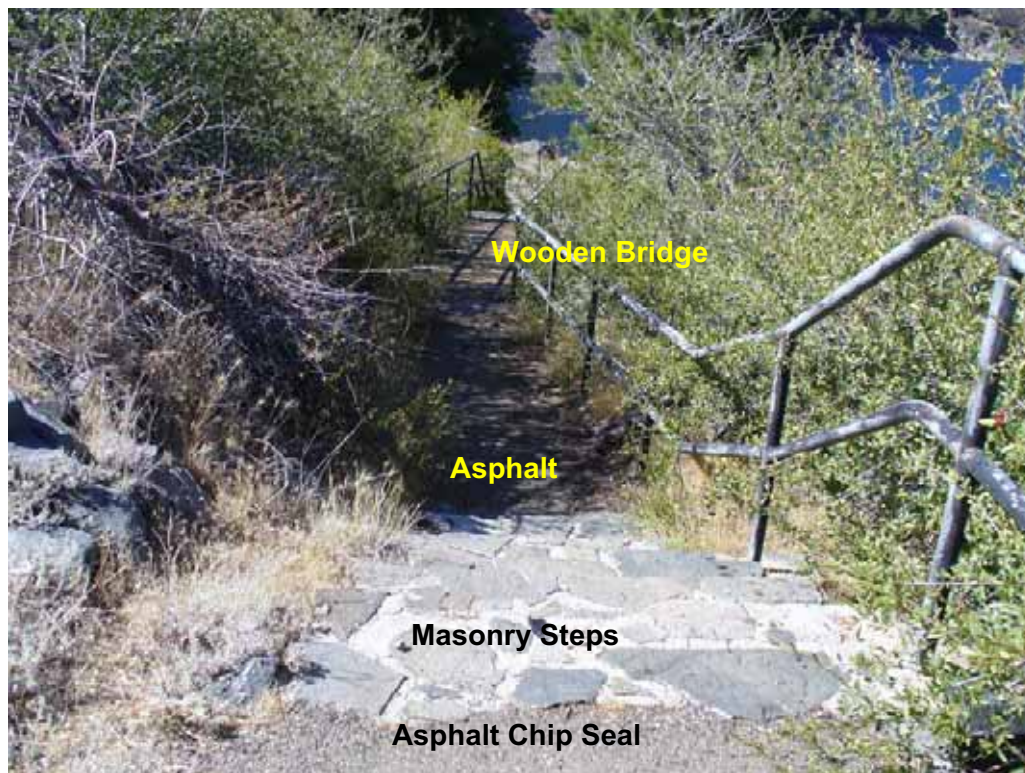
**Photo H-2-31. Top portion of trail/stairway to Hell Hole Boat Ramp. Note various surface types: asphalt chip seal landing/masonry steps/asphalt/wooden bridge/asphalt. Also note steel handrails. Not disabled accessible. (8/4/08)**

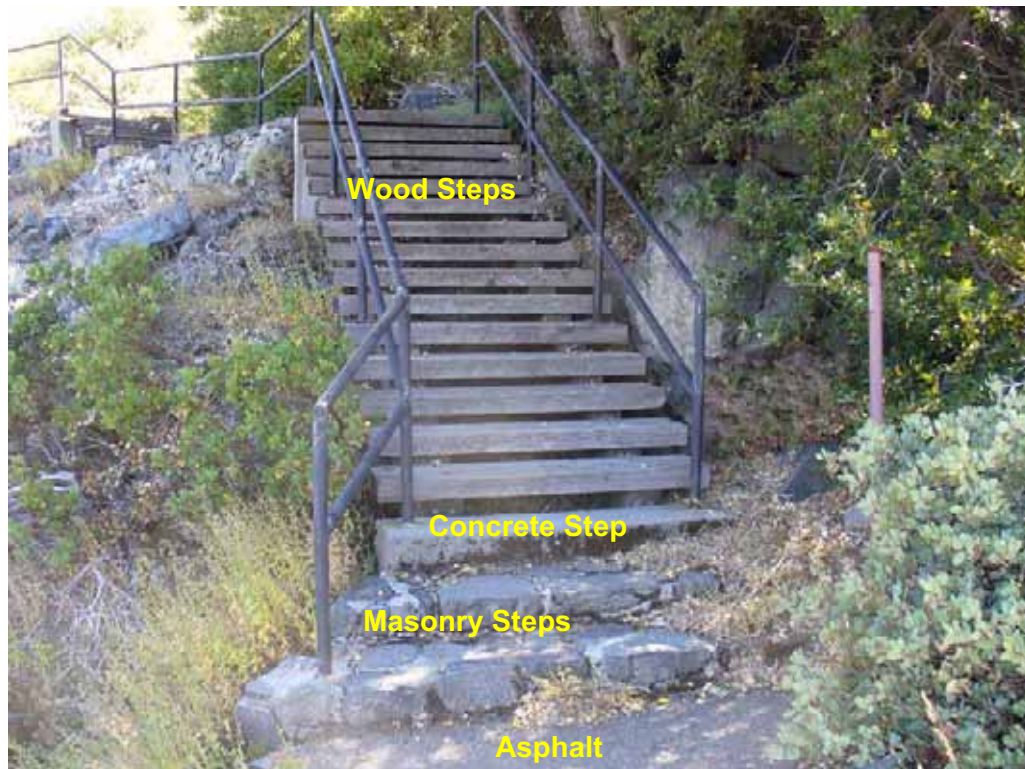
**Photo H-2-32. Lower portion of trail/stairway looking up towards General Parking Area. Note various surface types: asphalt landing masonry steps/concrete step/wood steps. Also note steel handrails. Not disabled accessible. (8/4/08)**

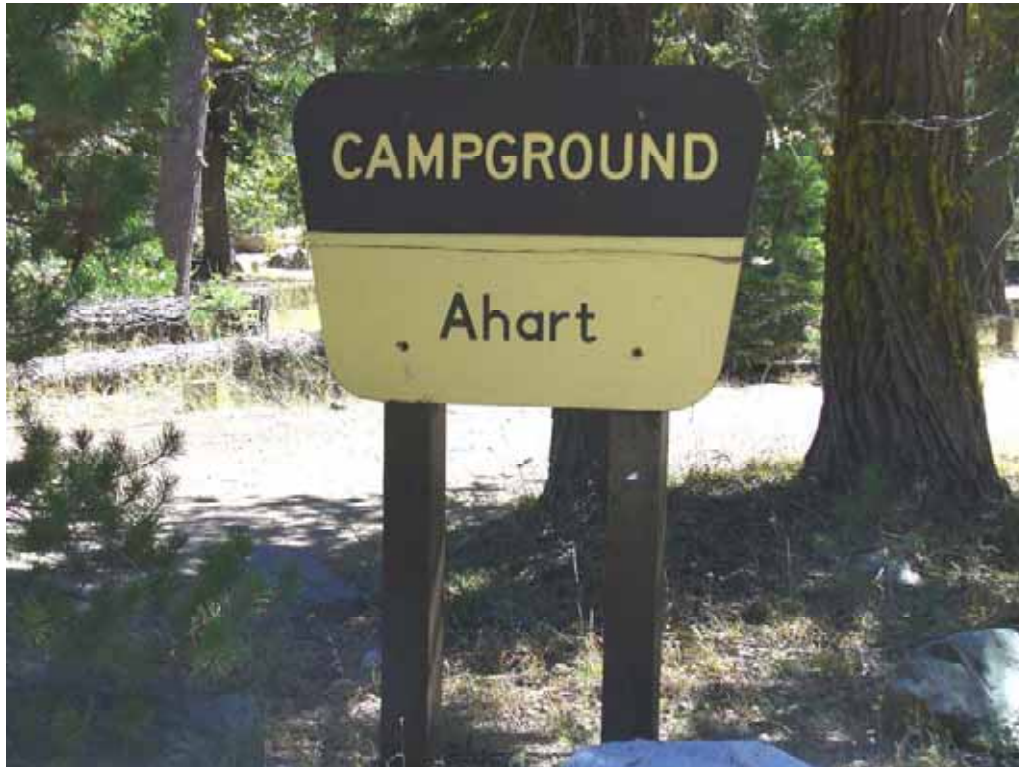
| Type of Sign | Location | Qt. | Material | Cond | Wording/Graphics | Remarks | Accessibility Notes |
|---|---|---|---|---|---|---|---|
| Site Identification | Entrance to campground (north side) | 1 | Painted MDO plywood on painted wood posts (36" x 51") | Fair | CAMPGROUND Ahart | Sign is functional but split horizontally. Needs to be repaired or replaced. | |

**Photo I-2-2. Site identification sign at entrance to Ahart Campground. This site is in fair condition due to the large crack. (9/04/08)**

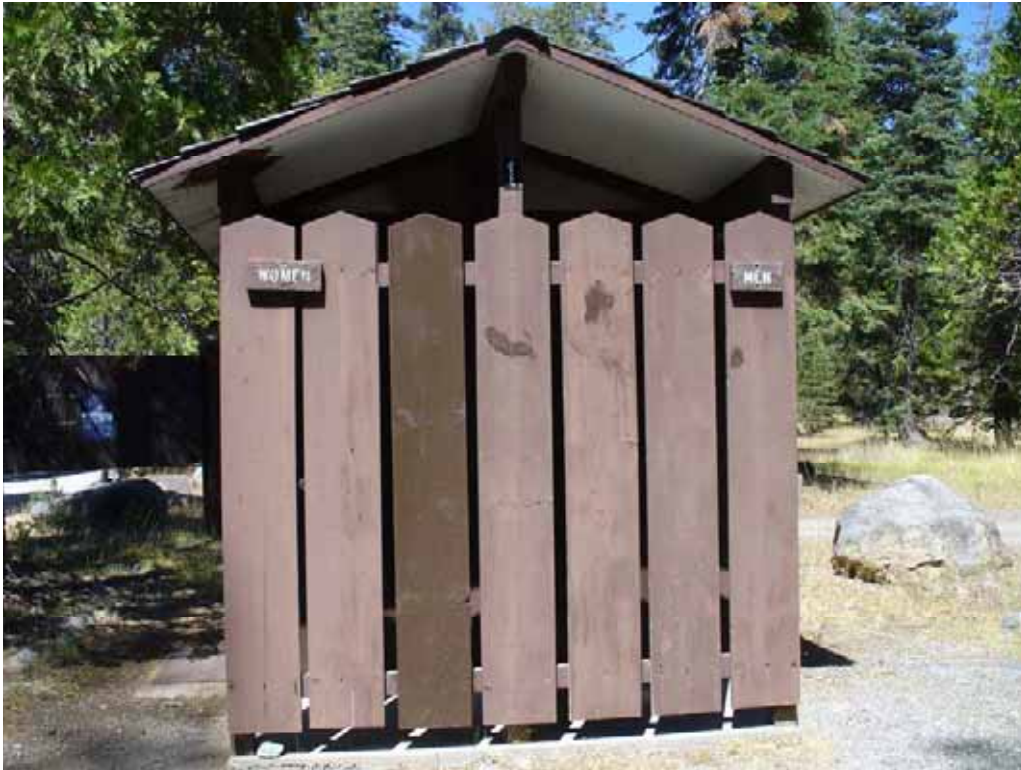
| Feature | Quantity or Dimensions | Location or Description | Material | Type | Cond | Accessibility | | | | | | Comments |
|---|---|---|---|---|---|---|---|---|---|---|---|---|
| <b>Bathroom</b> | 1 double unit | Across from Site 5. Identified as No. 1. | Wood | Vault | Fair | N | | | | | | Entrance and stall are too narrow. Concrete lip. Exterior condition is fair due to roof rot. Interior condition is good. |

**Photo I-2-13. Double-unit, vault toilet building (No. 1). (9/04/08)**

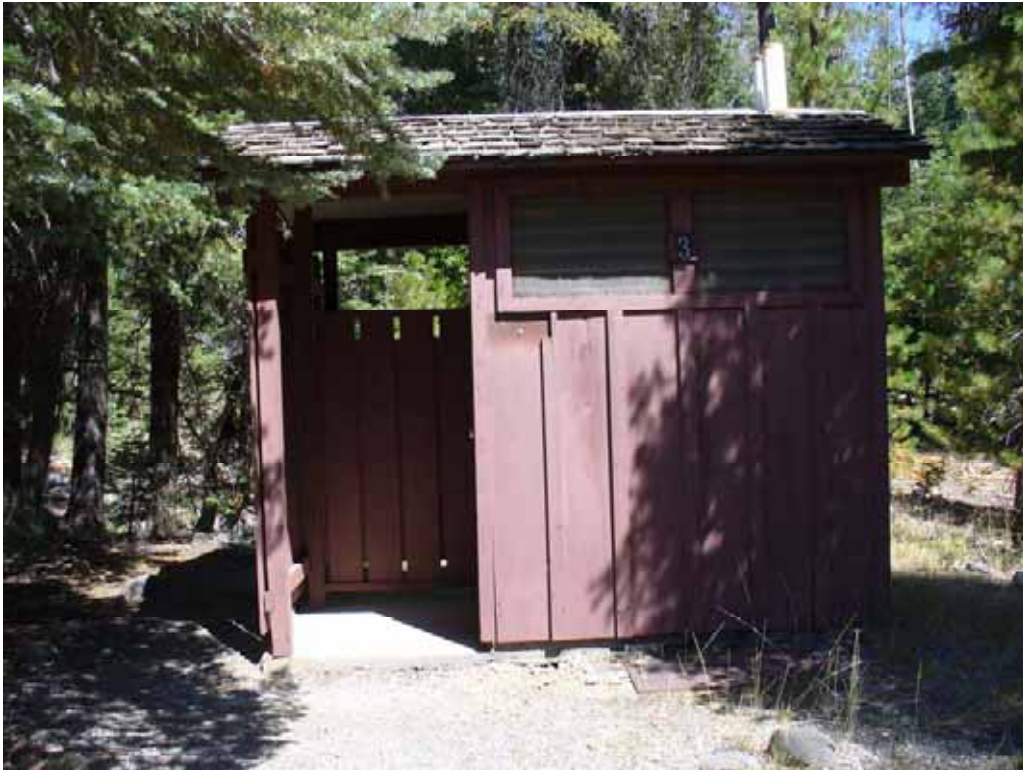
| Feature | Quantity or Dimensions | Location or Description | Material | Type | Cond | Accessibility | | | | | | Comments |
|---|---|---|---|---|---|---|---|---|---|---|---|---|
| <b>Bathroom</b> | 1 double unit | Next to Site 8. Identified as No. 3. | Wood | Vault | Good | N | | | | | | Entrance and stall are too narrow. Concrete lip. Exterior and interior condition is good. |

**Photo I-2-15. Toilet building No. 3. (9/04/09)**

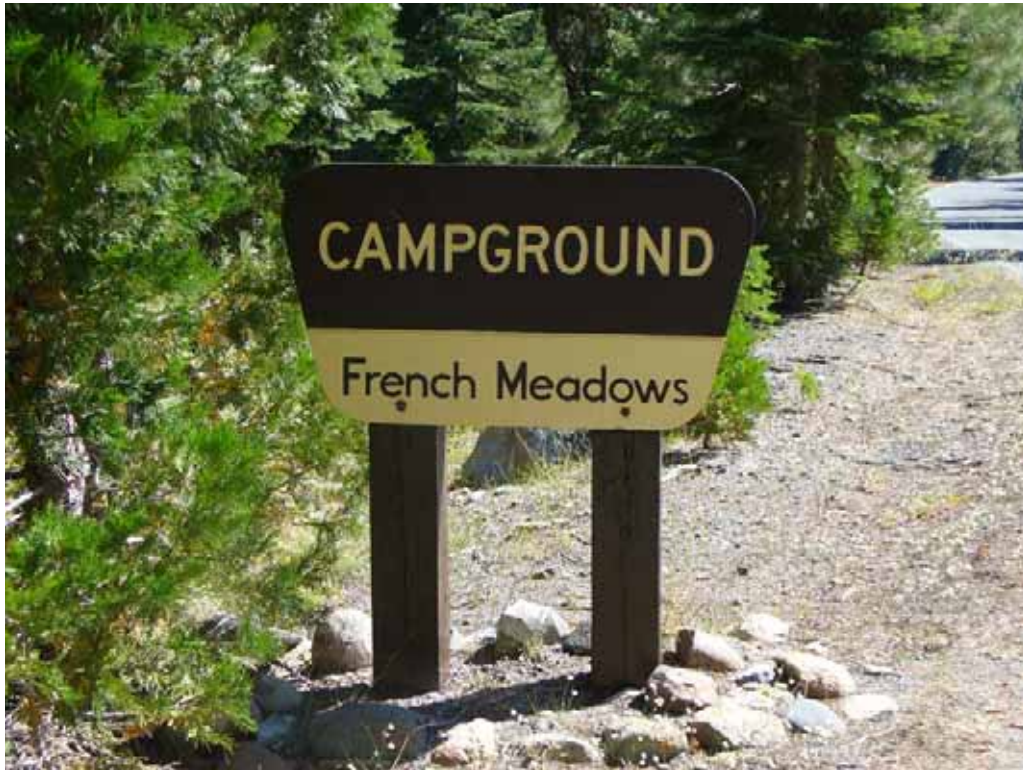
Photo J-2-1. Site Identification sign, good condition. (7/24/08)

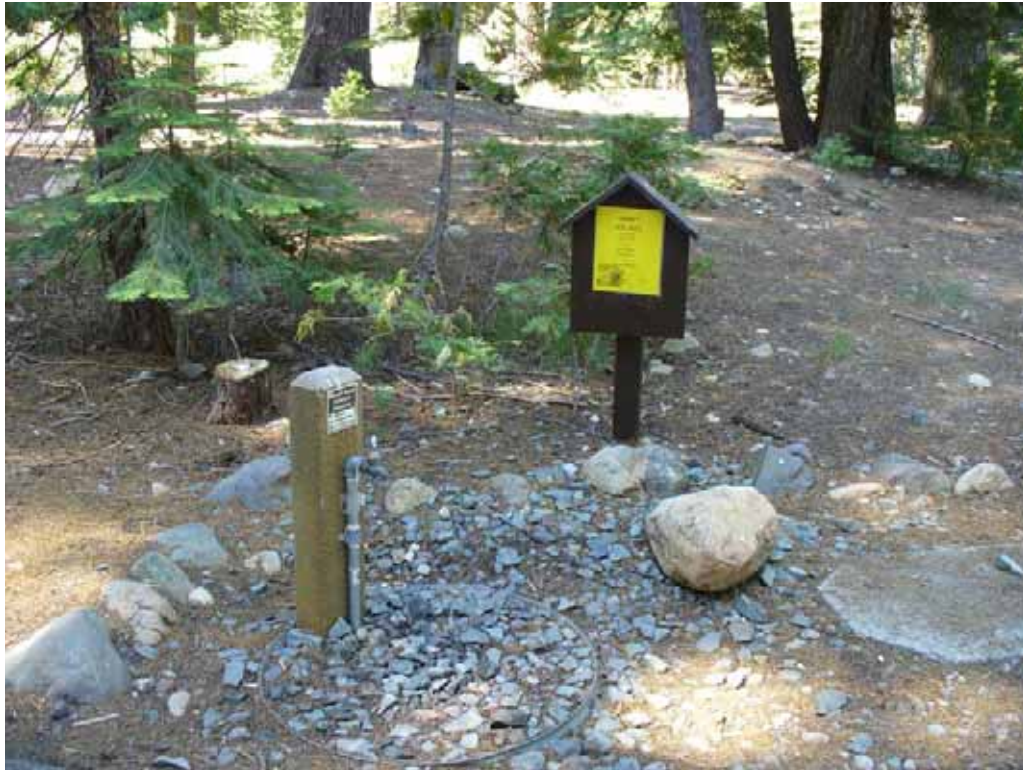
**Photo J-2-9. Typical water faucet and information board. Faucet is not accessible. (7/24/08)**

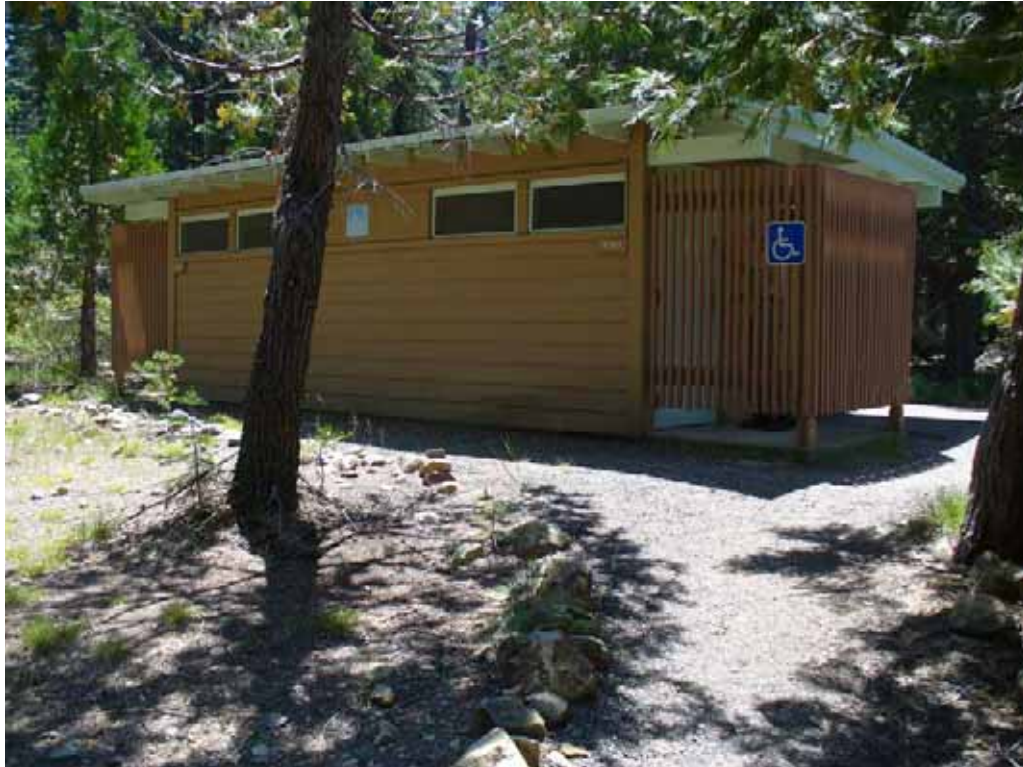
**Photo J-2-10. Wood bathrooms with have flush toilets and sinks, converted to be accessible. Note accessible pathway. (7/24/08)**

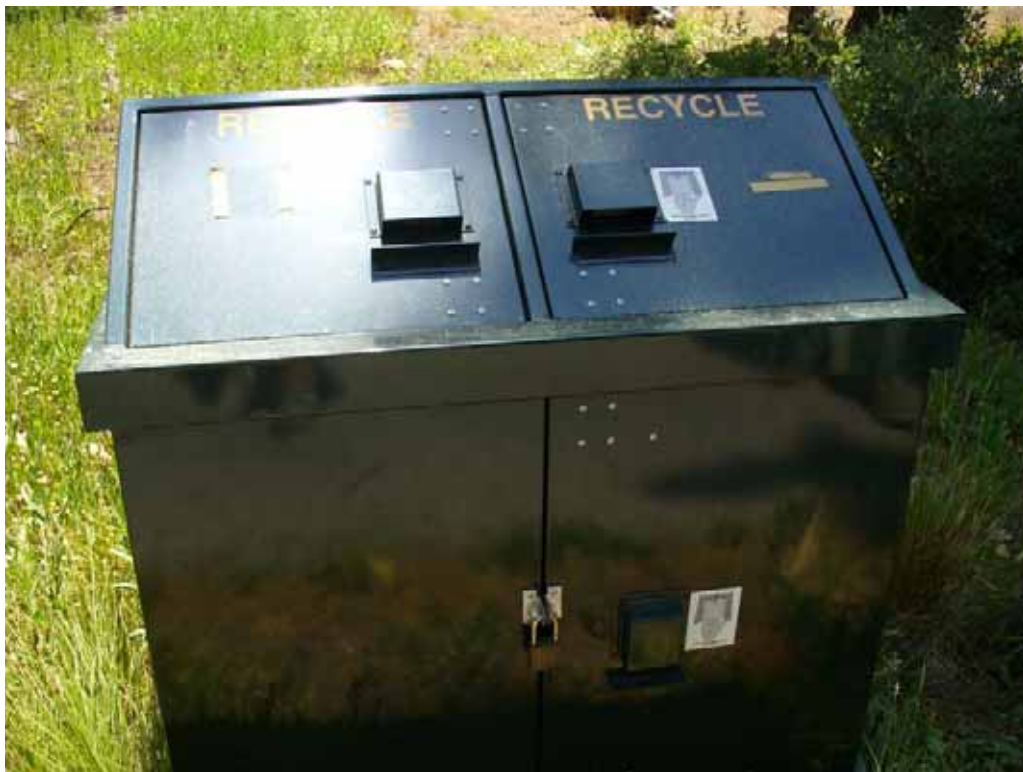
**Photo J-2-16. Bear-proof recycling container. (7/24/08)**

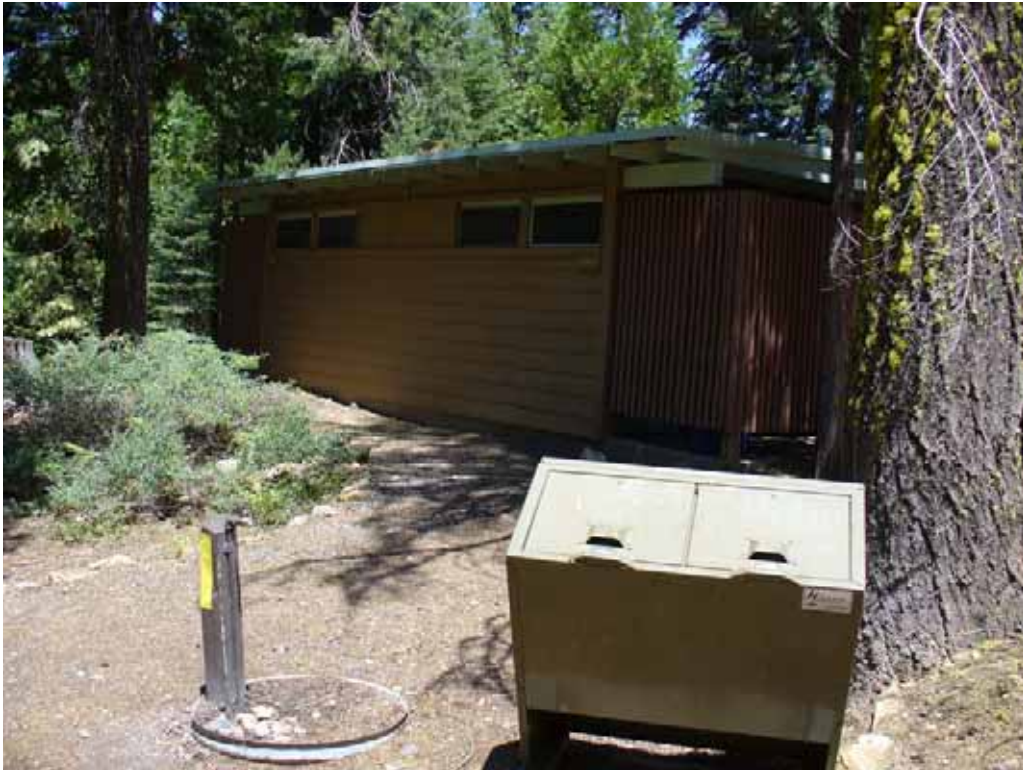
**Photo J-2-17. Typical bear-proof garbage container and water faucet. Bathroom #6 in background. (7/24/08)**

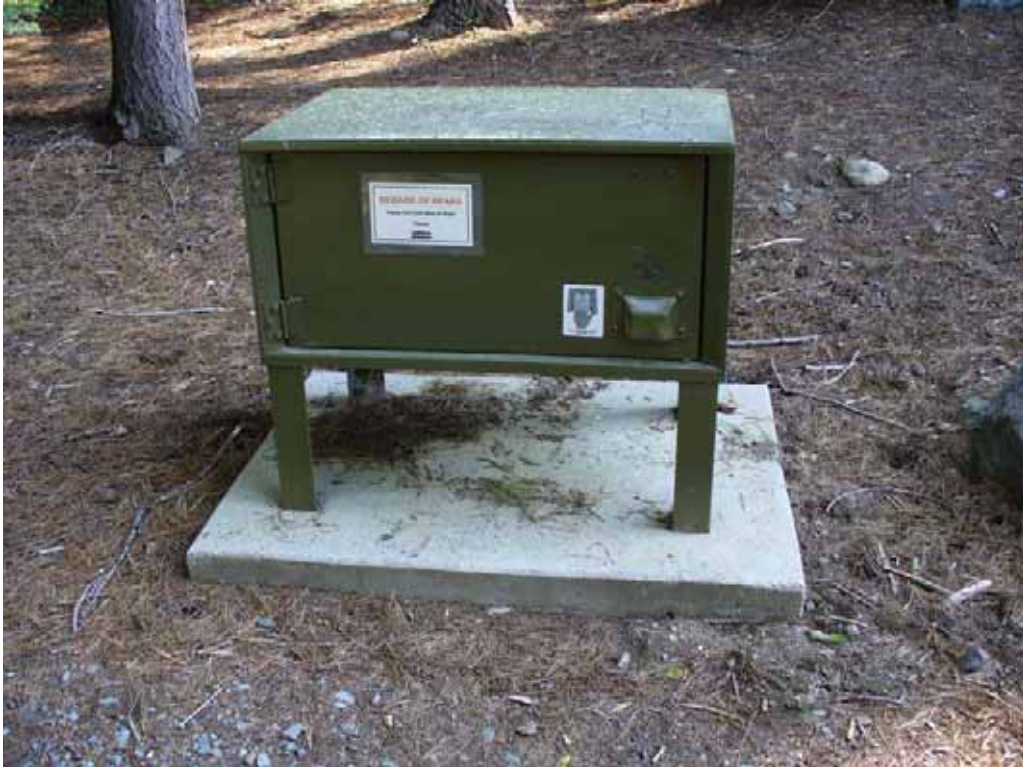
**Photo J-2-18. Typical bear-proof food storage locker (bear box) on concrete pad. (7/24/08)**

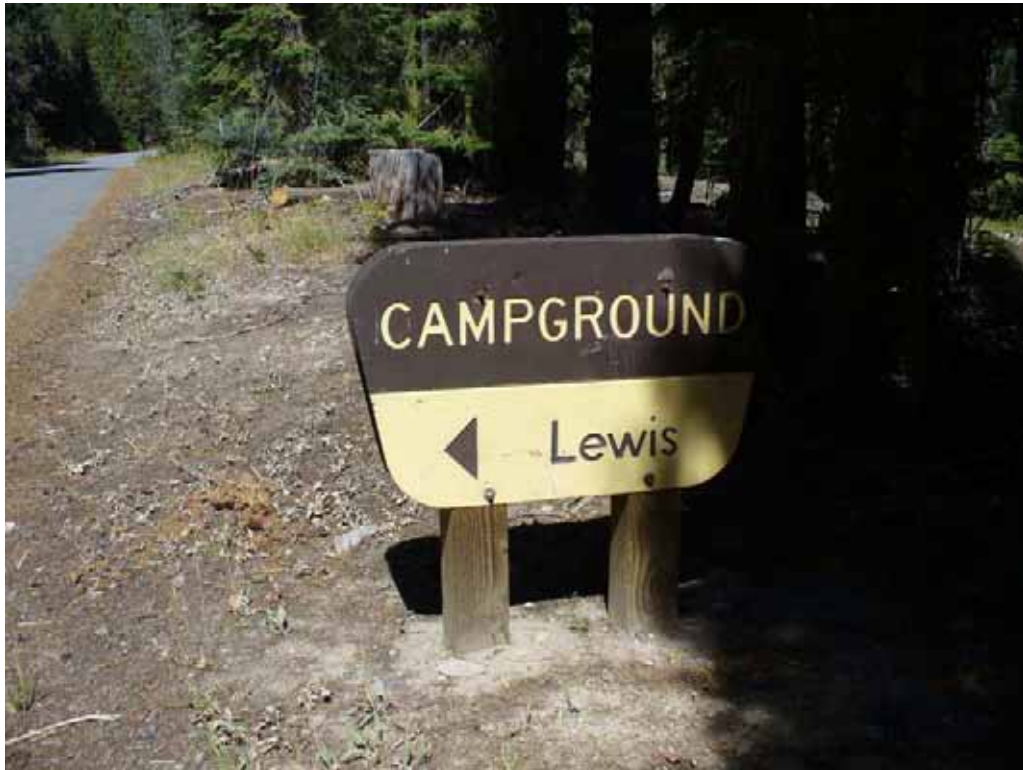
| Type of Sign | Location | Qt. | Material | Cond | Wording/Graphics | Remarks | Accessibility Notes |
|---|---|---|---|---|---|---|---|
| Site Identification | Across from entrance to campground on main access road | 1 | Painted MDO plywood on painted wood posts (24" x 39") | Good | CAMPGROUND Lewis | Sign is functional but split horizontally. Needs to be repaired or replaced. | |

**Photo K-2-1. Site Identification sign, good condition. (9/04/08)**

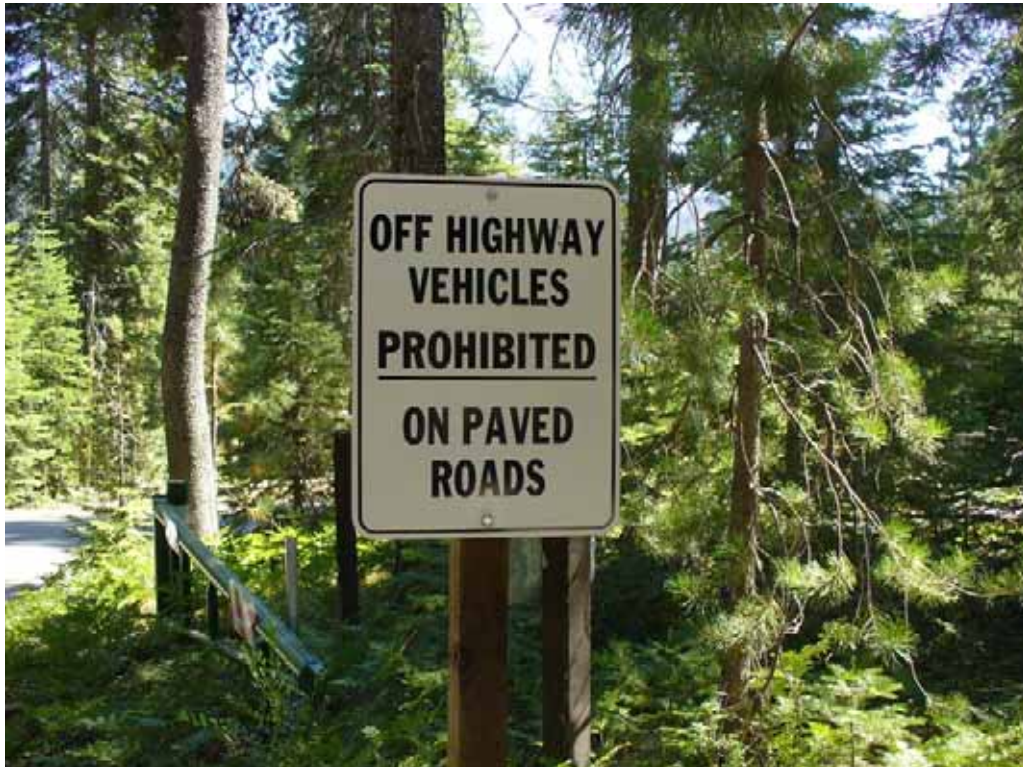
**Photo K-2-2. Signage at Lewis Campground exit, good condition. (9/04/08)**
