**Placer County Water Agency  
Middle Fork American River Project  
(FERC No. 2079)**

**REC 1 – RECREATION USE AND FACILITIES  
TECHNICAL STUDY REPORT**

Placer County Water Agency  
P.O. Box 6570  
Auburn, CA 95604

May 2010

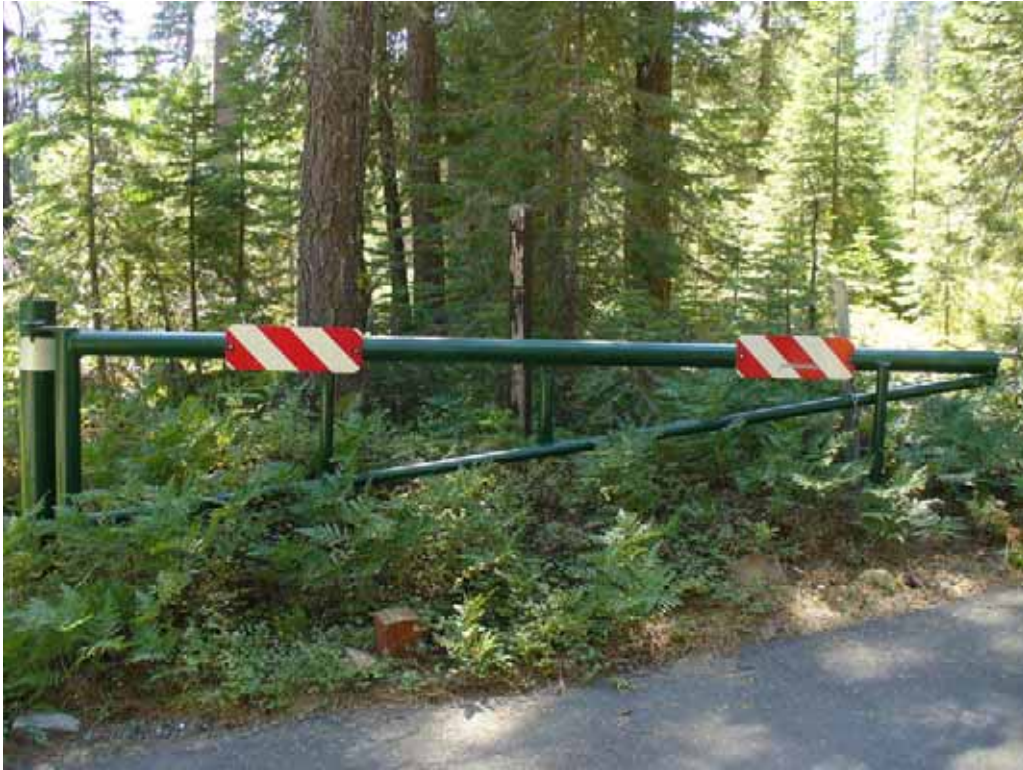
| Feature | Quantity or Dimensions | Location or Description | Material | Type | Cond | Accessibility | | | | | | Comments |
|---|---|---|---|---|---|---|---|---|---|---|---|---|
| <b>Double Swing gate</b> | 1 | At entrance | Green painted steel | Swing | Good | NA | | | | | | New and in excellent condition. |

| Type of Sign | Location | Qt. | Material | Cond | Wording/Graphics | Remarks | Accessibility Notes |
|---|---|---|---|---|---|---|---|
| Hazard signs | On double gate at entrance | 4 | Painted aluminum (8" x 24") | Good | Reflective red and silver striping | New | |

**Photo K-2-3. Swing gate with reflective hazard signs located at entrance to Lewis Campground, good condition. (9/04/08)**

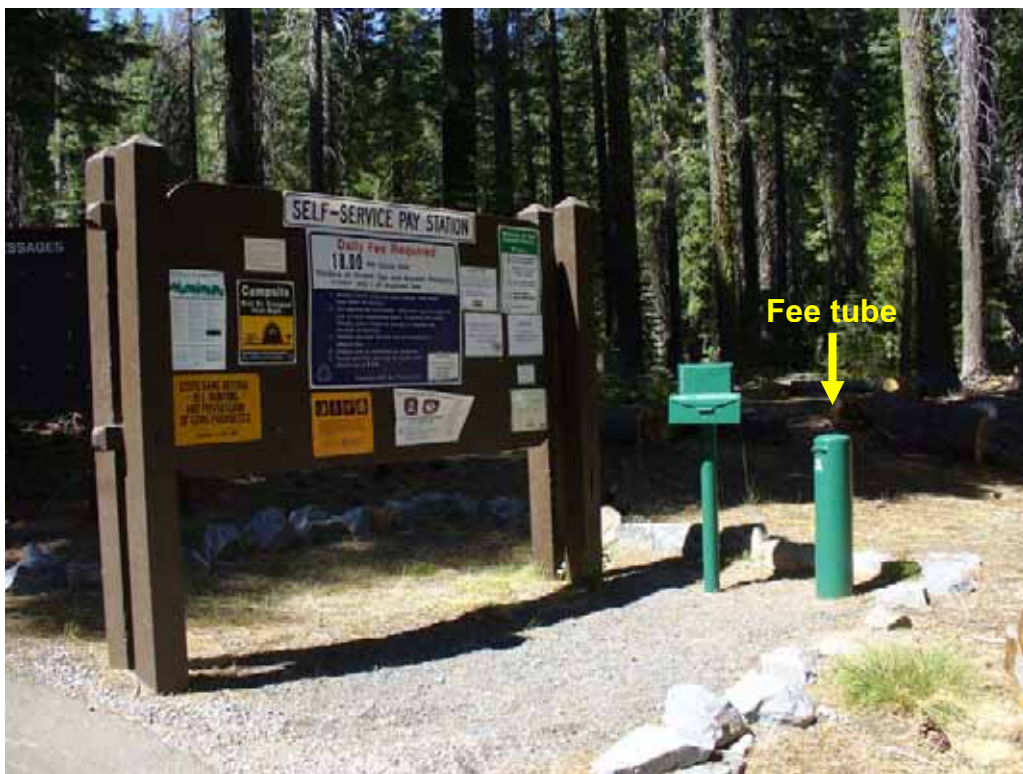
**Photo K-2-4. Fee station at Lewis Campground located near entrance, all in good condition. (9/04/08)**

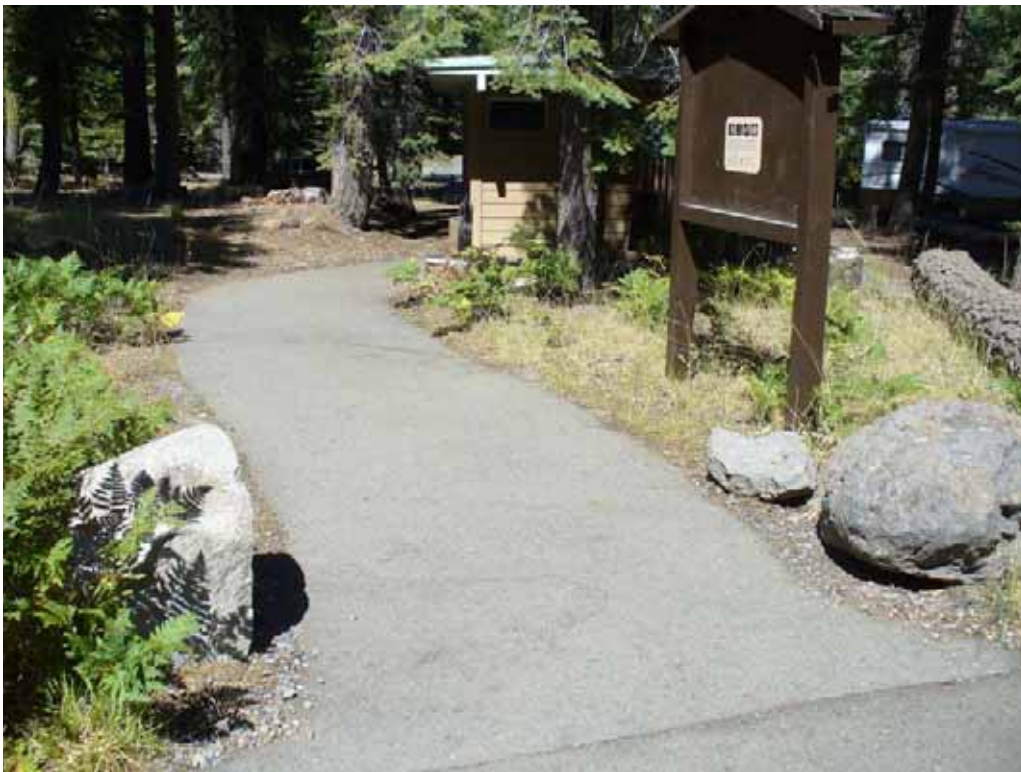
**Photo K-2-6. Paved accessible pathway to accessible bathroom with information board, adjacent to host site. All in good condition. (9/04/08).**

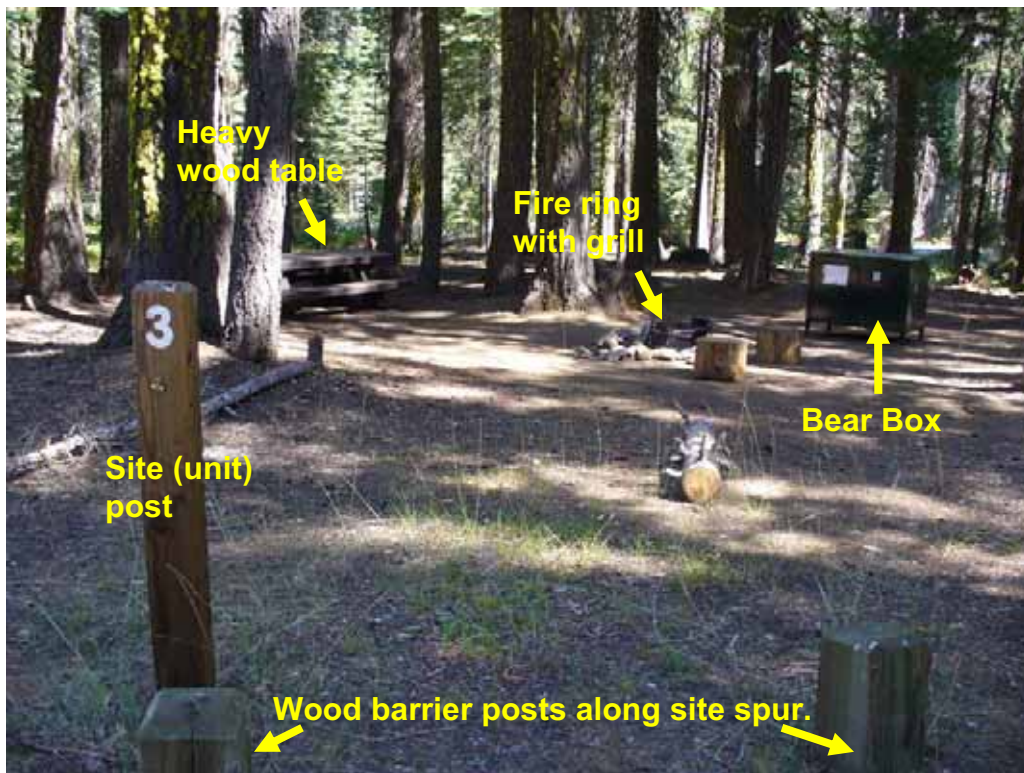
**Photo K-2-7. Typical non-accessible campsite. (9/04/08)**

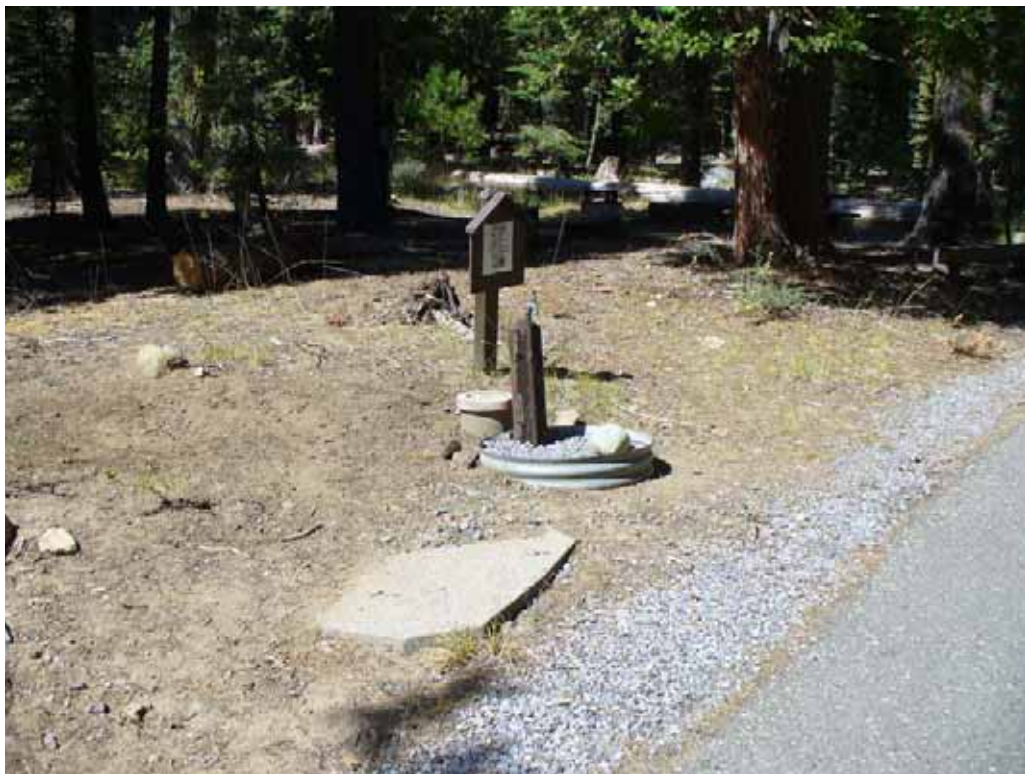
| Type of Sign | Location | Qt. | Material | Cond | Wording/Graphics | Remarks | Accessibility Notes |
|---|---|---|---|---|---|---|---|
| Small information board | Adjacent to 9 faucets | 9 | 11" x 18" painted MDO on painted wood post | Good to Poor | No fish cleaning, etc. at faucets | Most are in good condition. Three are in poor condition due to deteriorating wood. | |

**Photo K-2-8. Typical water faucet and information board located along loop roads, not accessible. (9/04/08)**

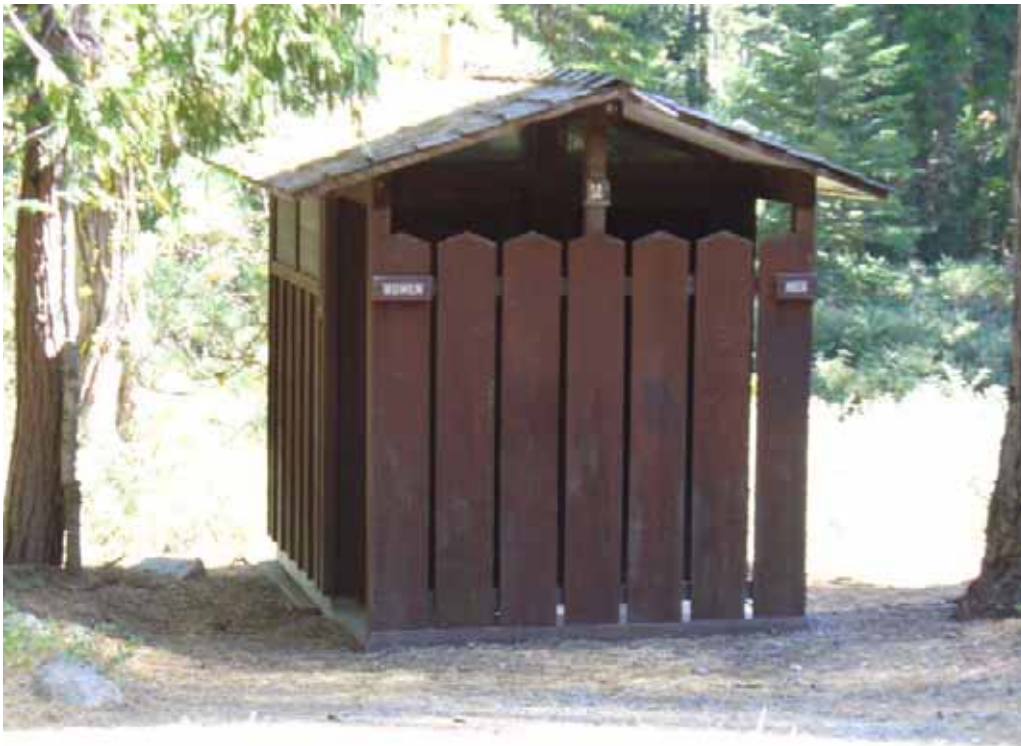
| Feature | Quantity or Dimensions | Location or Description | Material | Type | Cond | Accessibility | | | | | | Comments |
|---|---|---|---|---|---|---|---|---|---|---|---|---|
| <b>Bathroom</b> | 1 double unit with 1 toilet per unit, no sinks | Bathroom #2, located across from Site 12. | Wood | Vault | Good | N | | | | | | Entrance and stall are too narrow. Poor access. Concrete lip. Exterior condition is good except for roof rot. Interior condition is good. |

**Photo K-2-10. Wood bathroom structure No. 2. This is a double unit vault toilet in fair condition. Not accessible. (9/04/08)**

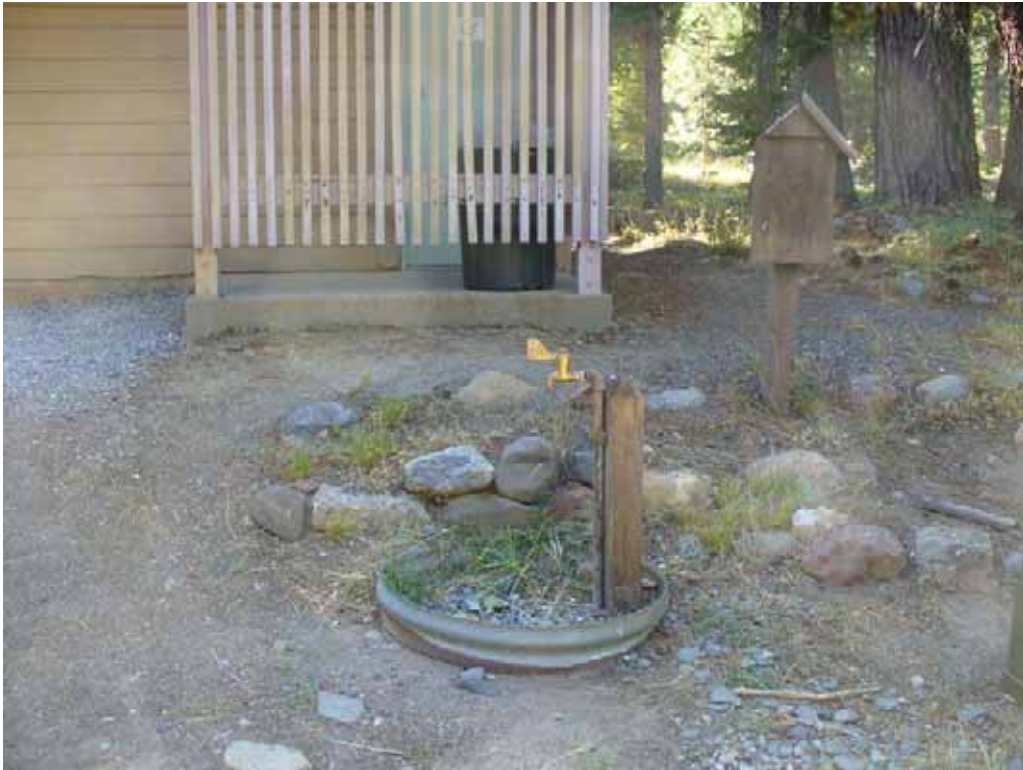
**Photo K-2-15. Faucet with accessible handle. (9/04/09)**

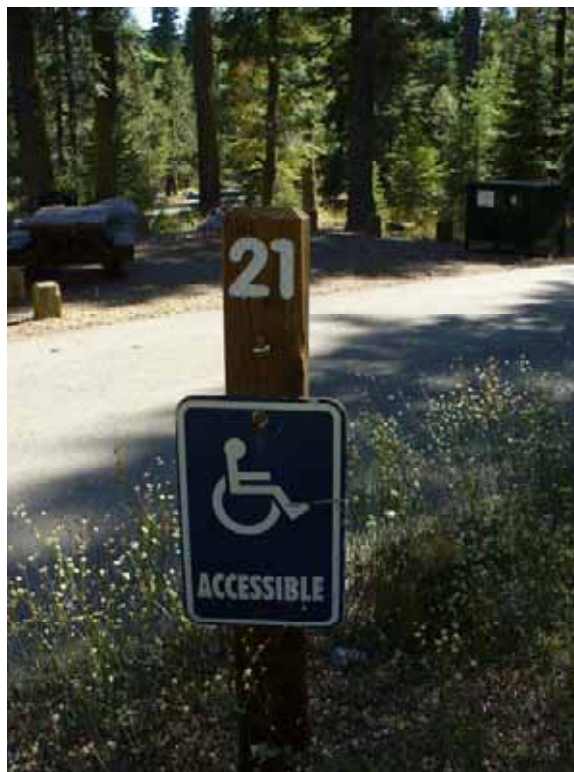
**Photo K-2-19. Designated accessible camp site. This type of sign is also present at Sites 4 and 19. (9/04/08)**

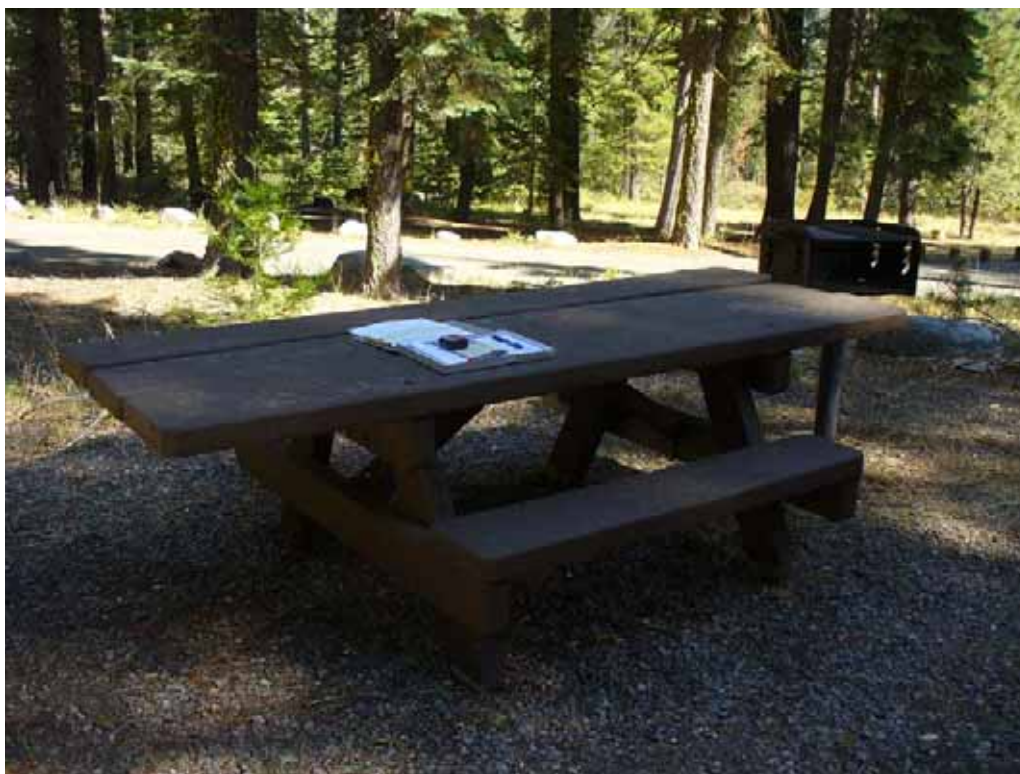
**Photo K-2-20. Accessible heavy wood table and pedestal grill at accessible Site 21. Note clear space around table and level, crushed rock surface. (9/04/08)**

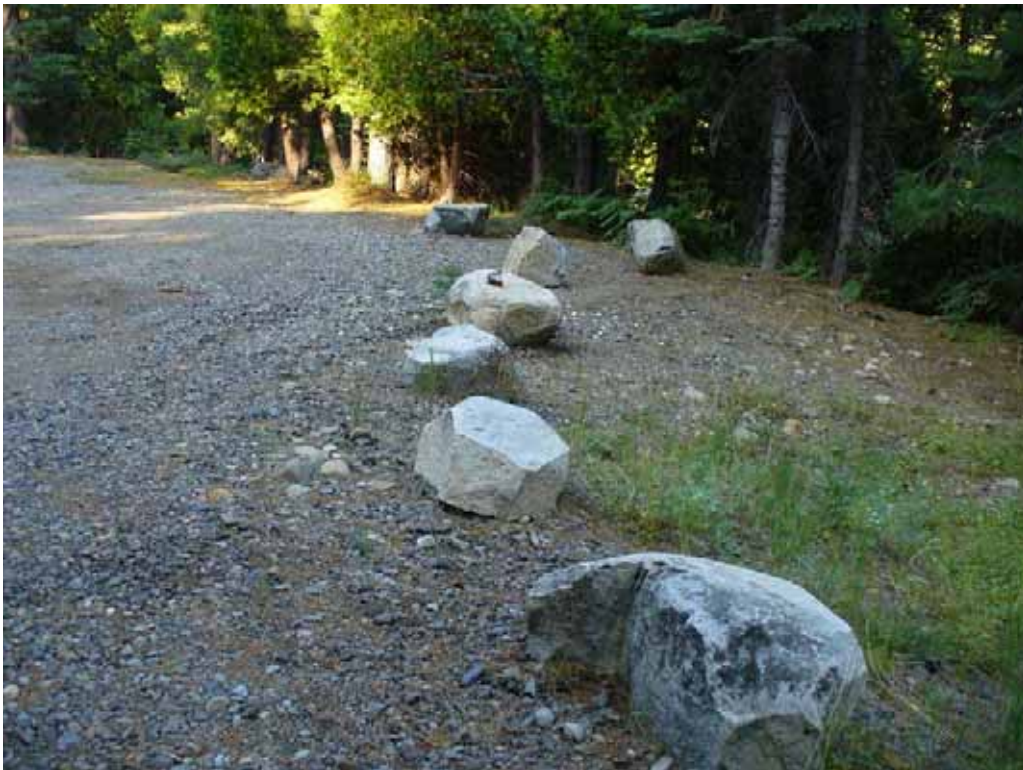
**Photo L-2-4. Barrier rock between parking area and bathroom. (7/23/08)**

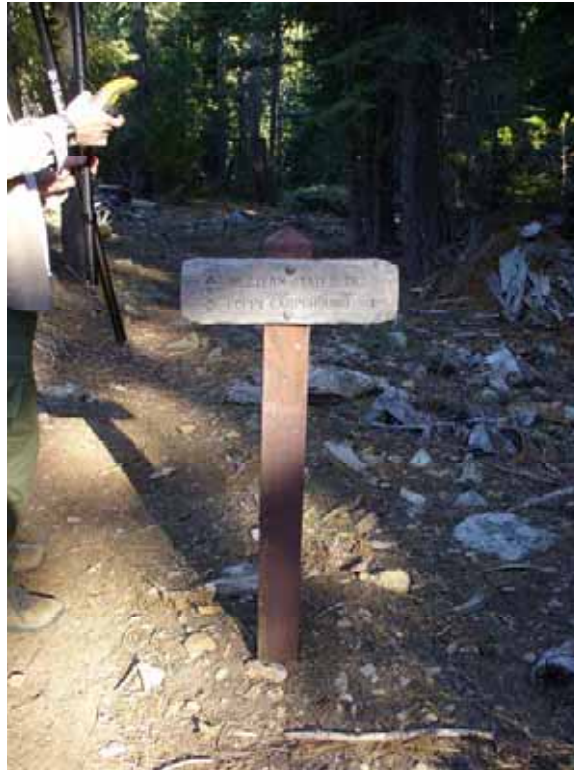
| Type of Sign | Location | Qt. | Material | Cond | Wording/Graphics | Remarks | Accessibility Notes |
|---|---|---|---|---|---|---|---|
| Trail Marker | Near east end of Trail | 1 | Redwood sign with engraved letters on painted wood post | Fair | WESTERN STATES TRAIL/POPPY CAMPGROUND 1 | Wood sign is deteriorating, poor contrast | Lettering too small. No contrast. |

**Photo L-2-9. Wood sign along trail to Poppy Campground. (7/24/08)**

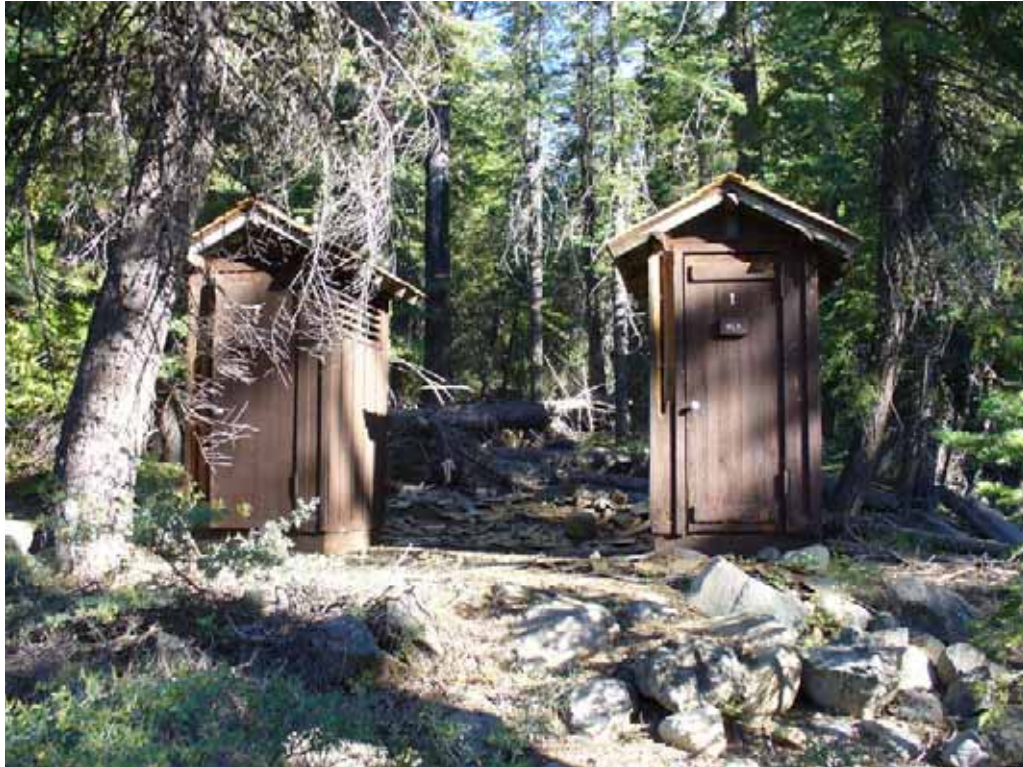
| Feature | Quantity or Dimensions | Location or Description | Material | Type | Cond | Accessibility | | | | | | Comments |
|---|---|---|---|---|---|---|---|---|---|---|---|---|
| <b>Bathroom</b> | 2 | Two single units (M & F) side by side in middle of campground. | Painted wood | Pit | Poor | N | | | | | X | Outdated and in poor condition. Stalls are too high and narrow to meet accessibility standards. Recently shingled. Excess shingles on ground surrounding bathrooms. |

**Photo L-2-14. Pit toilets in campground. No accessible. (7/24/08)**

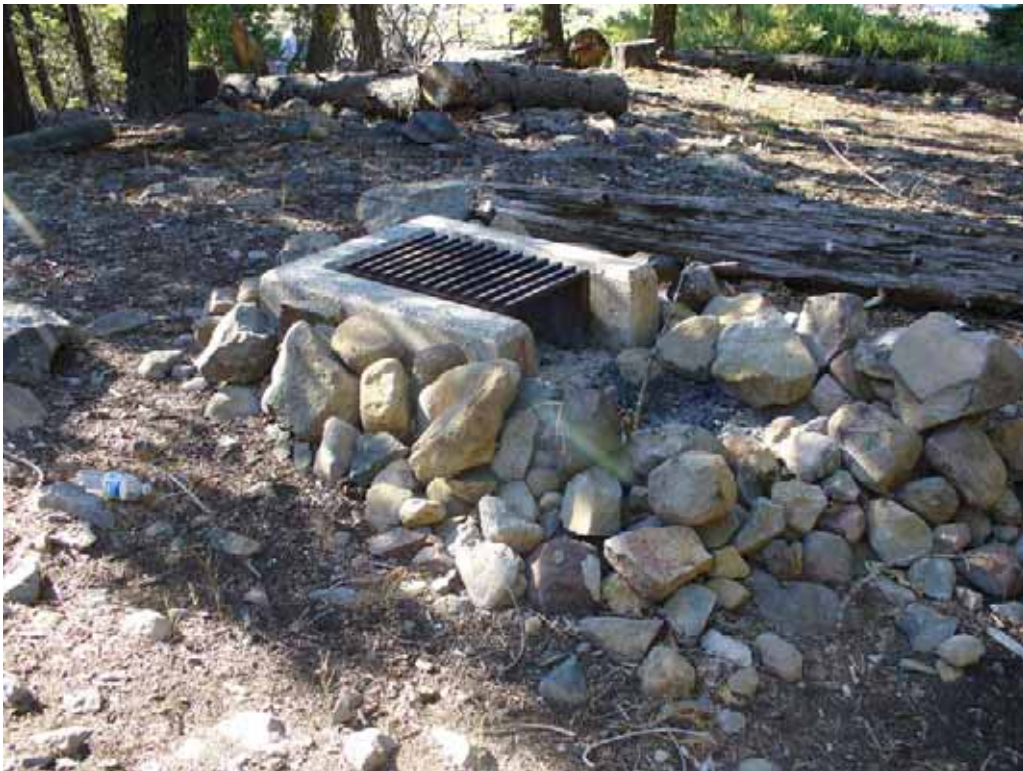
**Photo L-2-18. Concrete/steel grill with user created rock enclosure. (7/24/08)**

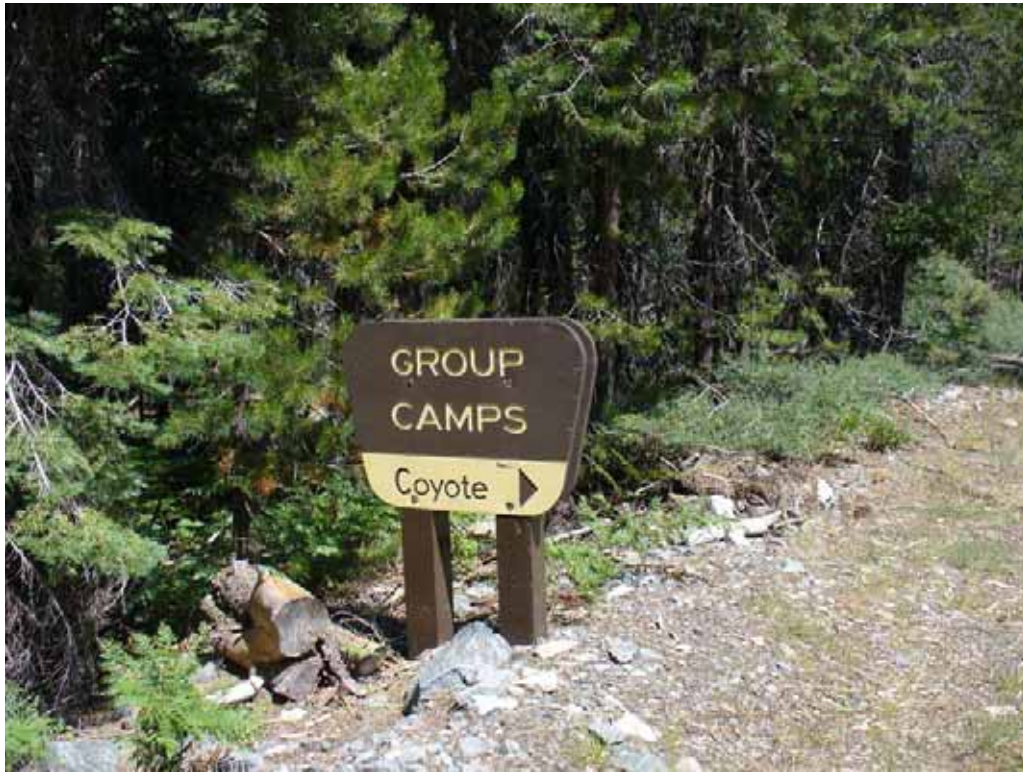
| Type of Sign | Location | Qt. | Materials | Cond. | Wording/Graphics | Remarks | Accessibility Notes |
|---|---|---|---|---|---|---|---|
| Site Identification | On east side of road FR 96, across from main entrance to campground | 1 | Painted MDO plywood on painted wood posts (double sided) | Fair | GROUP CAMPS<br>Coyote | Minor damage and paint flaking | Good contrast |

**Photo M-2-1. Site identification sign located on FR 96 across. (7/24/08)**

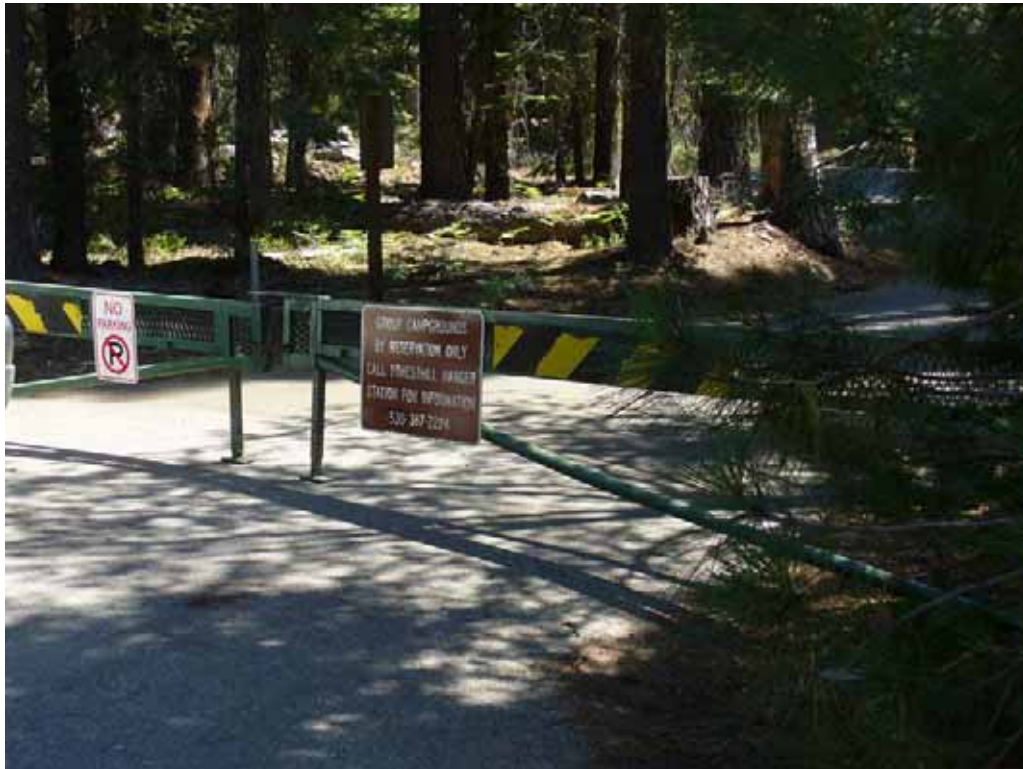
| Feature | Quantity or Dimensions | Location or Description | Material | Type | Cond | Accessibility | | | | | | Comments |
|---|---|---|---|---|---|---|---|---|---|---|---|---|
| <b>Gate</b> | 1 | At main entrance to Coyote Group Campground | Green painted steel | Double, swing gate | Good | NA | | | | | | Caution signage is in fair condition due to peeling paint. |

**Photo M-2-2. Double swing gate at intersection of FR-96 and Little Wolf and Brush Wolf Main Access Road. This gate is closed and locked when none of the sites are reserved. (7/24/08)**

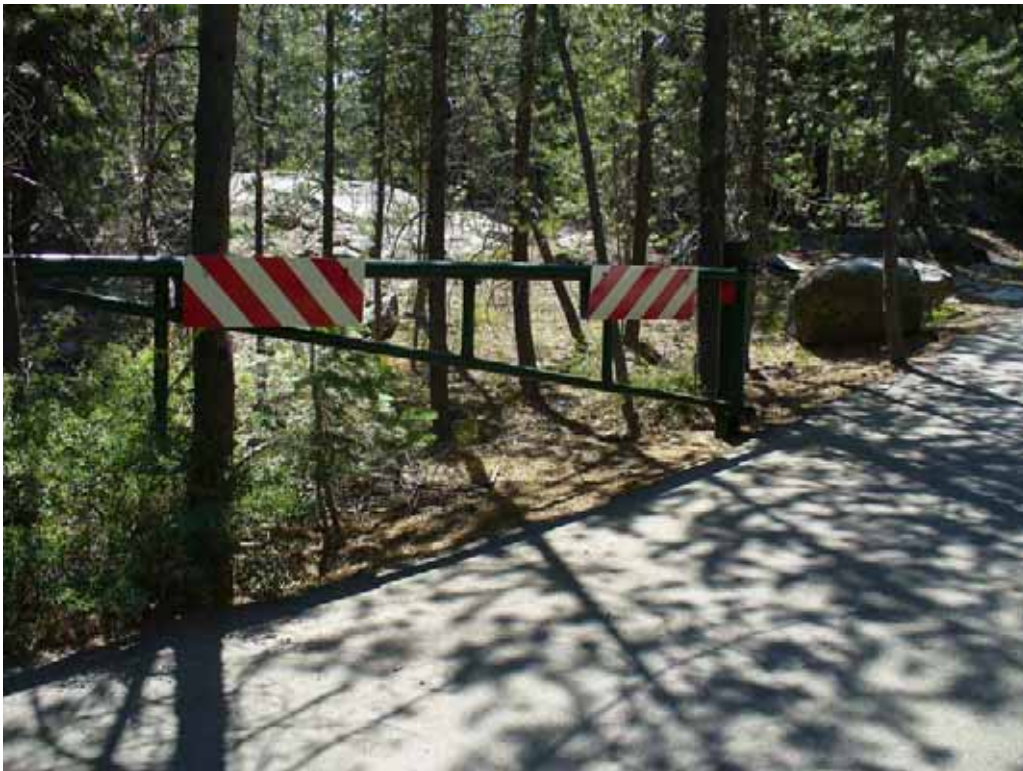
| Type of Sign | Location | Qt. | Materials | Cond. | Wording/Graphics | Remarks | Accessibility Notes |
|---|---|---|---|---|---|---|---|
| Traffic | On barrier gate on entrance road to Prairie Wolf | 4 | Painted aluminum on PTDF post mounted on gate | Good | Hazard sign - red and white diagonal | | |

**Photo M-2-12. Gate on road to Prairie Wolf. This gate was installed in October 2006.**

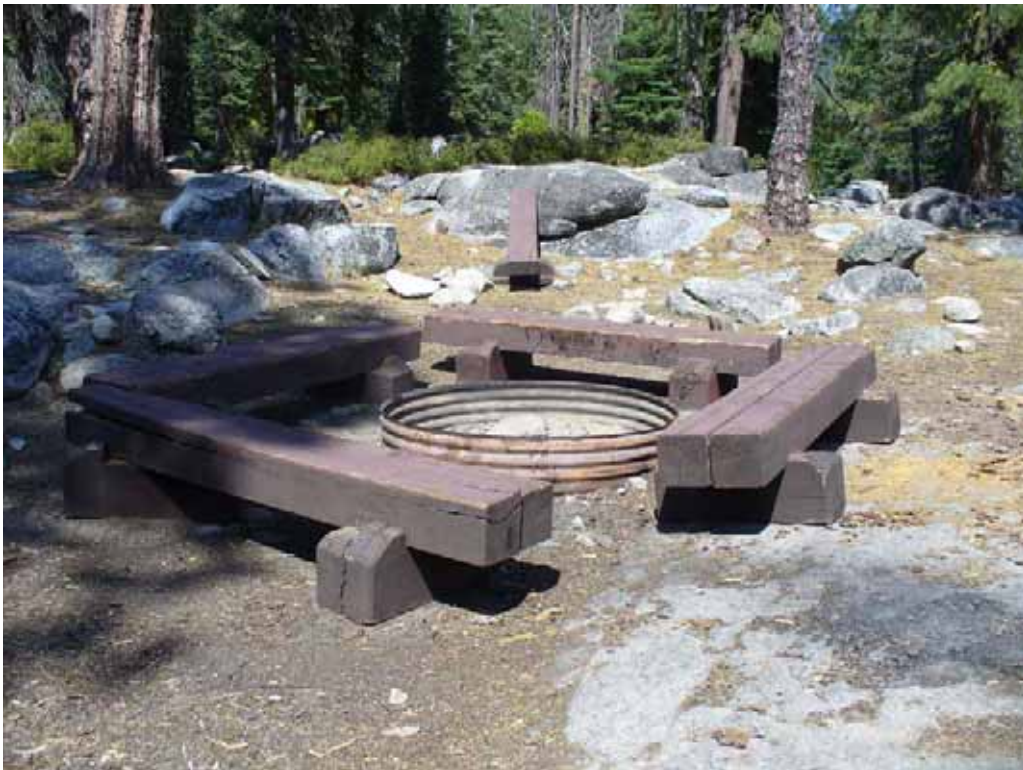
| | | | Accessibility Constraints | | | | Spur | | | | Site Signs | | | | | | | | | | | | | | | | | | Tables | | | | Other | | | | | | | | | | | | | | | | | | | | | | | | | | | | | | | | | | | | |
|---|---|---|---|---|---|---|---|---|---|---|---|---|---|---|---|---|---|---|---|---|---|---|---|---|---|---|---|---|---|---|---|---|---|---|---|---|---|--|--|--|--|--|--|--|--|--|--|--|--|--|--|--|--|--|--|--|--|--|--|--|--|--|--|--|--|--|--|--|--|
| | | No | X | X | | | Lots of rocks and bedrock obstruct all travel paths around site. This site would be very difficult to make accessible. | 2 | 7 | Paved and striped with barrier posts, bars, and rocks around edges. | Good Barrier posts and bars are in good condition. Individual stalls are narrow. | X | Aluminum on PTDF post | Good | | 1-1966 | Fair Ring is made of corrugated steel set about 16 inches above grade. | 5-1966 | Fair Old style benches. Not accessible. Limited clear space. Need sanding and painting. One is not near fire ring. | | | 1-2002 | Good | | | 2-2002 | Good. Both are set on concrete pads. | 2-1999 | Good | | | 3 | Good | 4 | Good | | According to Ed Moore, it is not possible to install new benches around fire ring at this site because the soil horizon is thin. That is, there is bedrock immediatley below the surface. | | | | | | | | | | | | | | | | | | | | | | | | | | | | | | | | |

**Photo M-2-16. Group fire ring with old benches at Prairie Wolf. Note bedrock. (7/24/08)**

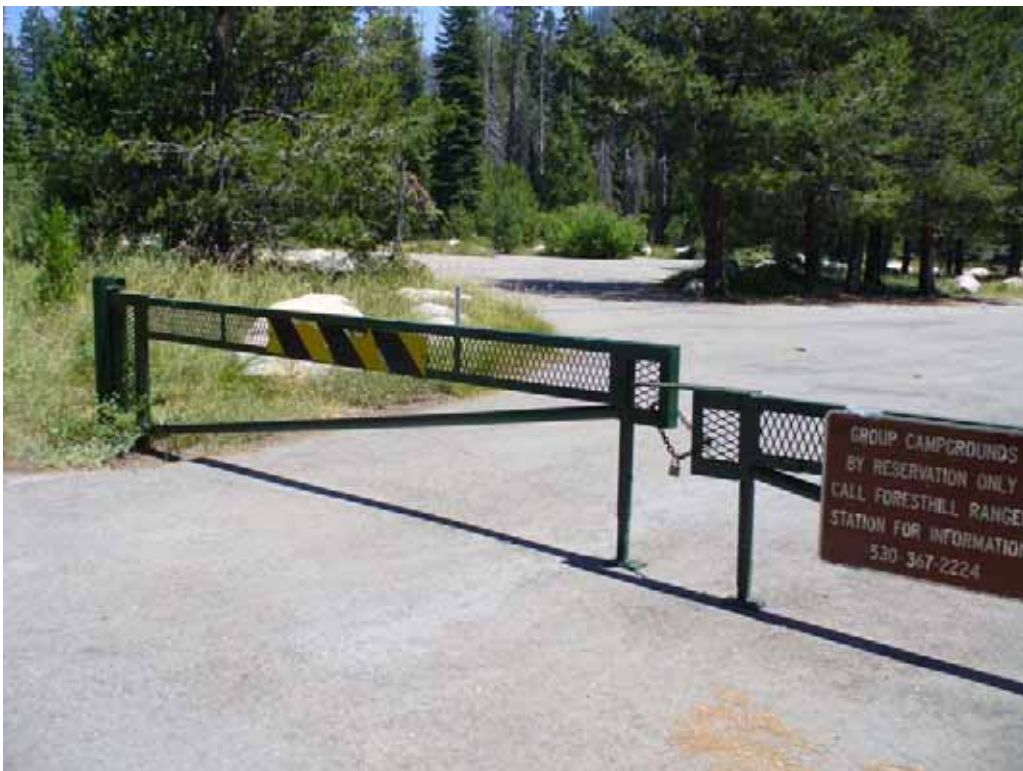
| Feature | Quantity<br>or<br>Dimensions | Location or<br>Description | Material | Type | Cond | Accessibility | | | | | | Comments |
|---|---|---|---|---|---|---|---|---|---|---|---|---|
| <b>Gate</b> | 1 | At entrance to Black Bear | Green painted steel | Single swing gate | Good | NA | | | | | | Caution signage is in fair condition due to peeling paint. |

**Photo M-2-18. Double swing gate at entrance to Black Bear. (7/24/08)**

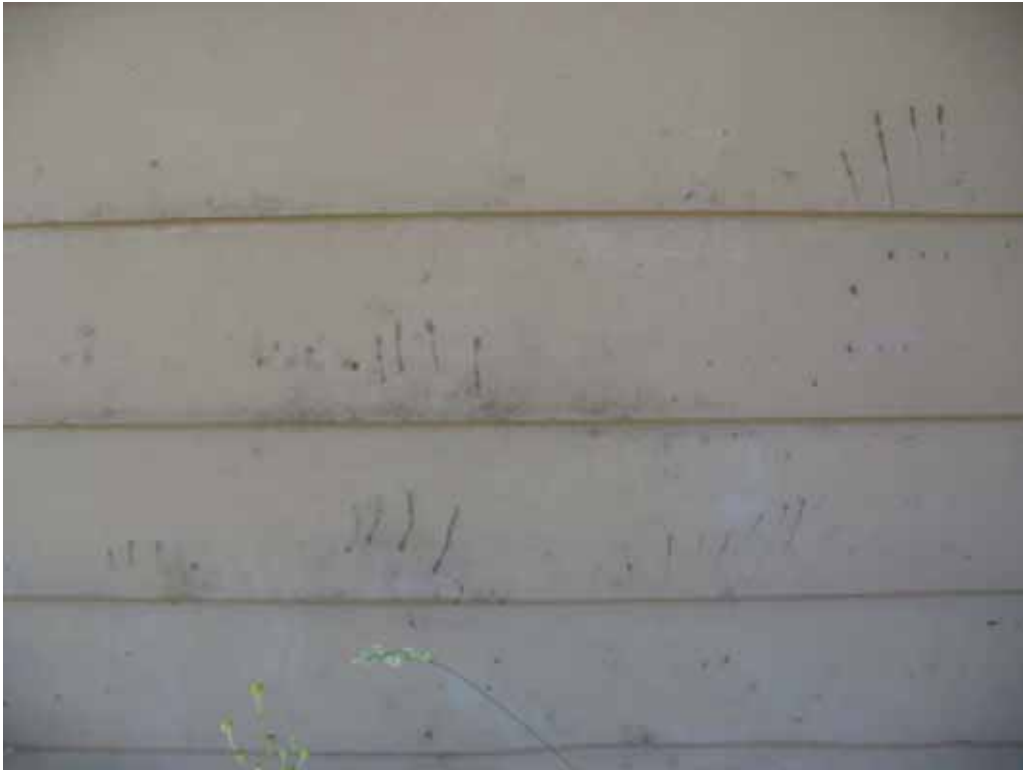
| Feature | Quantity or Dimensions | Location or Description | Material | Type | Cond | Accessibility | | | | | | Comments |
|---|---|---|---|---|---|---|---|---|---|---|---|---|
| Bathroom | 1 | Black Bear | Wood, double unit<br>Women's side has 2 toilets and 1 sink.<br>Men's side has 1 toilet, 1 urinal and 1 sink. | Flush | Good | Y | X | | X | | | Bathroom is generally in good condition, inside and outside. Bear claw marks are present on the door. According to Ed Moore, people store their food in the bathroom. This bathroom was converted to be accessible. A small lip is present at the entrance which should be filled. Also, brush by impede access. |

**Photo M-2-21. Bear scratches on bathroom at Black Bear. (7/24/08)**

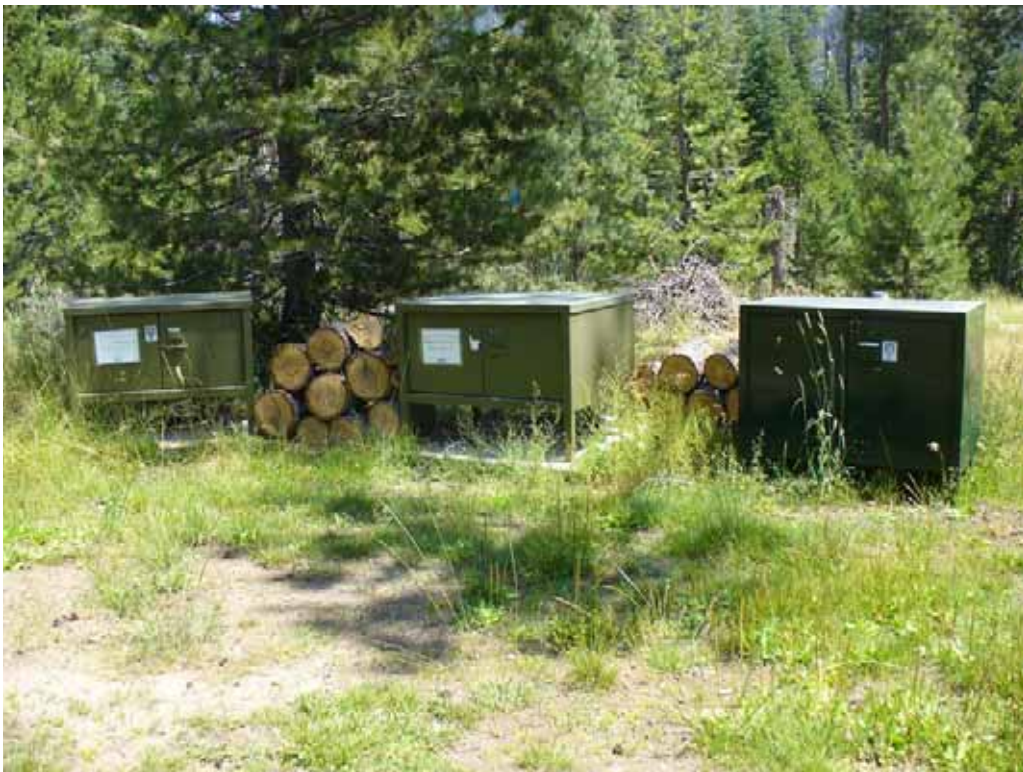
**Photo M-2-22. Three bear boxes at Black Bear. Two on concrete pads. Stacked wood was left by fire crews who used this site as a staging area in 2008. Note vegetation. (7/24/08)**

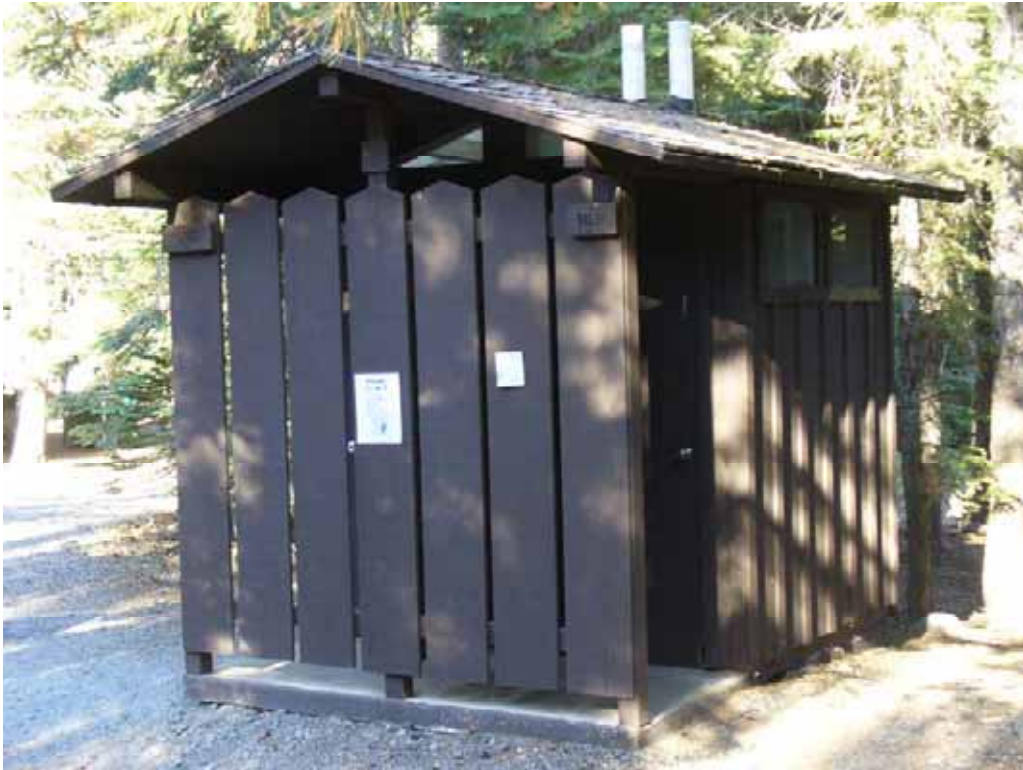
**Photo N-2-9. Typical vault bathroom in Gates Group Campground. This bathroom is located in Ponderosa Campground. None of the bathrooms in the Gates Group Campground are accessible. (9/4/08)**

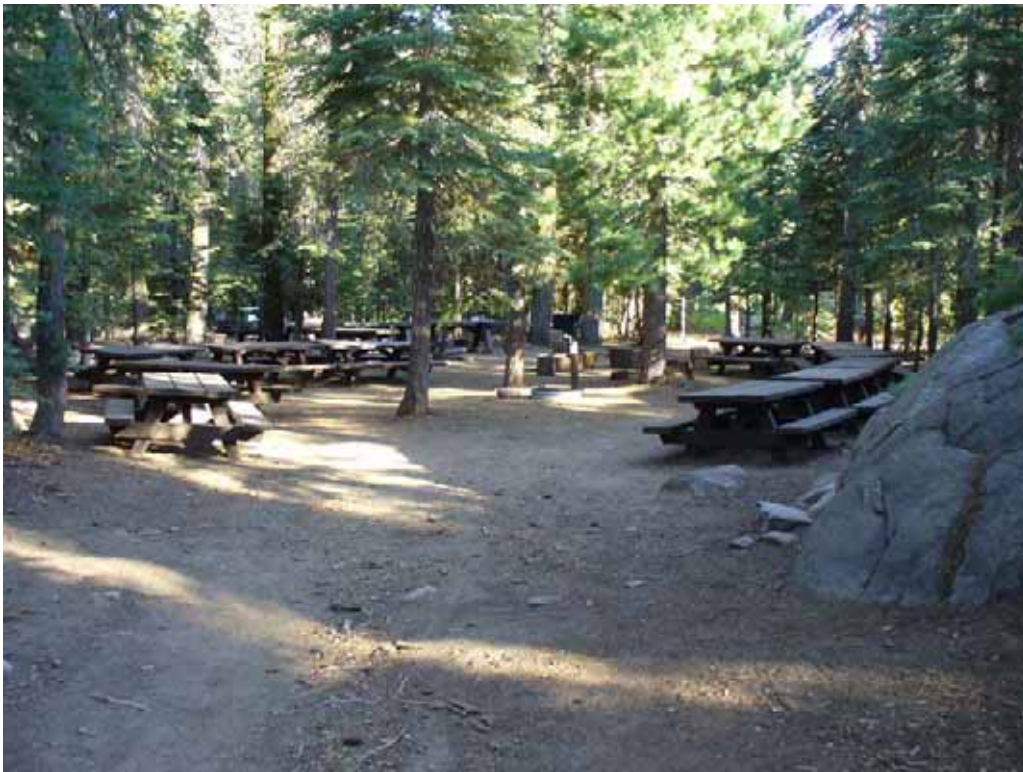
**Photo N-2-10. Ponderosa, a 75 person group camp. (9/4/08)**

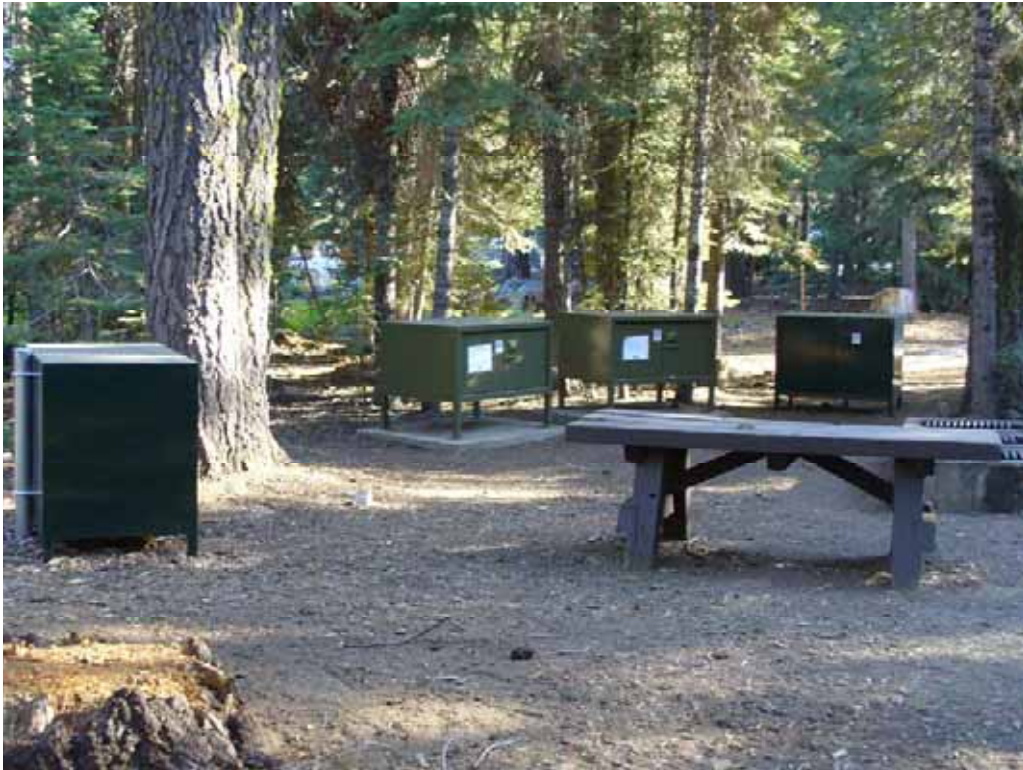
**Photo N-2-11. Four bear-proof garbage containers (bear boxes) and a heavy wood serving table at Ponderosa. (9/4/08)**

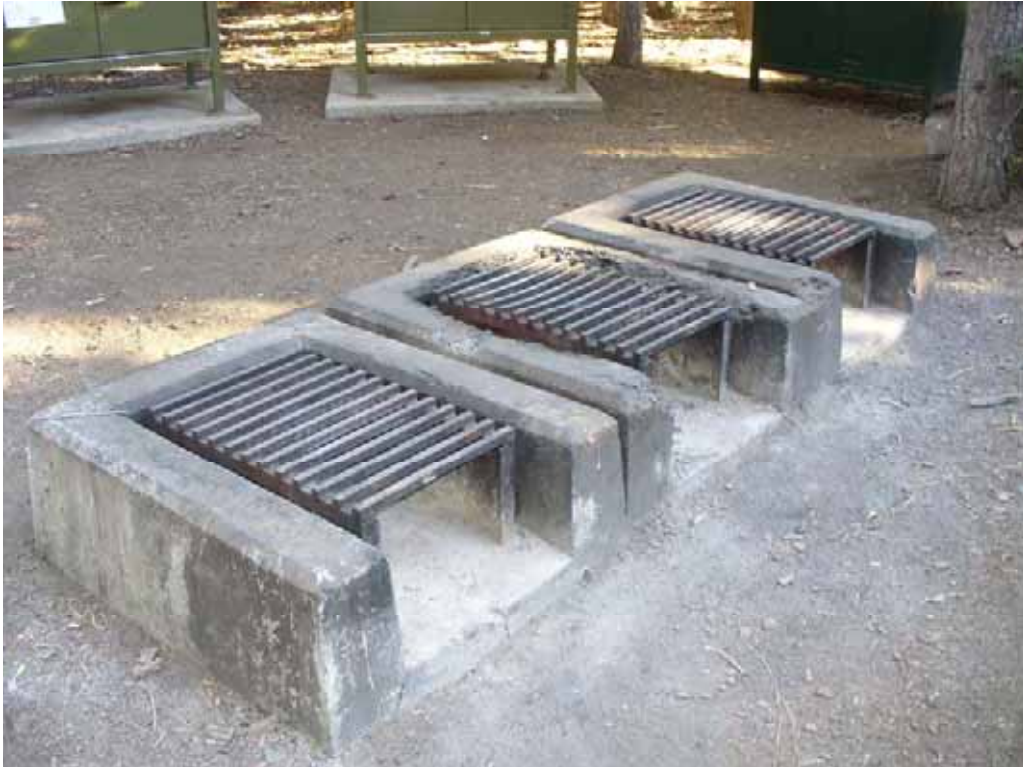
**Photo N-2-12. Three concrete stoves with steel gills at Ponderosa. (9/4/08)**

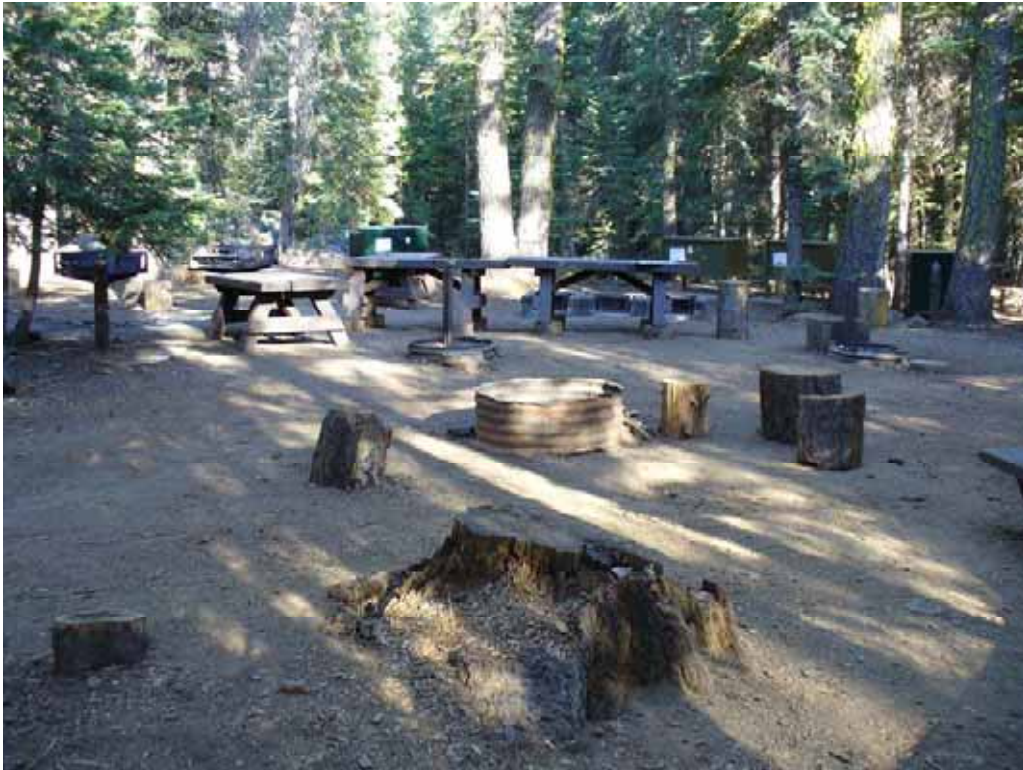
**Photo N-2-13. Small fire pit in Ponderosa kitchen area. (9/4/08)**

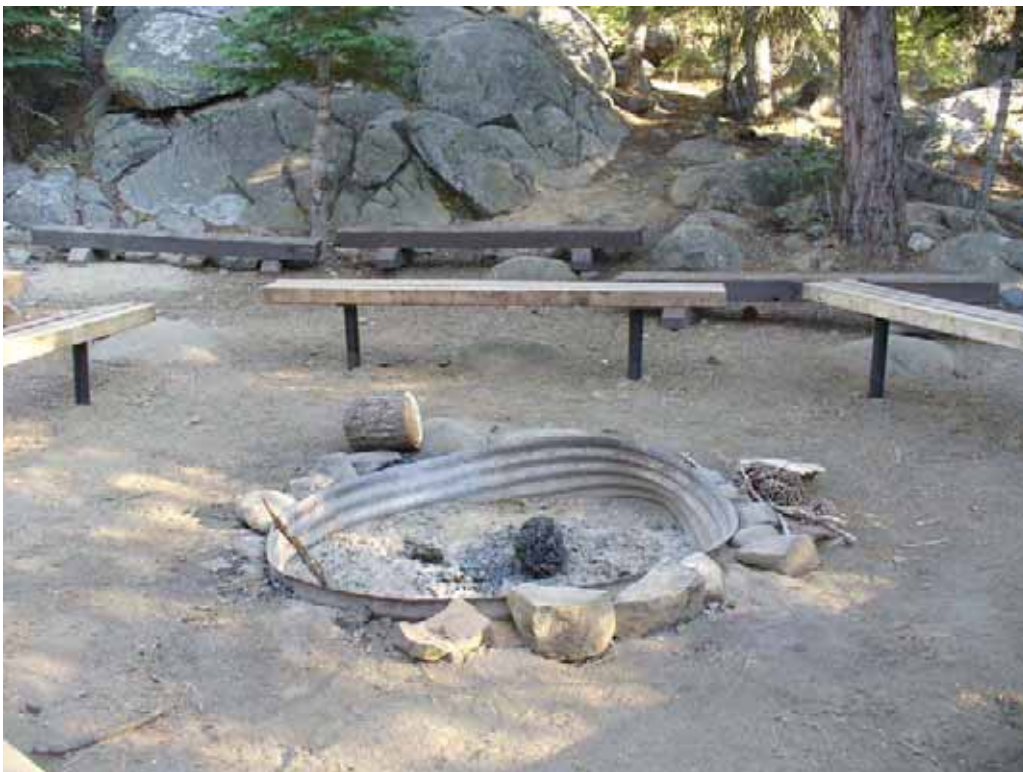
**Photo N-2-14. Damaged group fire pit at Ponderosa. Note new benches in middle ground and old benches in background. (9/4/08)**

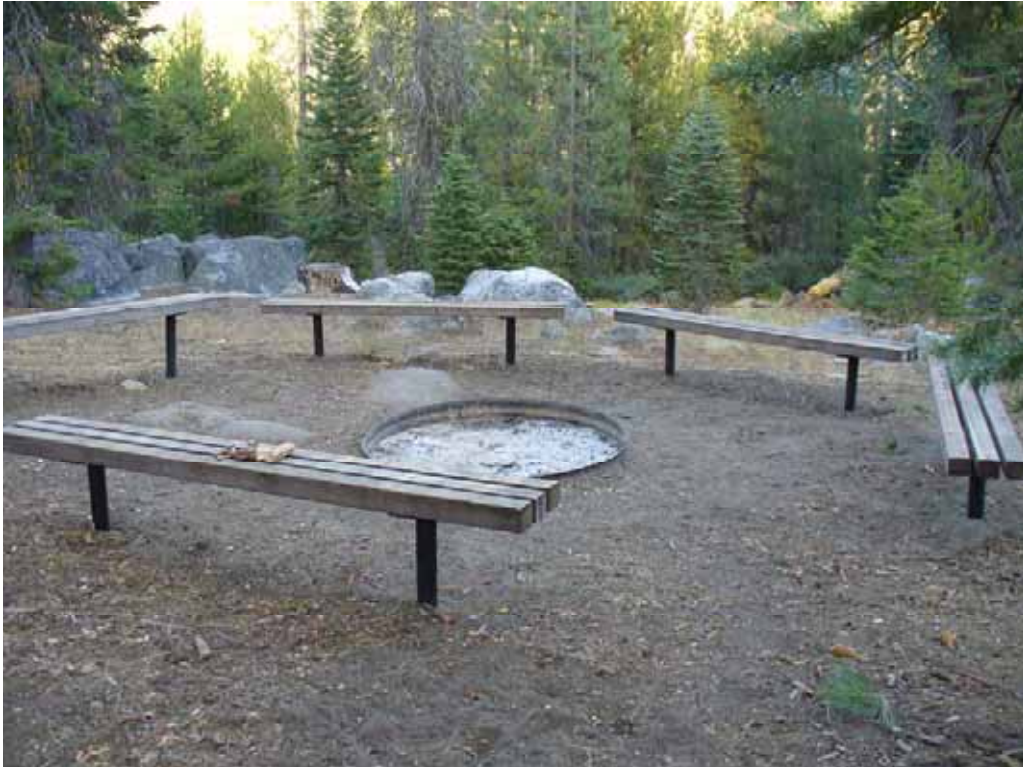
**Photo N-2-16. Group fire pit and new benches at Lodgepole. (9/4/08)**
