**Placer County Water Agency  
Middle Fork American River Project  
(FERC No. 2079)**

**REC 1 – RECREATION USE AND FACILITIES  
TECHNICAL STUDY REPORT**

Placer County Water Agency  
P.O. Box 6570  
Auburn, CA 95604

May 2010

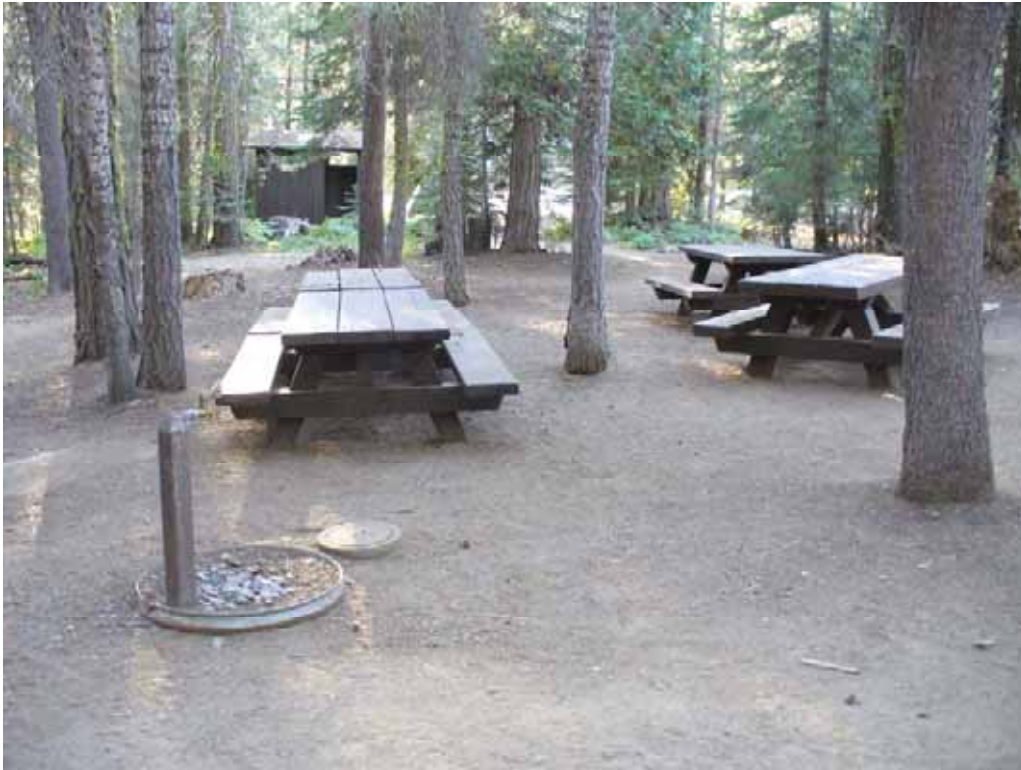
**Photo N-2-17. Typical heavy wood picnic tables and water faucet in Gates Group Campground. This photograph was taken at Aspen. (9/4/08)**

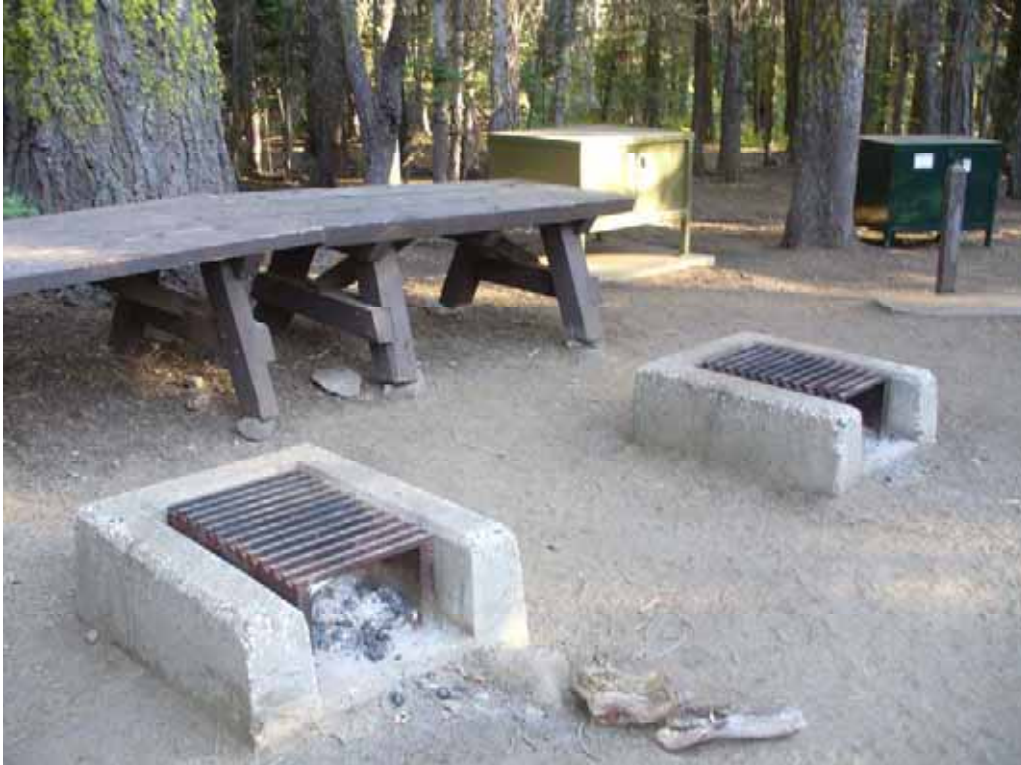
**Photo N-2-18. Typical heavy wood serving tables and concrete stoves with steel grills in Gates Group Campground. This photograph was taken at Aspen. (9/4/08)**

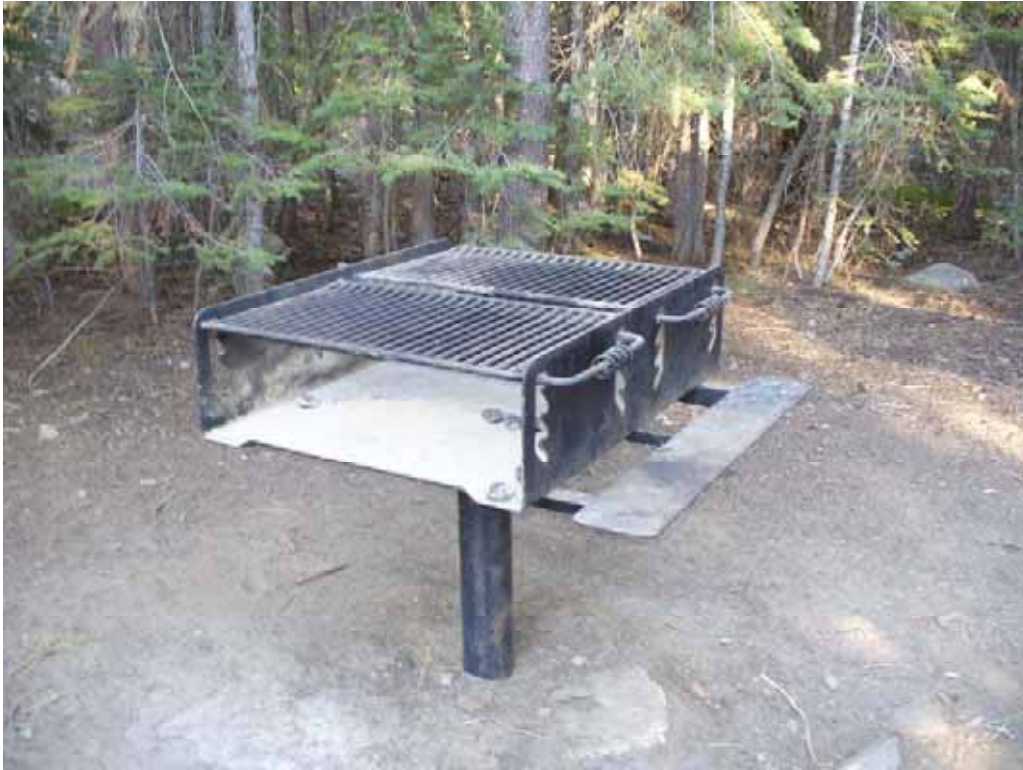
**Photo N-2-19. Double, handicap accessible, steel, adjustable cooking grill. This photograph was taken at Aspen. (9/4/08)**

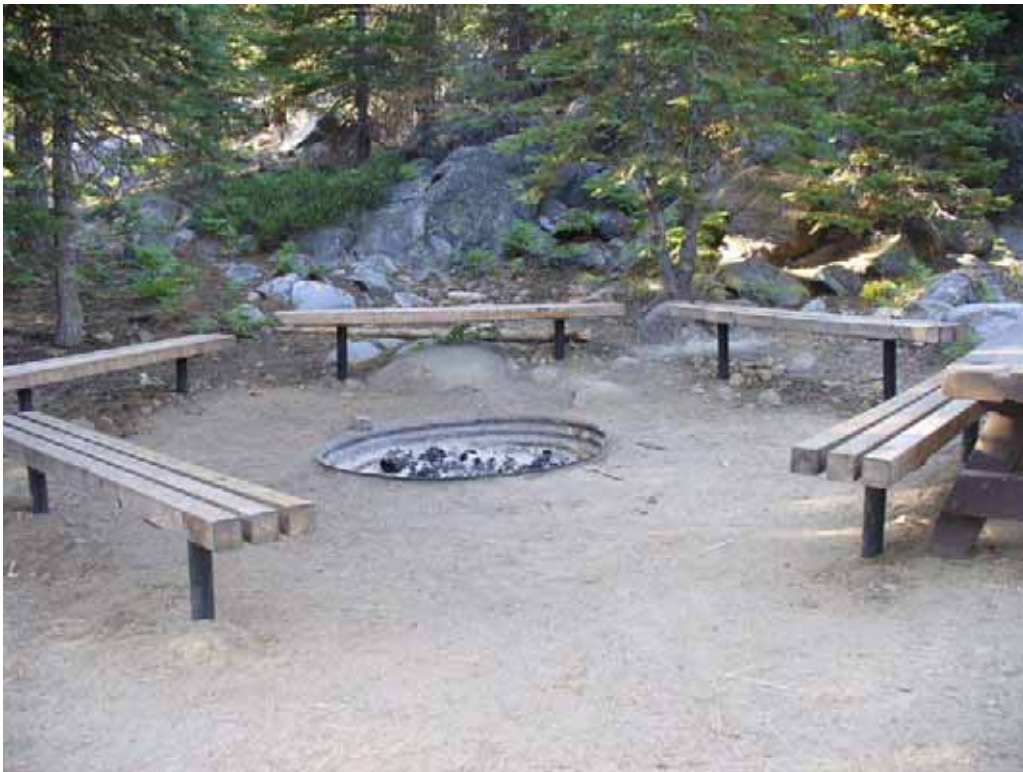
**Photo N-2-20. Group fire pit and new benches at Aspen. (9/4/08)**

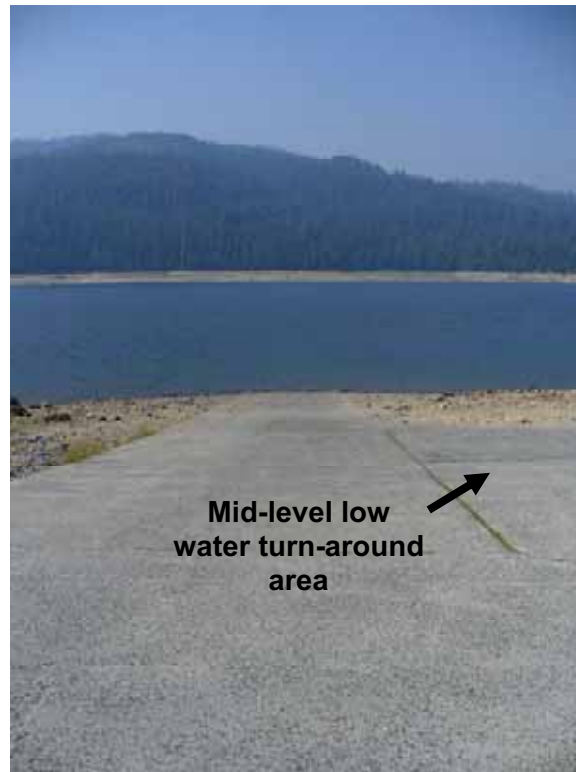
| <b>Condition of Facility:</b> Overall, the boat ramp is in fair condition. The ramp is functional but the concrete is spalling and cracked, and vegetation is growing in the cracks. The parking area is functional has deteriorated to aggregate base rock and is therefore in poor condition relative to its original condition. The road connecting the boat ramp and parking area is paved and in good condition. The bathroom is in fair condition. |

**Photo O-2-1. French Meadows Boat Ramp on July 23, 2008 (WSE = 5,220 ft).**

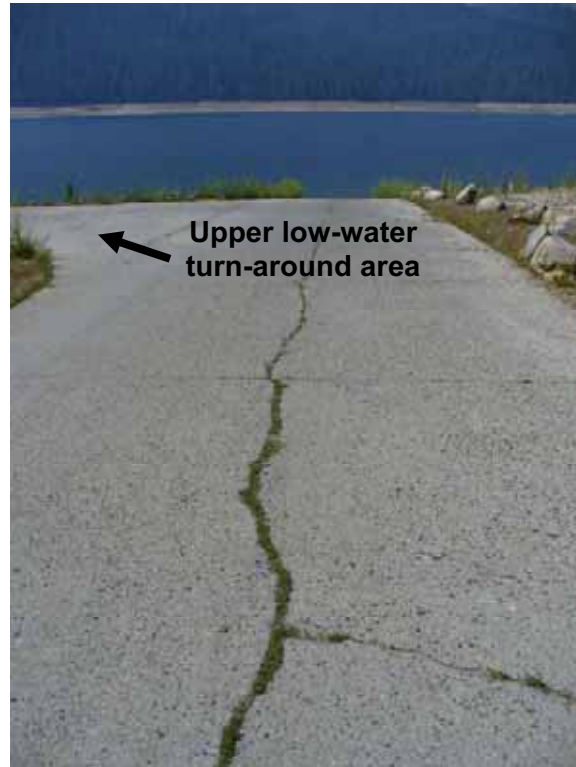
| Feature | Quantity or Dimensions | Location or Description | Material | Type | Cond | Accessibility | | | | | | Comments |
|---|---|---|---|---|---|---|---|---|---|---|---|---|
| <b>Boat Ramp</b> | Approx. 600 feet long by 20 feet wide (1.5 lane) | Concrete section extending from access road to end of ramp. Includes three low water turn around areas. | Concrete | NA | Fair | N | | X | | X | | Ramp does not meet accessibility standards due to excessive slope and the presence of debris (obstacles) deposited as water level recedes. Ramp surface is deteriorating due to cracks that have filled with vegetation. |

**Photo O-2-2. Cracking in-filled with vegetation along French Meadows Boat Ramp, upper section. (7/23/08)**

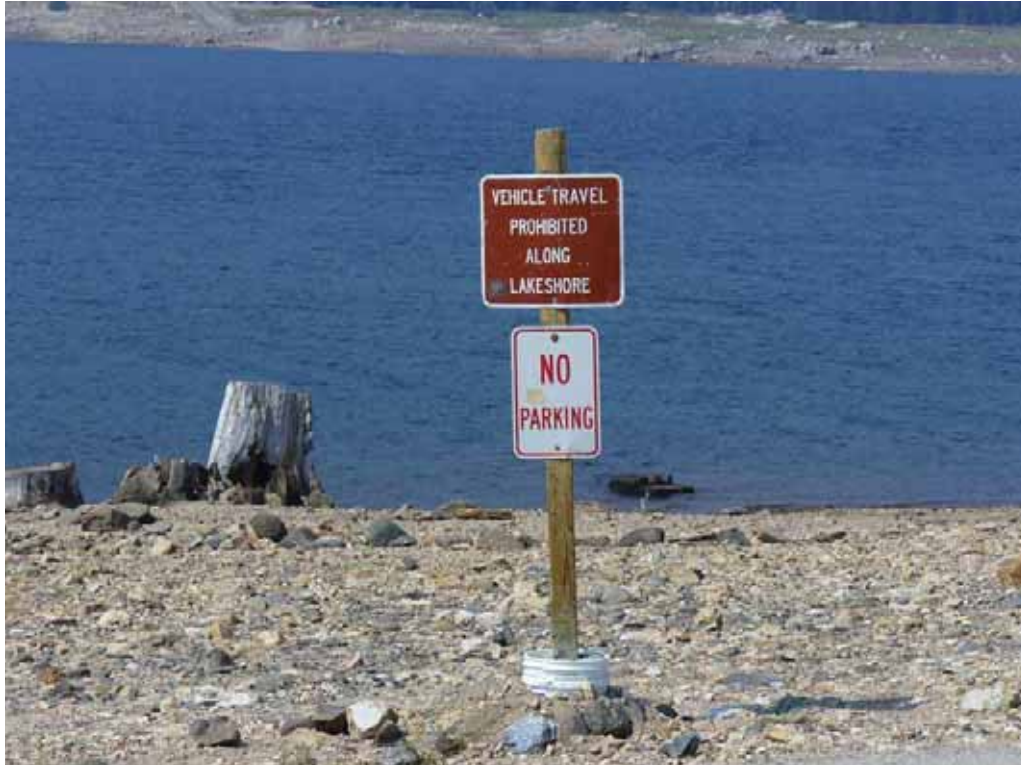
**Photo O-2-4. Temporary sign located in middle low-water turn around area. This sign may be moved as water levels fluctuate. (7/23/08)**

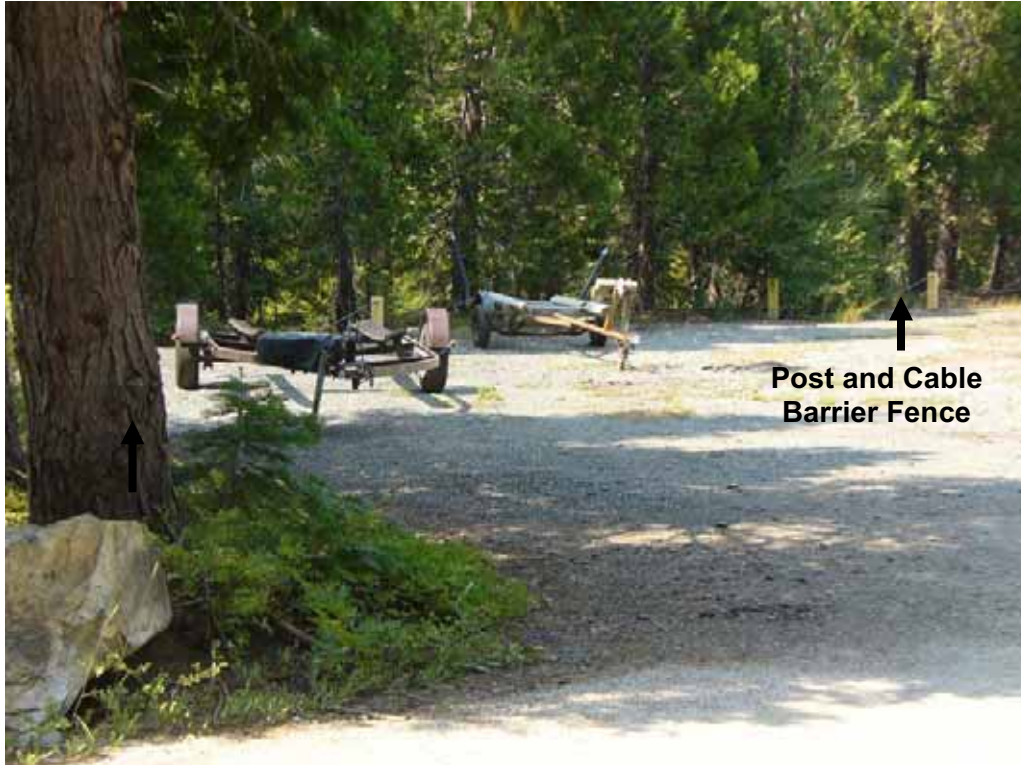
**Photo O-2-6. French Meadows Boat Ramp Parking Area. Note post and cable barrier fence. (7/23/08)**

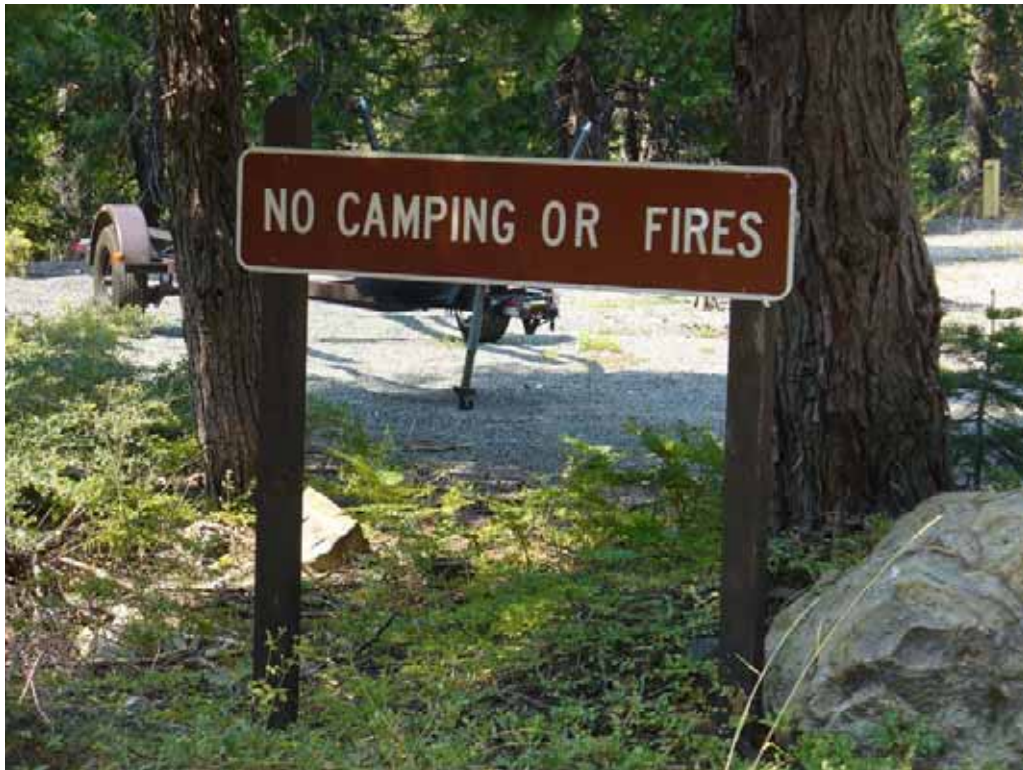
**Photo O-2-7. Sign at entrance to French Meadows Boat Ramp Parking Area. Sign is in good condition. (7/23/08)**

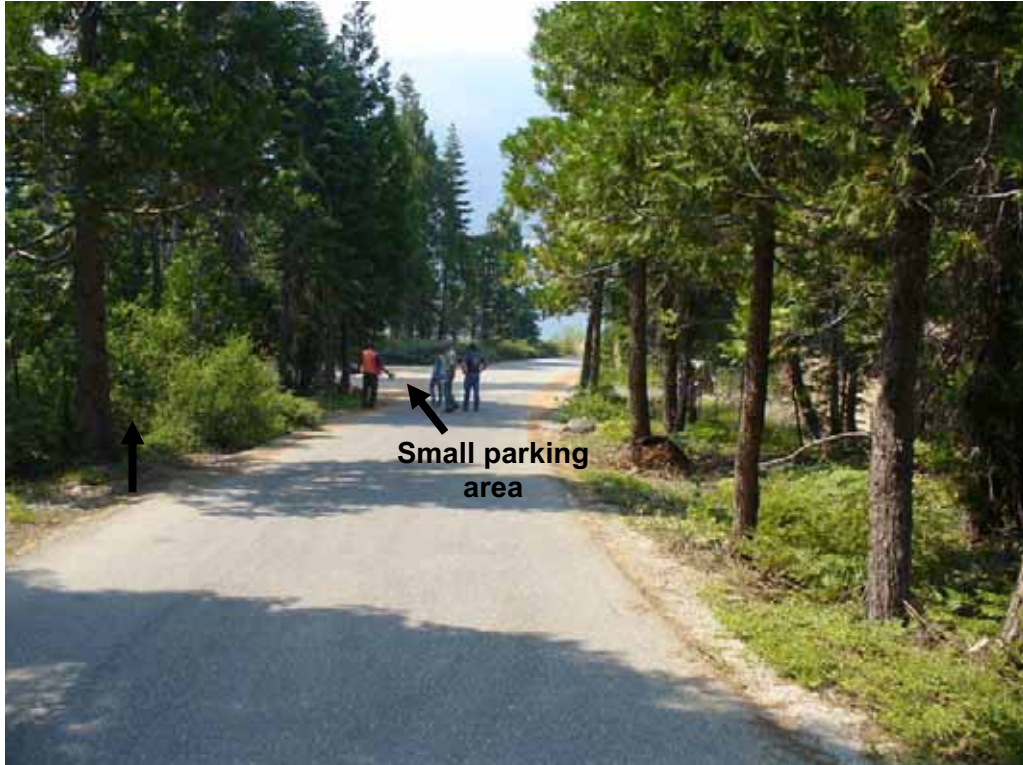
**Photo O-2-8. Paved road extending from French Meadows Boat Ramp Parking Area to French Meadows Boat Ramp. Note small parking area on left side of road. This area also functions as a high water turn-around at max WSE. (7/23/08)**

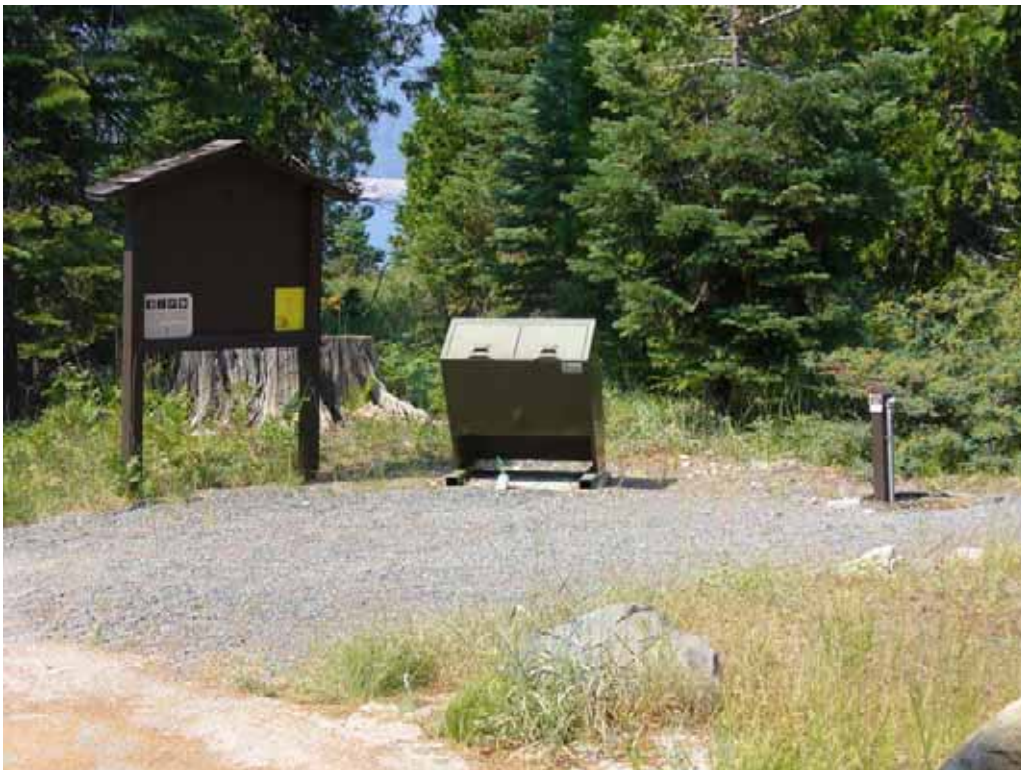
**Photo O-2-10. Information board, bear-proof garbage container, and water faucet located adjacent to bathroom. (7/23/08)**

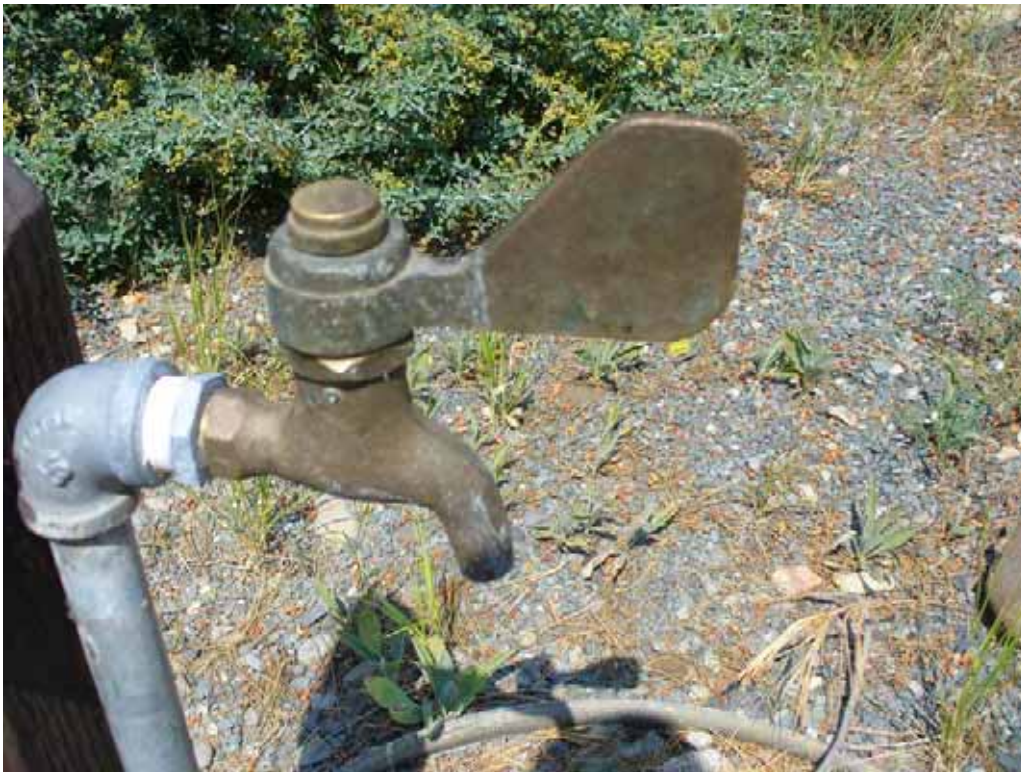
**Photo O-2-12. Example of disabled accessible faucet handle.**

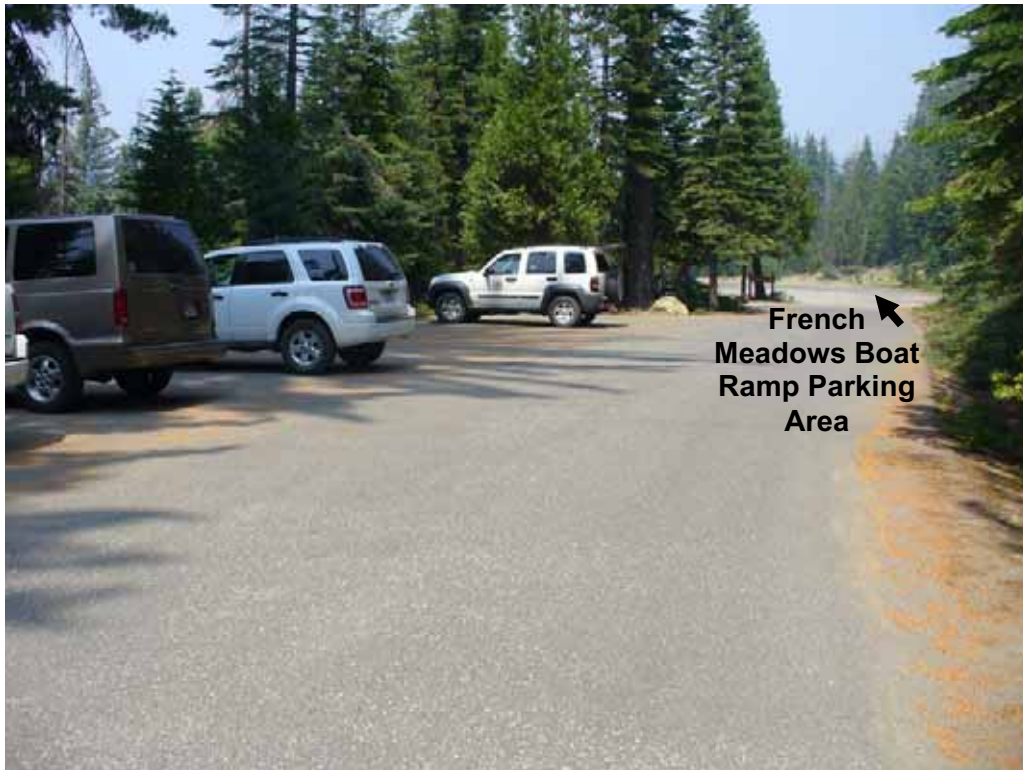
**Photo O-2-13. French Meadows Picnic Area Parking. Parking and roadway surfaces are in good condition. Note Boat Ramp Parking Area in background. (7/23/08)**

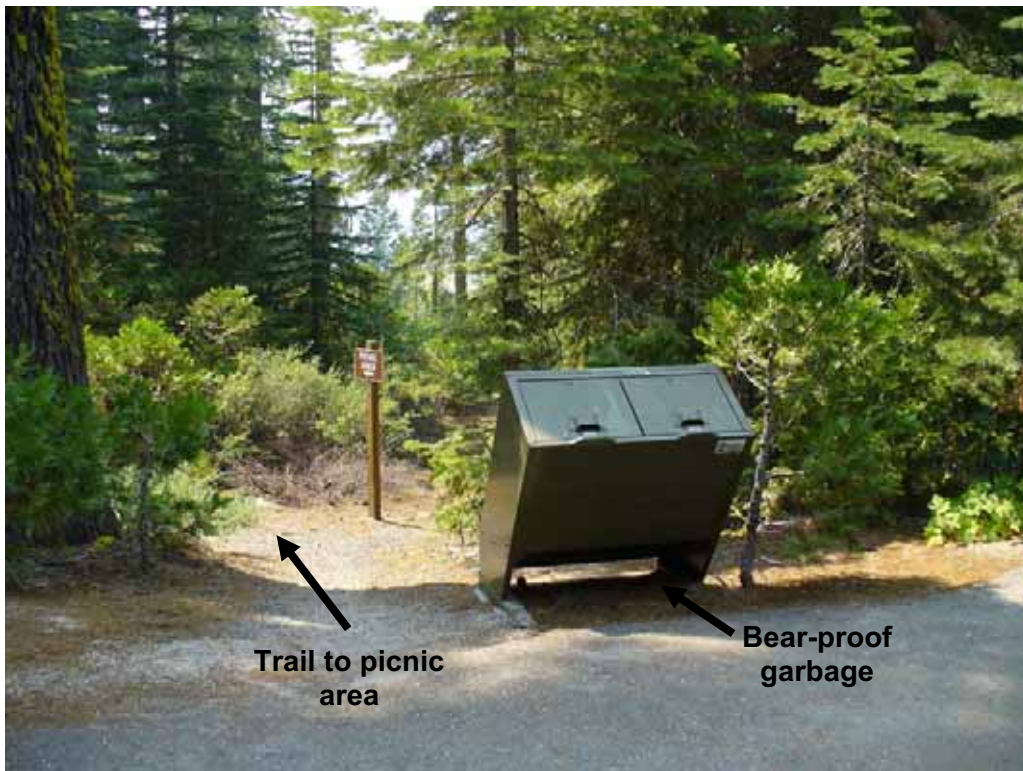
**Photo O-2-14. Entrance to French Meadows Picnic Area. (7/23/08)**

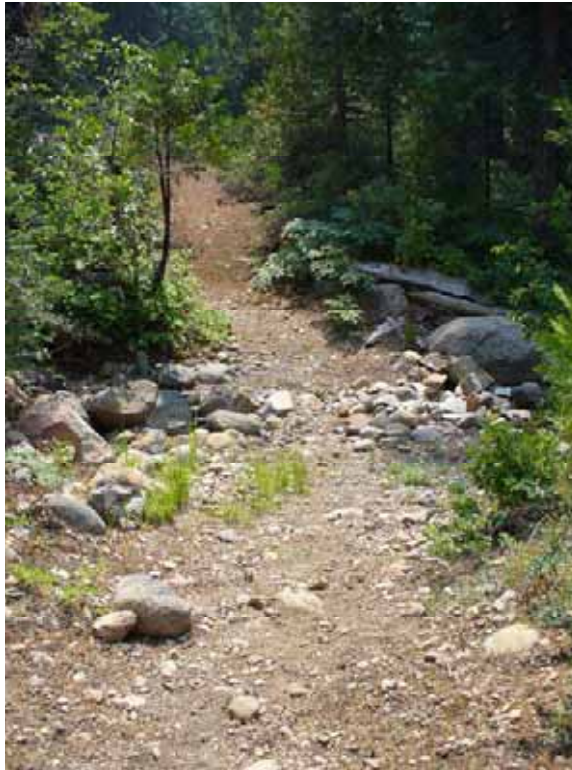
**Photo O-2-15. Trail to French Meadows Parking Area. Trail is not considered disable accessible due to obstacles, level changes, excessive slope, and narrow width. (7/23/08)**

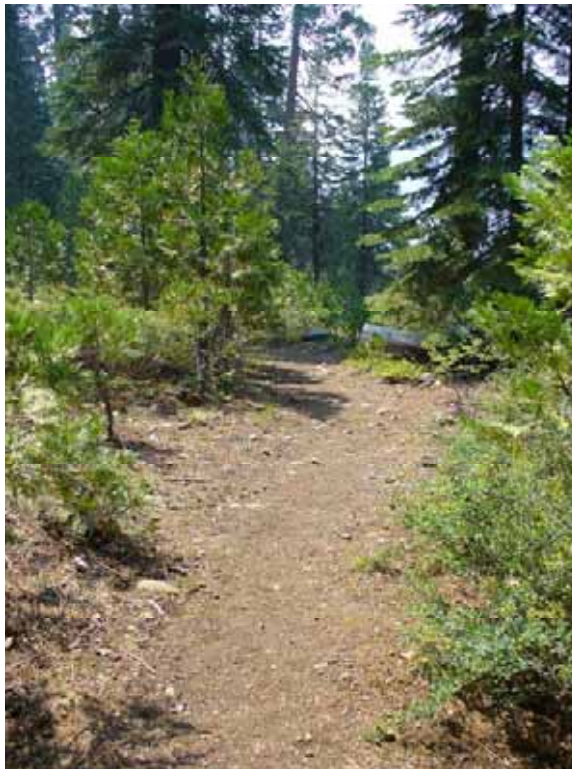
**Photo O-2-16. Trail to French Meadows Parking Area. (7/23/08)**

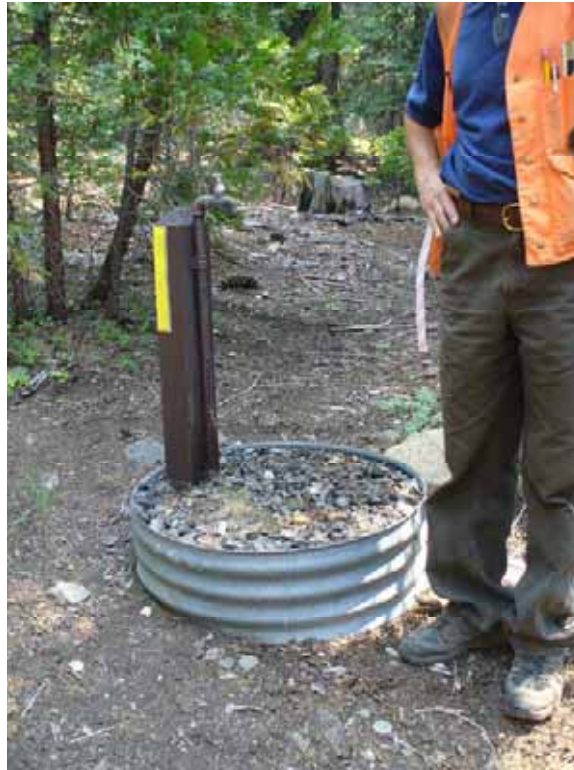
**Photo O-2-19. Water faucet in picnic area. Does not meet accessibility standards due to handle design and level changes. (7/23/08)**

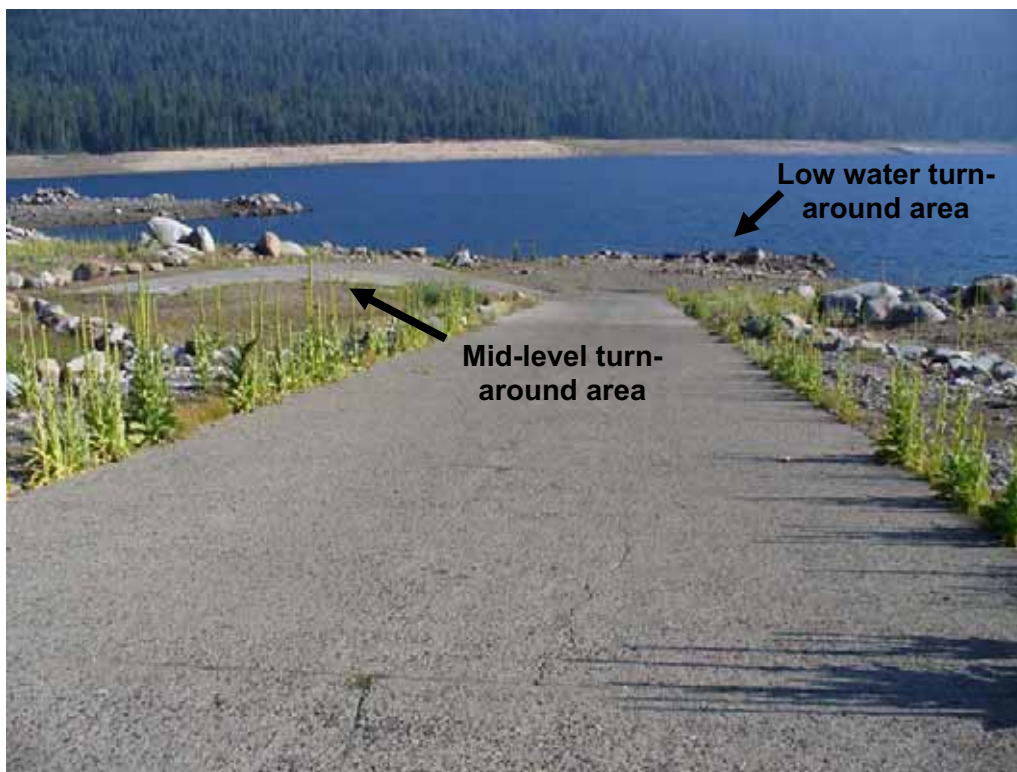
| Feature | Quantity or Dimensions | Location or Description | Material | Type | Cond | Accessibility | | | | | | Comments |
|---|---|---|---|---|---|---|---|---|---|---|---|---|
| <b>Boat Ramp</b> | Approx. 800 feet long by 20 feet wide (1.5 lane) | Concrete section extending from end of access road to end of ramp. | Concrete | NA | Good | N | X | X | | X | X | Overall, the ramp is in good condition, with the following exceptions:<br>- Minor cracking.<br>- Substantial debris (rock and gravel) present on ramp from mid level turn-around area to end of ramp.<br>Ramp does not meet accessibility standards due to excessive slope and the presence of debris (obstacles) deposited as water level recedes. |

**Photo P-2-1. McGuire Boat Ramp on July 23, 2008 (WSE = 5,220 ft).**

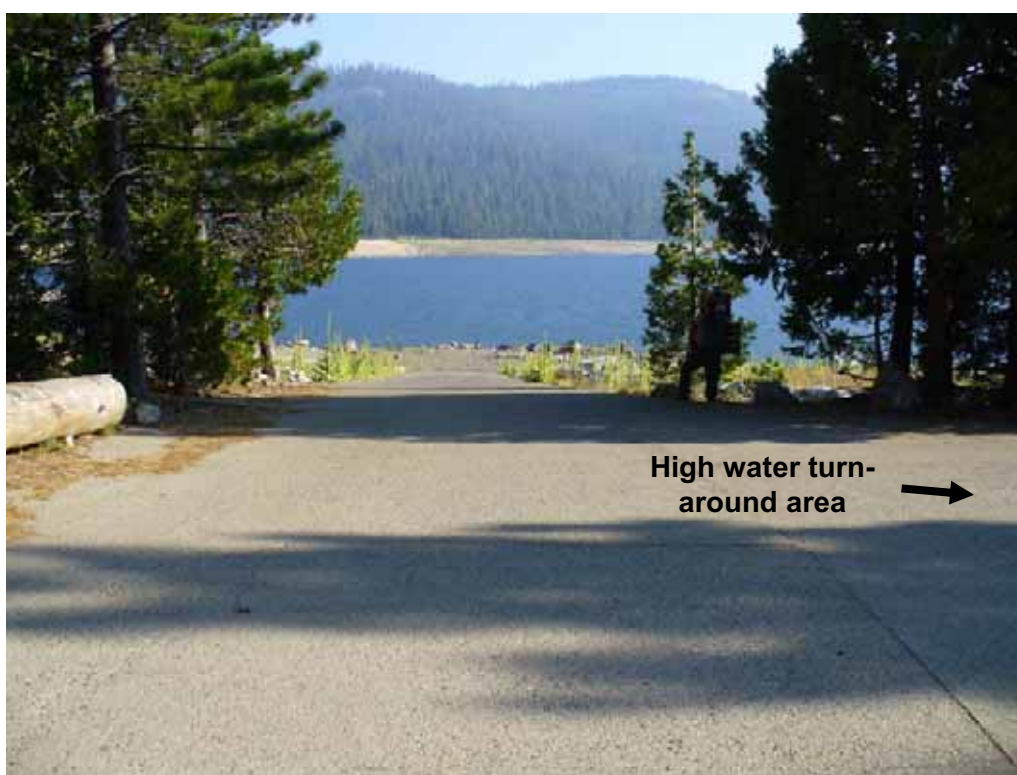
**Photo P-2-2. View of McGuire Boat Ramp from top of ramp. (7/23/08)**

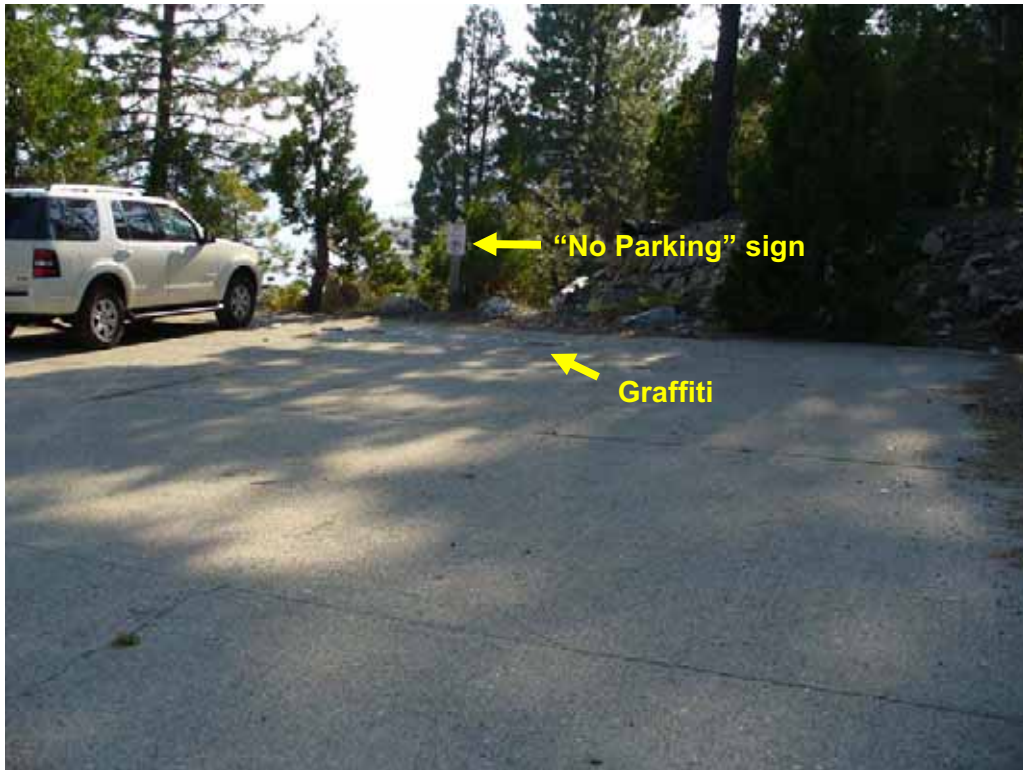
**Photo P-2-3. High water turn-around and loading/unloading area. Note "no parking" sign and graffiti on surface. (7/23/08)**

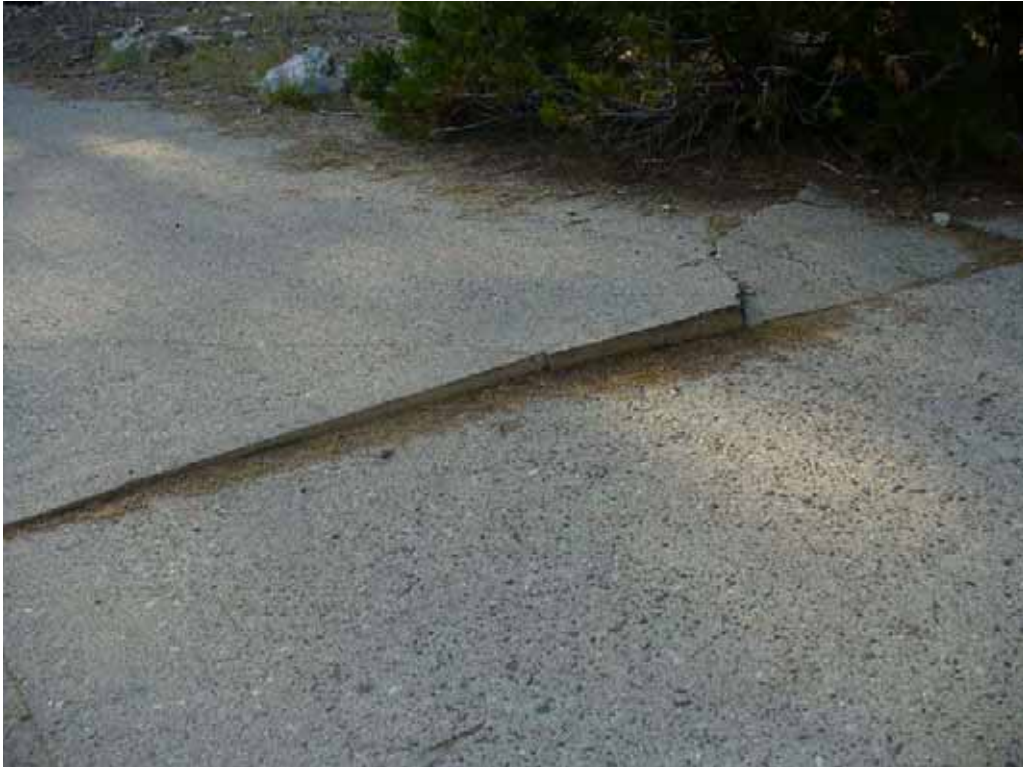
| Feature | Quantity or Dimensions | Location or Description | Material | Type | Cond | Accessibility | | | | | | Comments |
|---|---|---|---|---|---|---|---|---|---|---|---|---|
| <b>Boat Ramp Turn-Around Areas</b> | 3 | One low water turn-around, one mid-level turnaround, one highwater turn around. | Concrete | NA | Fair | N | | | | | | Low and mid-level turn around areas are in good condition but covered in debris.<br>High water turn around (approx. 2,000 square feet) is in good condition with following exceptions:<br>- Concrete is uplifted at edge of turnaround.<br>- Graffiti present. |

**Photo P-2-4. Uplifted concrete at edge of high water turn-around area. (7/23/08)**

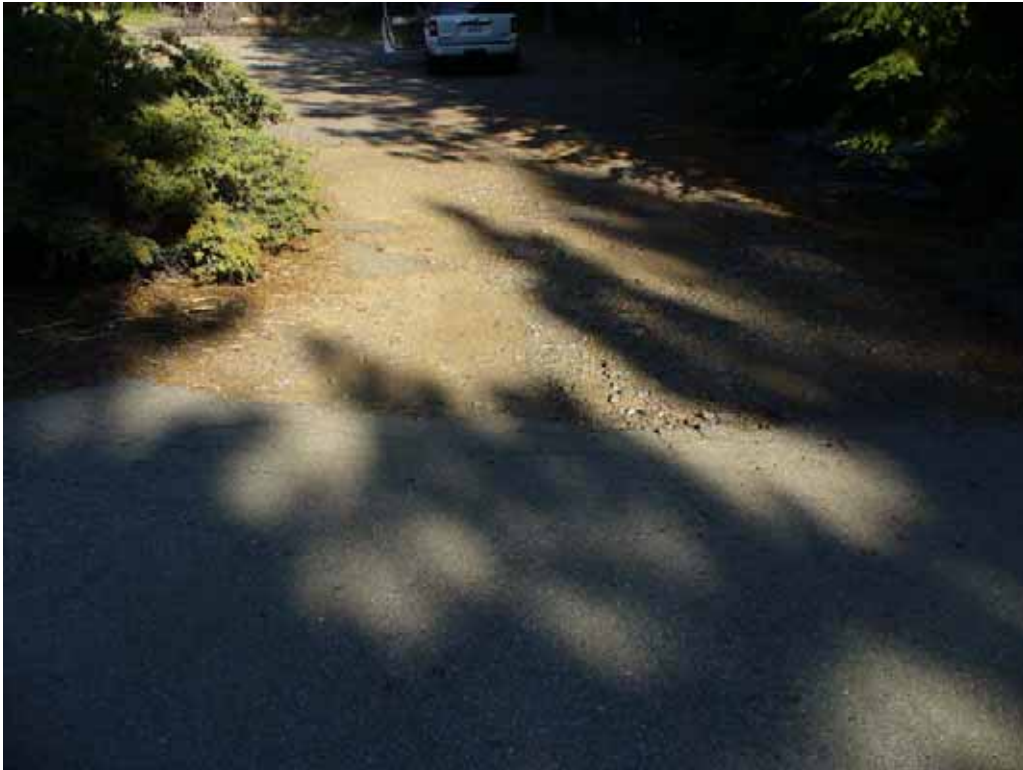
**Photo P-2-5. Entrance to McGuire Boat Ramp Parking Area – southeast lot. Note transition from asphalt pavement access road to base rock in parking area. (7/23/08)**

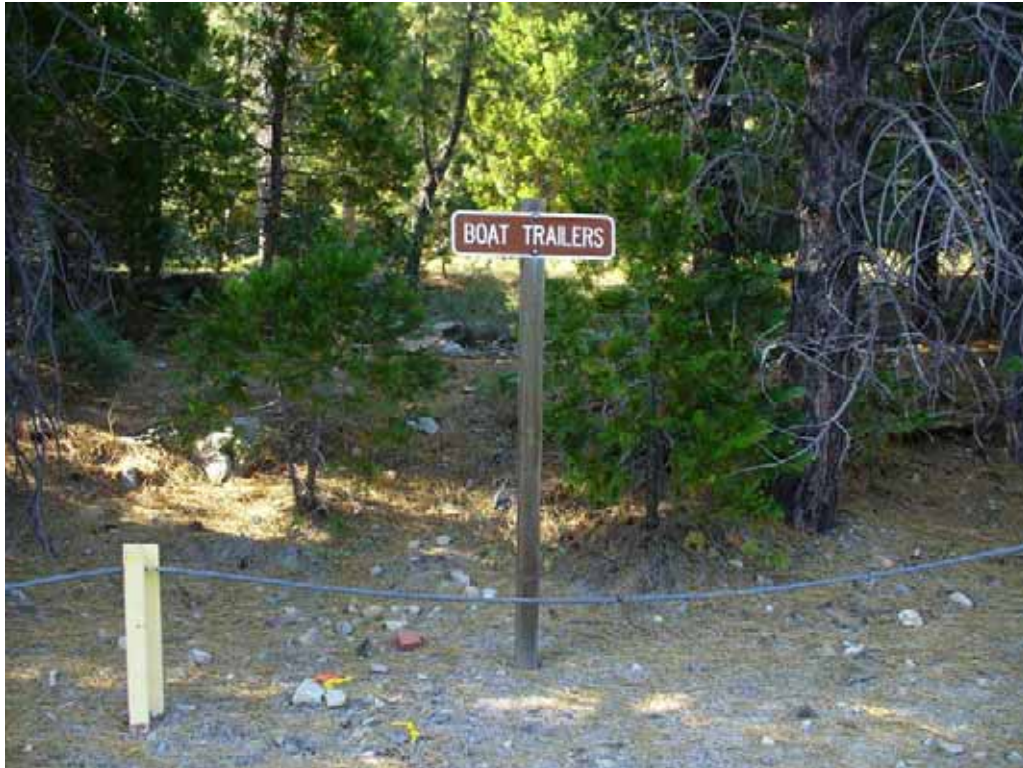
**Photo P-2-7. Sign and post and cable barrier fence along north side of McGuire Boat Ramp Parking Area southeast lot. (7/23/08)**

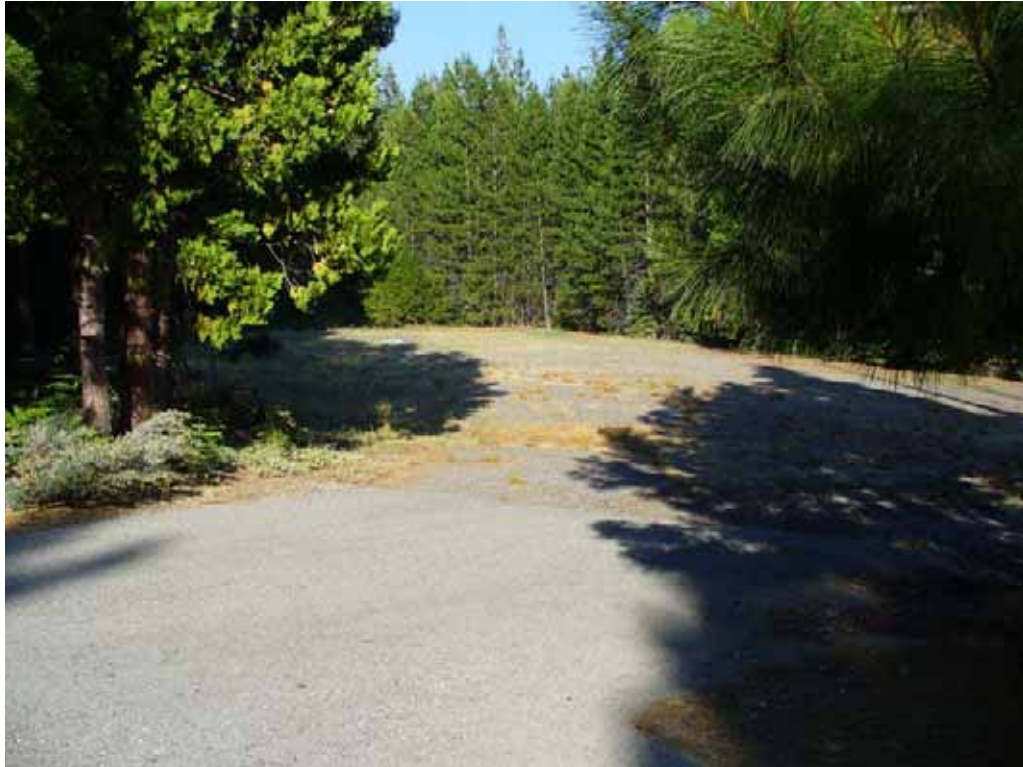
**Photo P-2-8. North entrance to McGuire Boat Ramp Parking Area – northeast lot. Note transition from asphalt pavement access road to base rock in parking area. (7/23/08)**

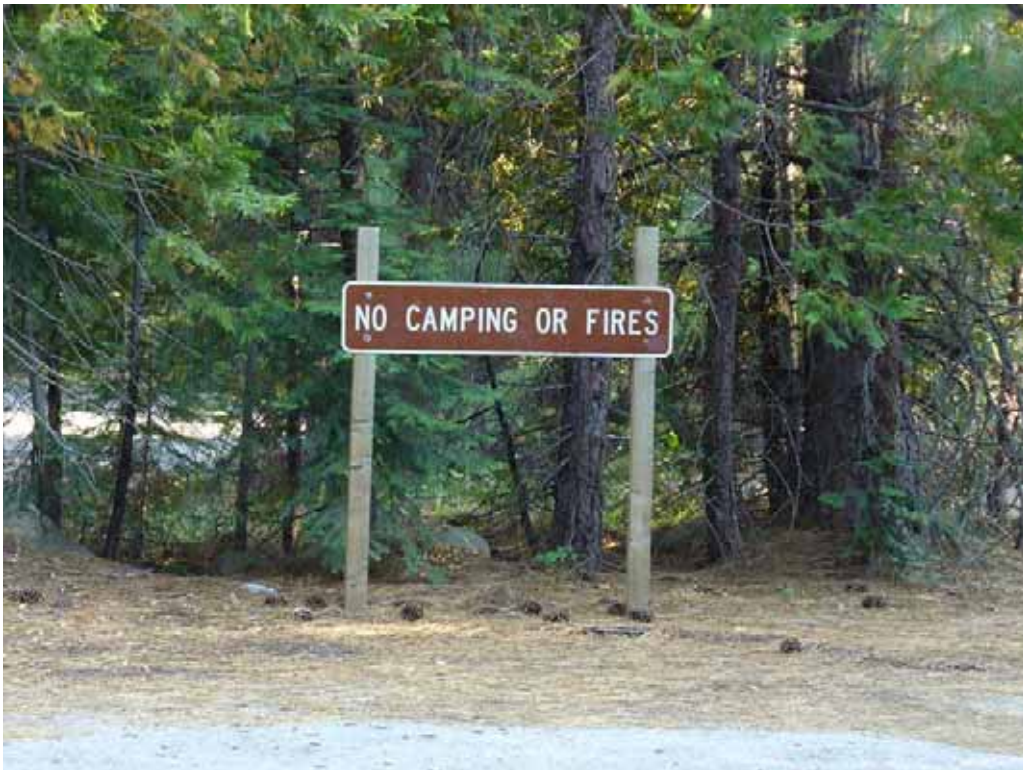
**Photo P-2-10. Sign along access road near McGuire Boat Ramp Parking Area – between northeast and southeast lots. (7/23/08).**

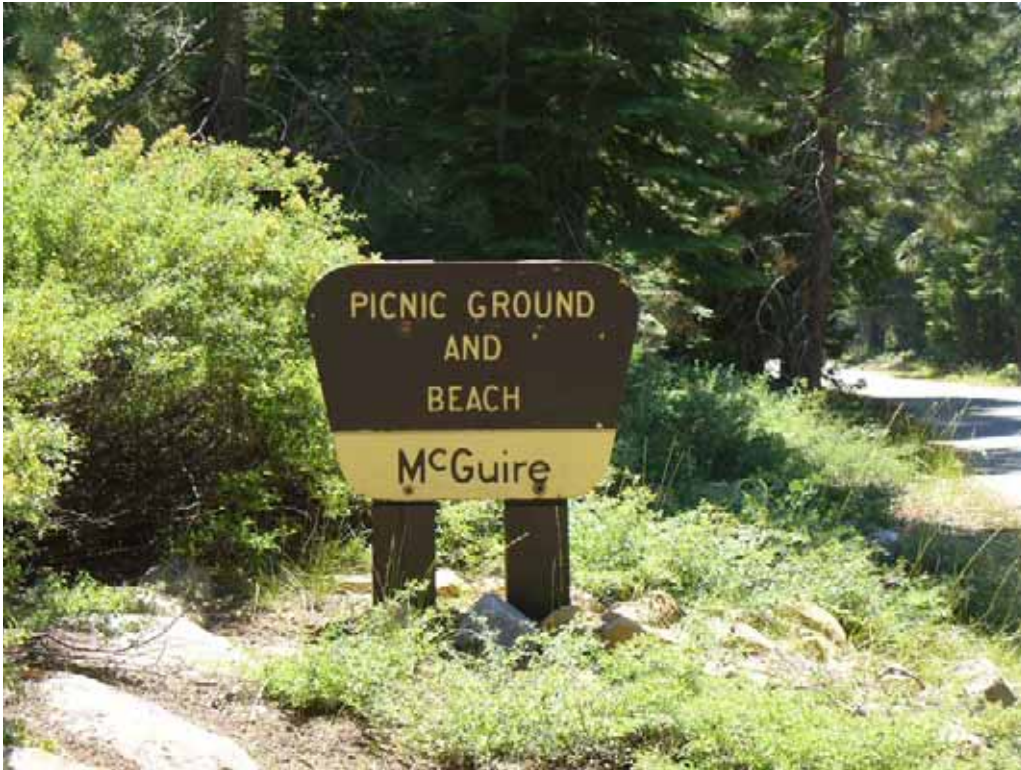
**Photo Q-2-1. Site identification sign at entrance to McGuire Picnic Area. (7/24/09)**

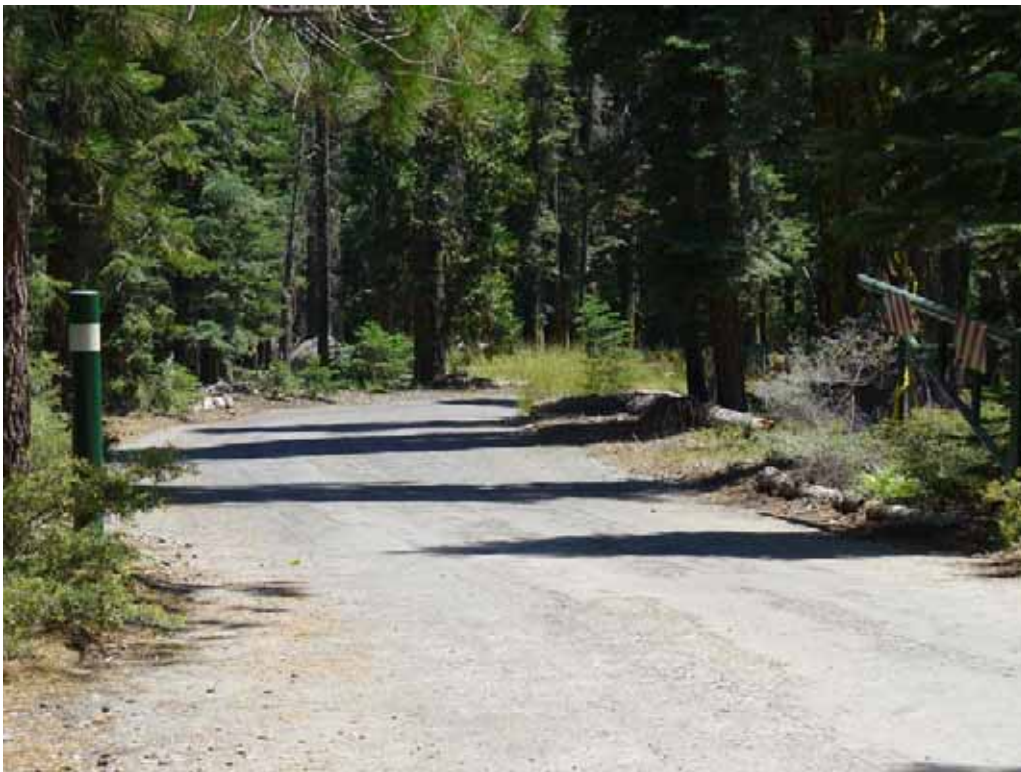
**Photo Q-2-2. Gated entrance and access road to McGuire Picnic Area, beach, and parking area. (7/24/08)**

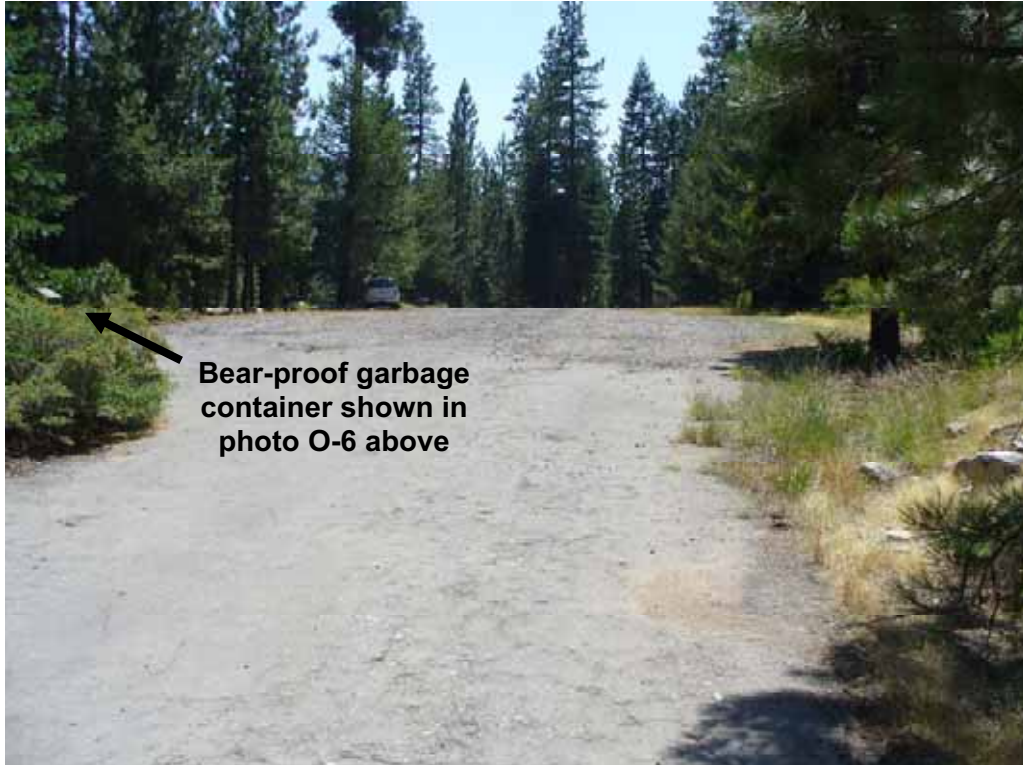
**Photo Q-2-4. McGuire Picnic Area and Beach parking area. Note deteriorated asphalt surface. (7/24/08)**

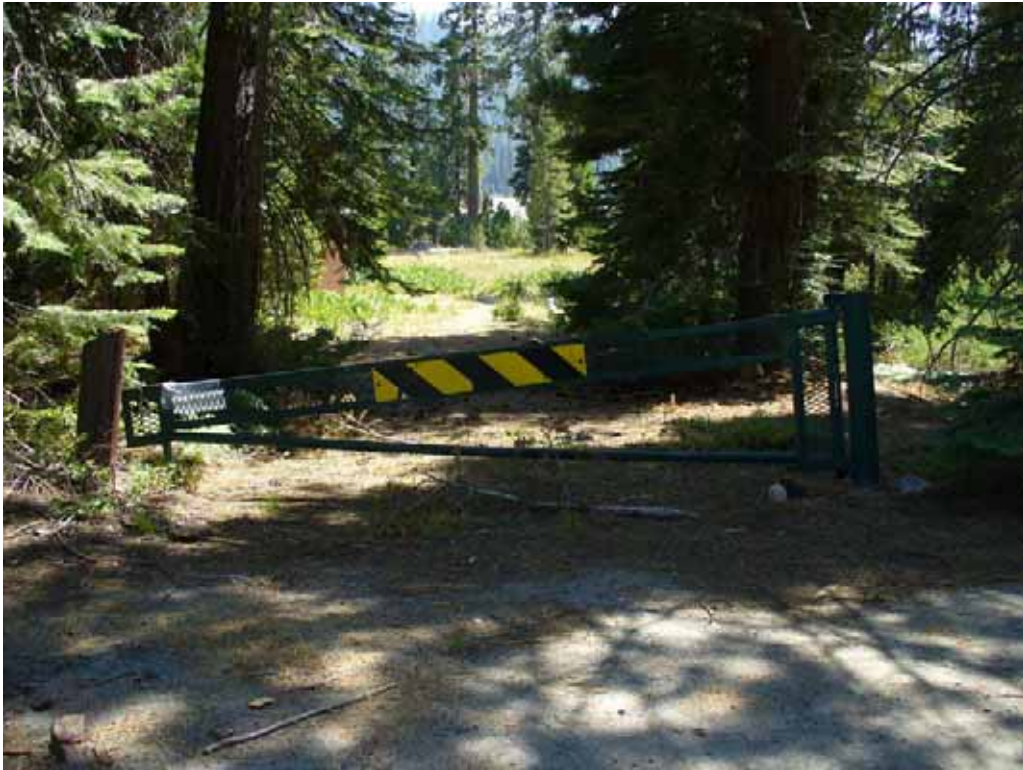
**Photo Q-2-5. Gate blocking access to old service road. (7/24/08)**
