**Placer County Water Agency  
Middle Fork American River Project  
(FERC No. 2079)**

**REC 1 – RECREATION USE AND FACILITIES  
TECHNICAL STUDY REPORT**

Placer County Water Agency  
P.O. Box 6570  
Auburn, CA 95604

May 2010

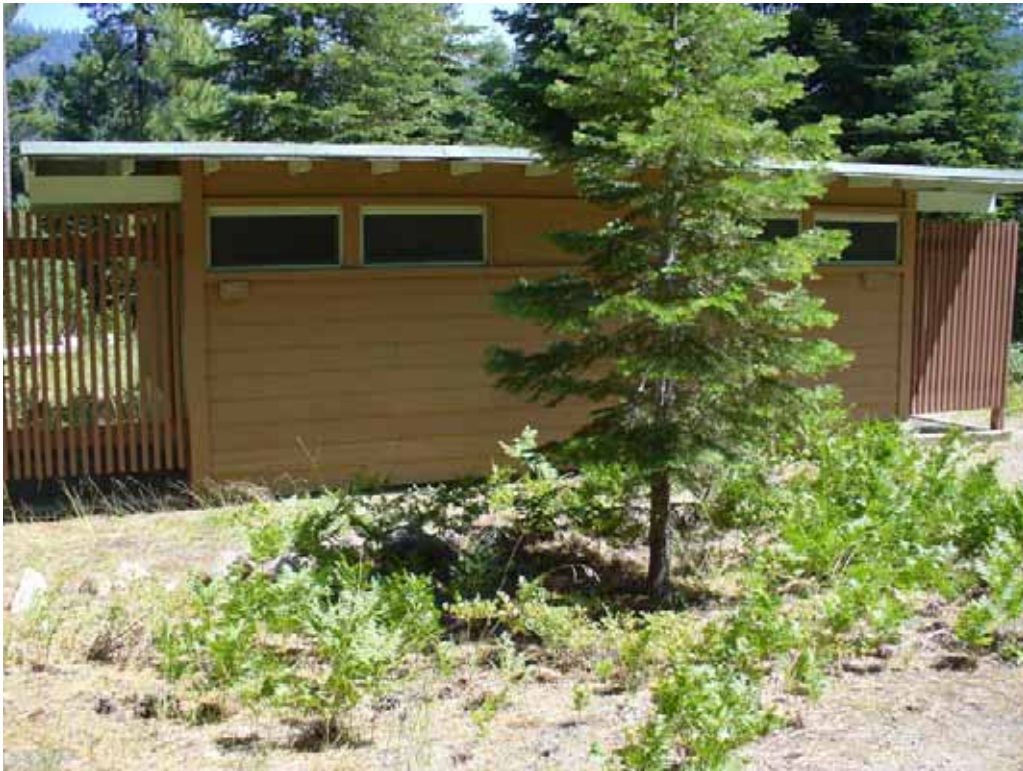
**Photo Q-2-6. Bathroom located adjacent to parking area. Not disabled accessible. (7/24/08)**

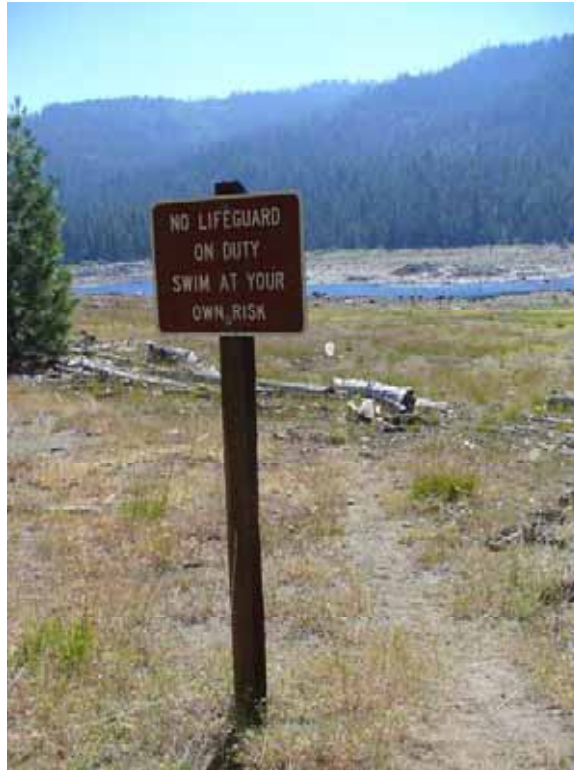
**Photo Q-2-13. Trail to McGuire Beach with sign. (7/24/08)**

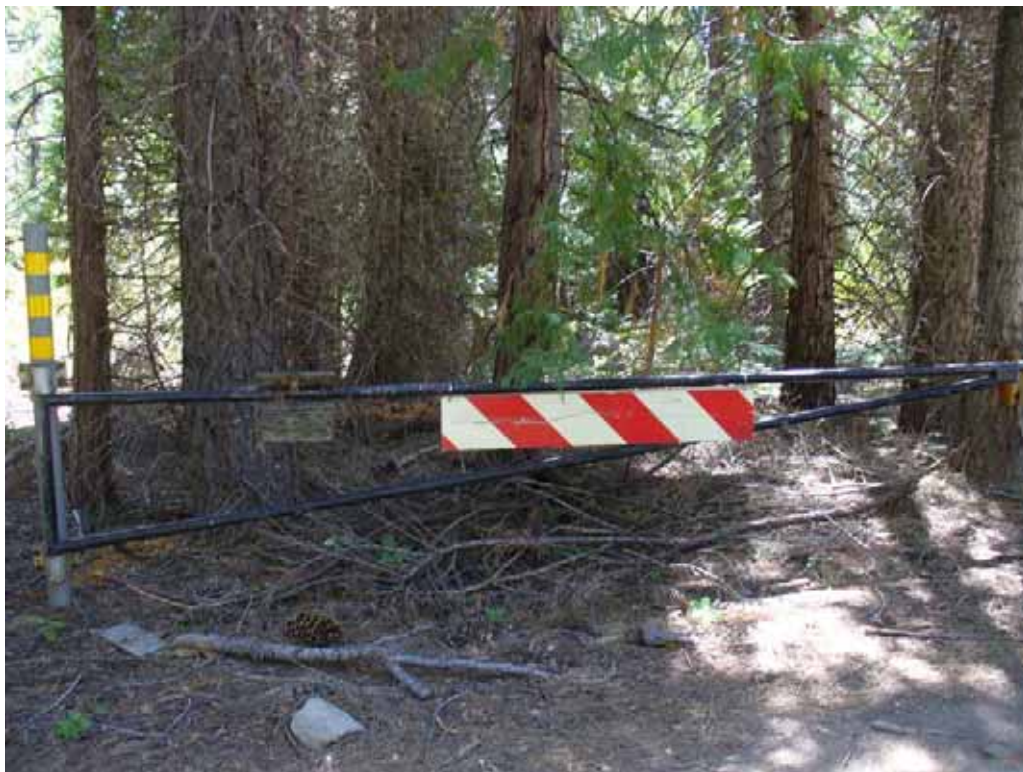
| Feature | Quantity<br>or<br>Dimensions | Location or<br>Description | Material | Type | Cond | Accessibility | | | | | | Comments |
|---|---|---|---|---|---|---|---|---|---|---|---|---|
| <b>Gate</b> | 1 | Along Middle Meadows Group Campground Road, near intersection with FR-2 | Black painted steel with hazard signage. | Double swing gate. | Fair | NA | | | | | | Gate is functional but is bent and in need of paint. |

**Photo R-2-2. Gate at entrance to Middle Meadows Campground Access Road (14N28). (8/21/08)**

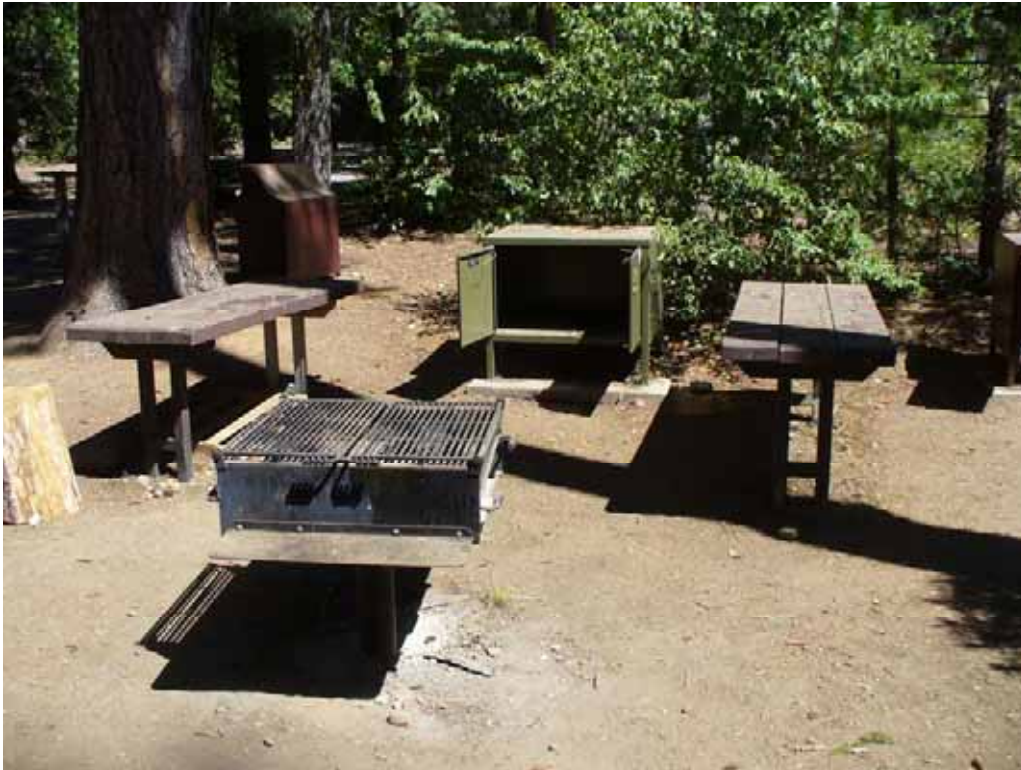
**Photo R-2-11. Kitchen area in Unit 1. Note accessible double pedestal grill, bear box on concrete pad, and new serving tables. (8/21/08)**

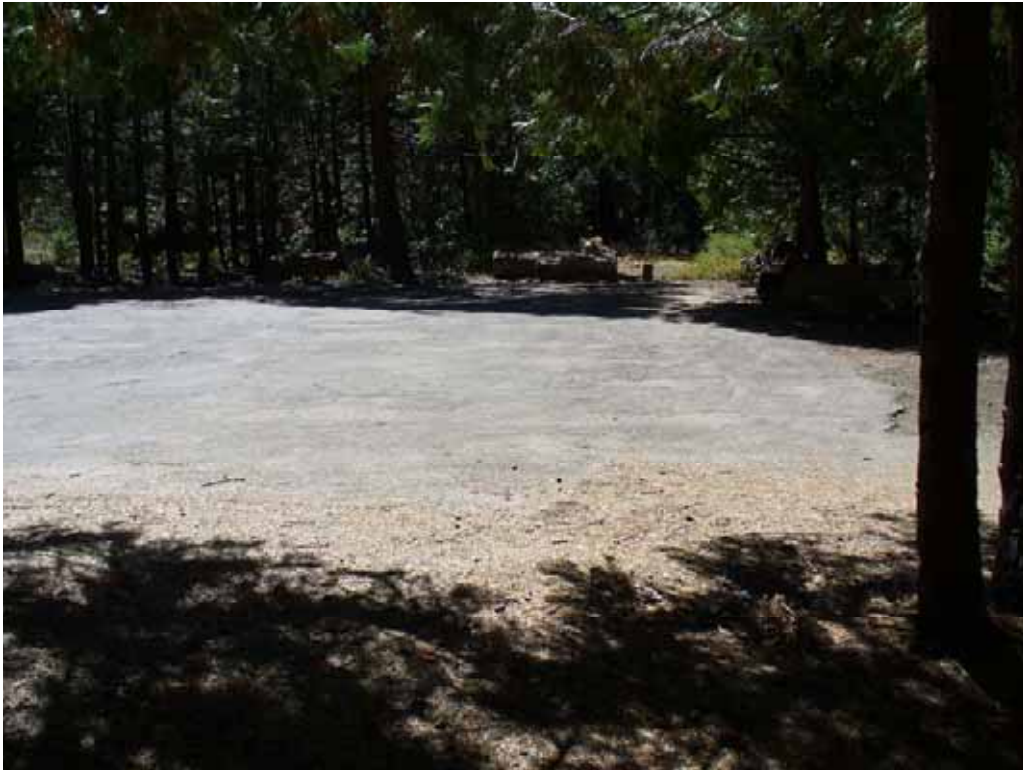
| Feature | Quantity or Dimensions | Location or Description | Material | Cond | Accessibility | | | | | | Comments |
|---|---|---|---|---|---|---|---|---|---|---|---|
| <b>Parking Area</b> | Total of 1,500 square feet | Unit 2 | Paved (AC) | Fair | Y | | | | | | Space for 5-6 vehicles. Some potholes and cracking. Generally deteriorating. |

**Photo R-2-13. Parking for Unit 2.**

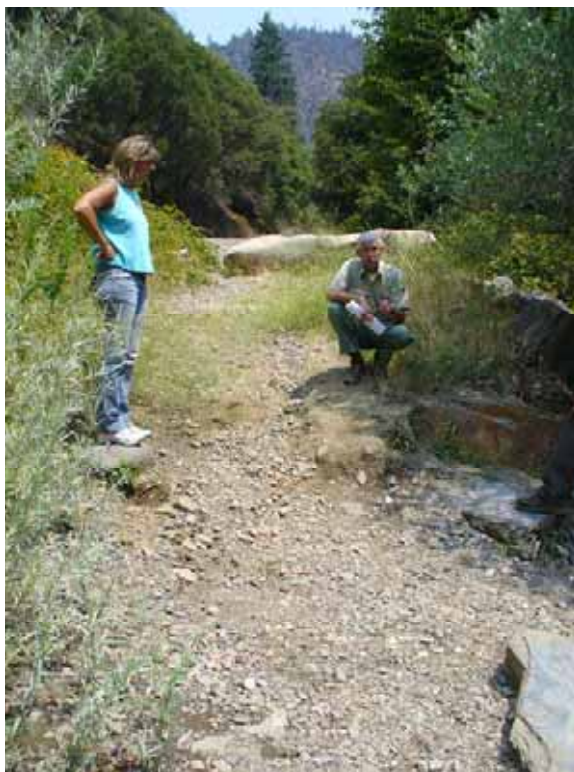
| Feature | Quantity or Dimensions | Location or Description | Material | Type | Cond | Accessibility | | | | | | Comments |
|---|---|---|---|---|---|---|---|---|---|---|---|---|
| <b>Boat Ramp</b> | Approx. 12-15 feet wide by 95-125 feet long, depending upon water level. | Between Sites 1 and 2. | Native surface | Car top launching. | Poor | N | X | X | | X | X | Overall, the ramp is in poor condition but is functional for launching car top boats. The boat ramp is unimproved with a native surface, which has eroded. The ramp is narrow, steep, and launching is somewhat complicated by the presence of a large barrier rock in the middle of the ramp. The ramp does not meet accessibility standards due to excessive slope, the surface materials, and the presence of obstacles. |

**Photo S-2-8. Ralston Car Top Boat Ramp on November 12, 2008 at 10:33 A.M. This photograph was taken during PCWA's annual maintenance outage when the reservoir WSE was about 1,155 feet. Note the large rock in center of ramp.**

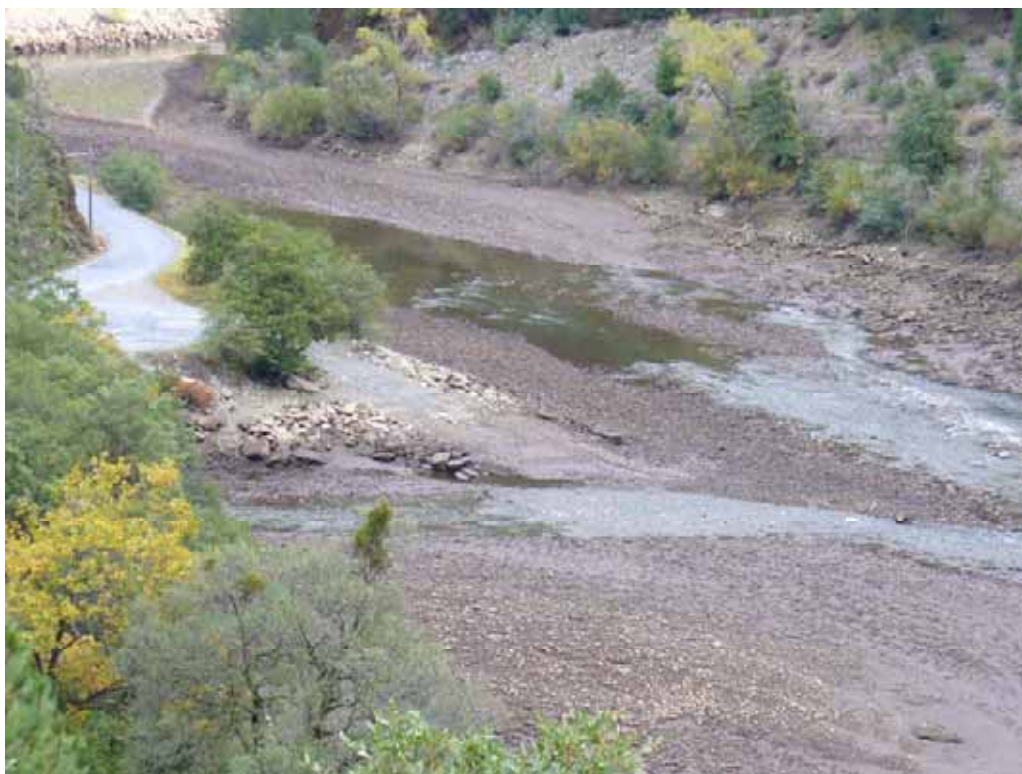
**Photo S-2-9. Close up of Ralston Car Top Boat Ramp Note large rock in center of ramp. (7/23/08)**

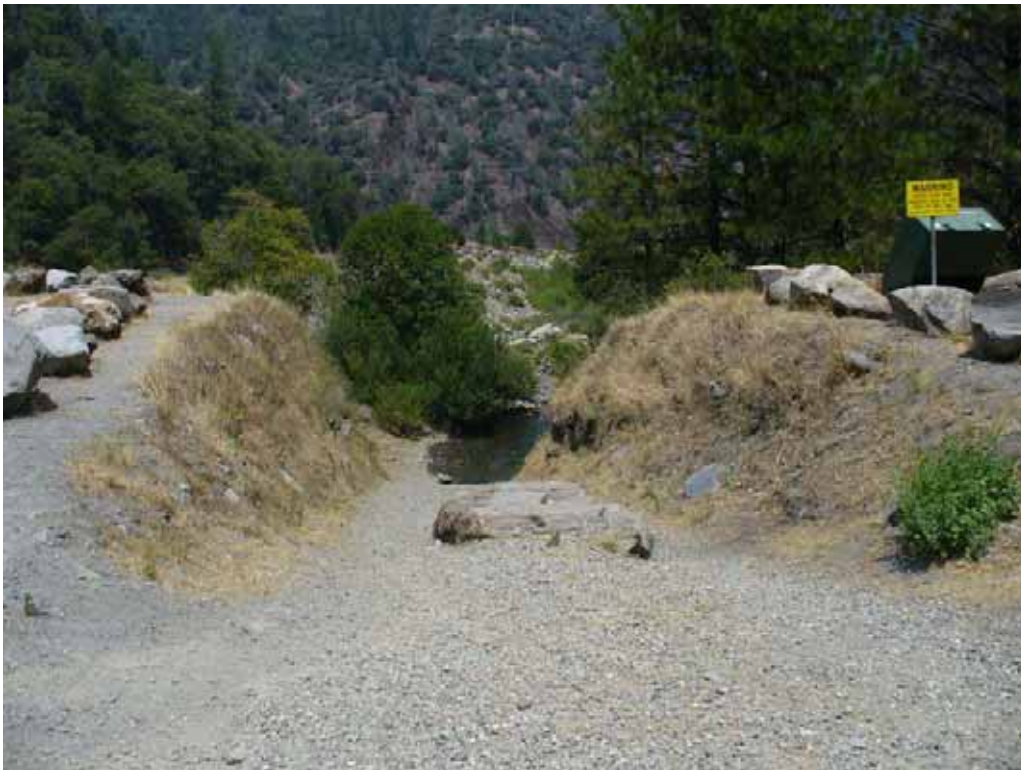
**Photo T-2-4. Boat launch ramp. Note warning sign and bear proof garbage to right of ramp. (7/23/08)**

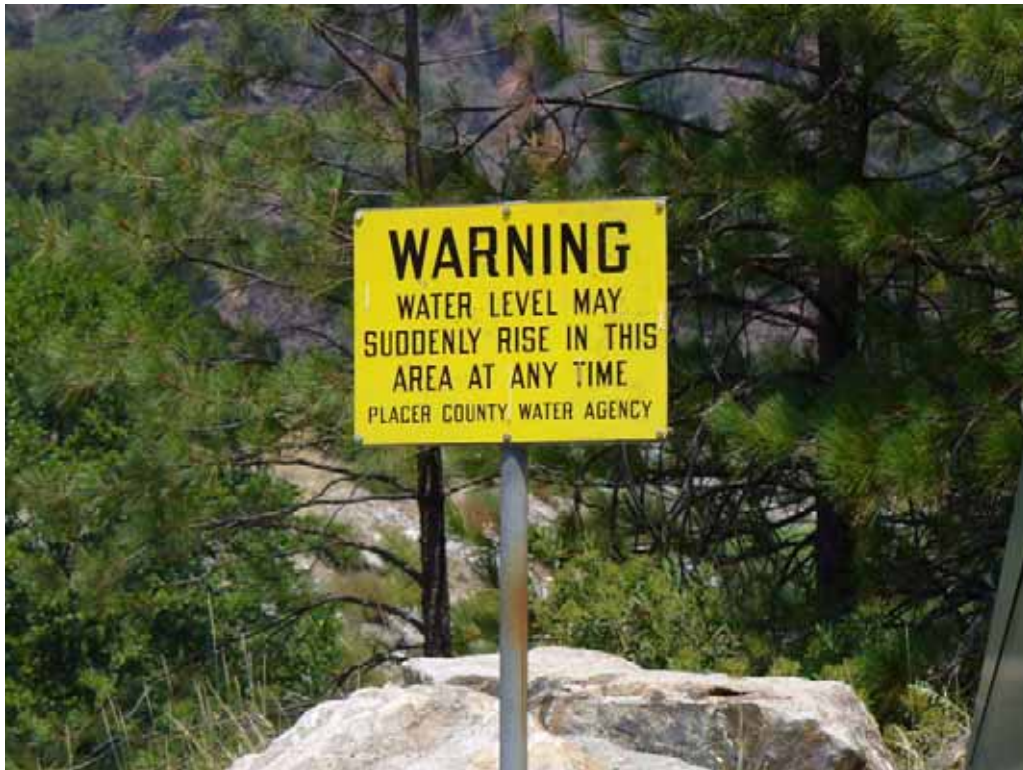
**Photo T-2-5. Warning sign adjacent to boat launch ramp. (7/21/08)**

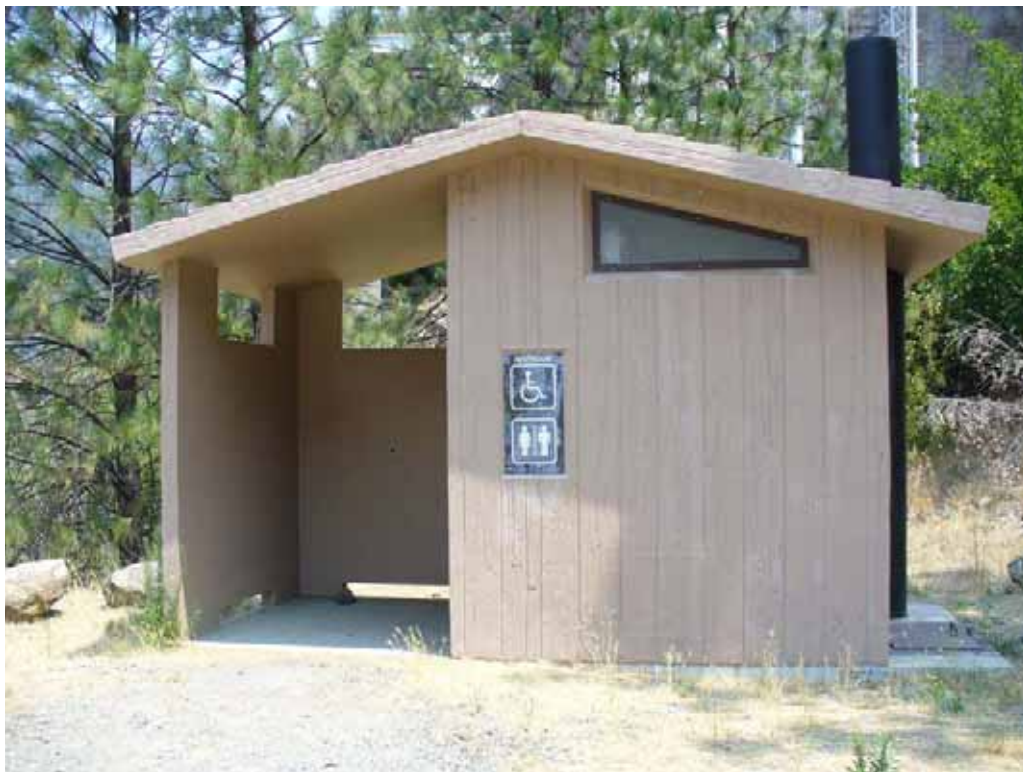
**Photo T-2-6. Single unit accessible CXT adjacent to boat launch ramp.**

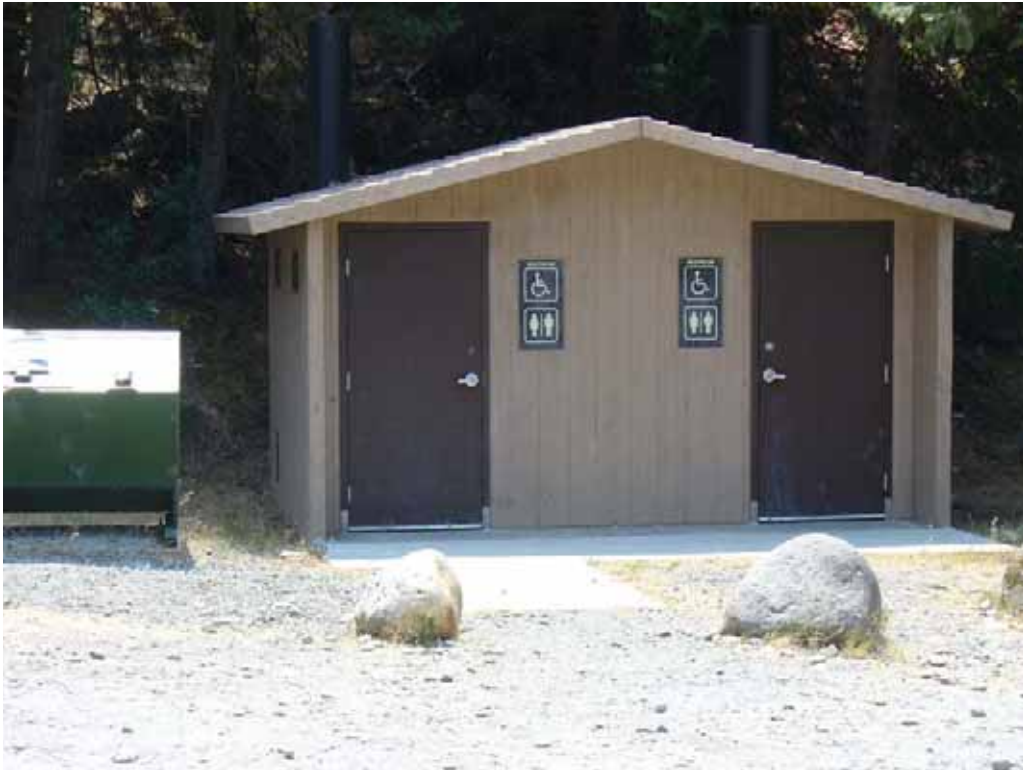
**Photo T-2-7. Double unit accessible CXT and bear-proof garbage adjacent to parking area. (7/23/08)**

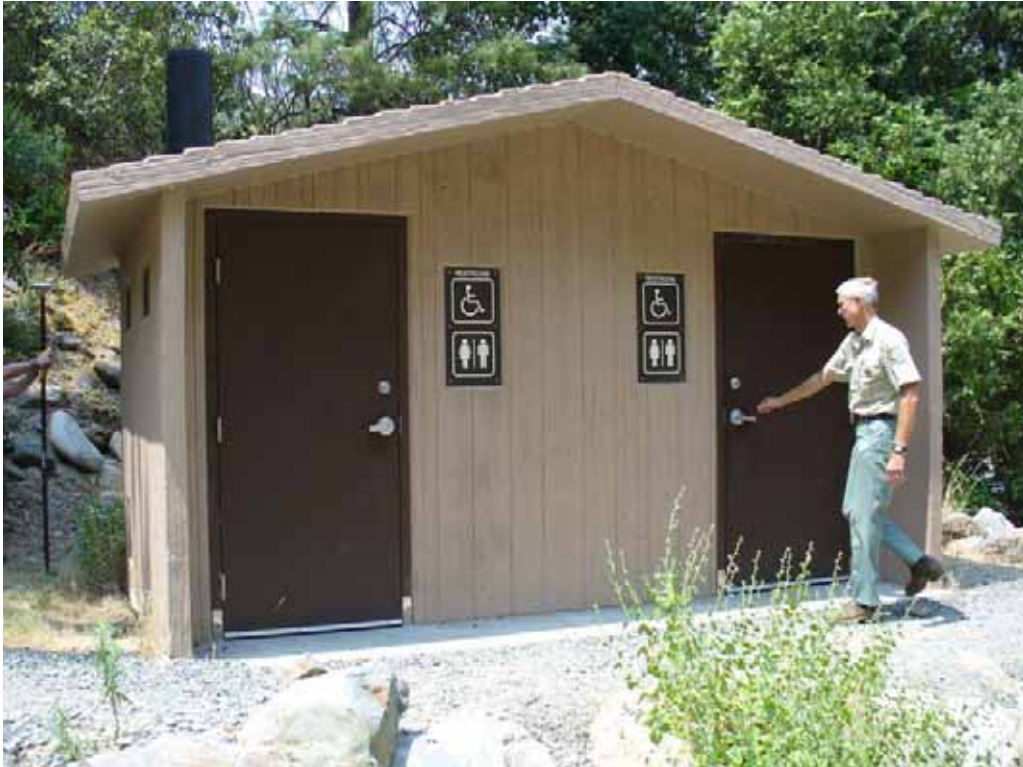
**Photo T-2-8. Double unit accessible CXT upslope from parking area. (7/23/08)**

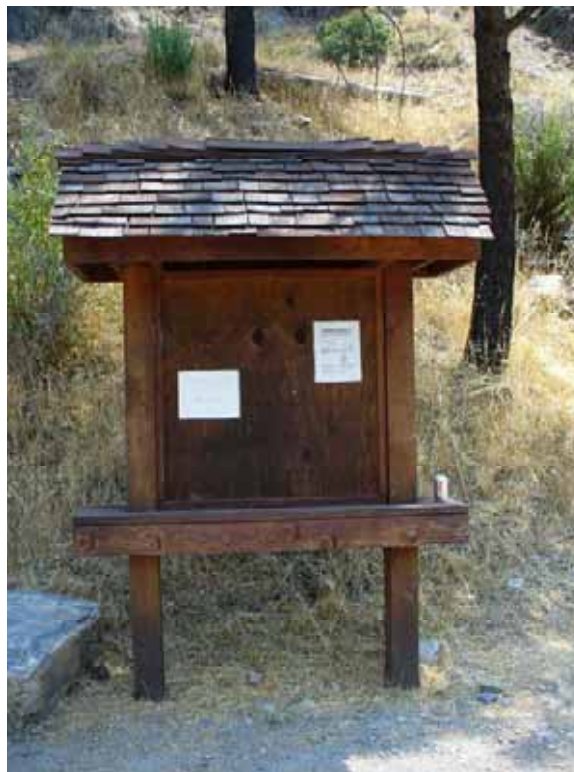
**Photo T-2-10. Good condition information board adjacent to boat launch ramp. (7/23/08)**

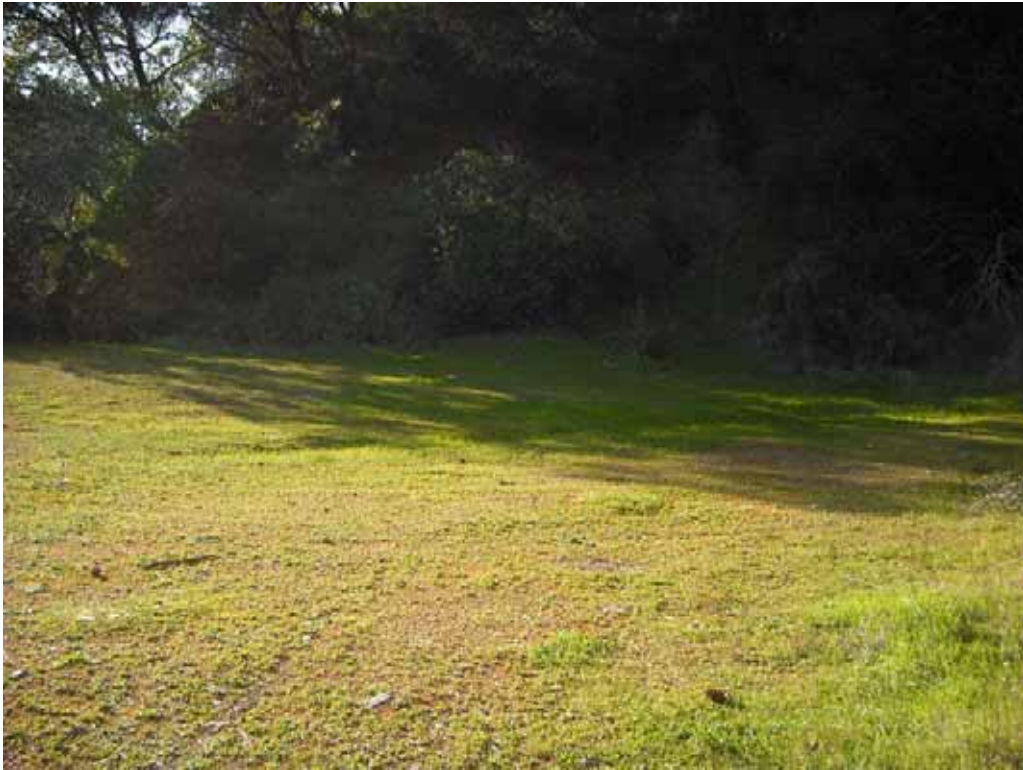
**Photo U-2-1. The parking/turnaround area located on the northwest side of Canyon Creek. (3/12/09)**

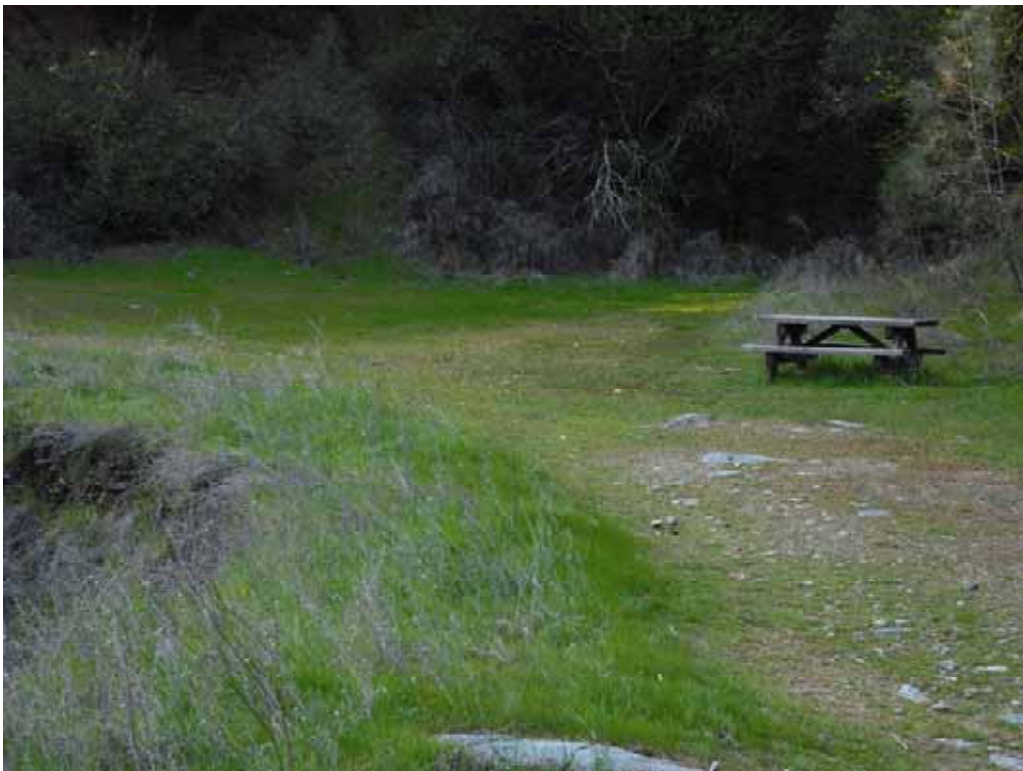
**Photo U-2-2. The lack of use of the parking/turnaround area has allowed for vegetation overgrowth. (3/12/09)**

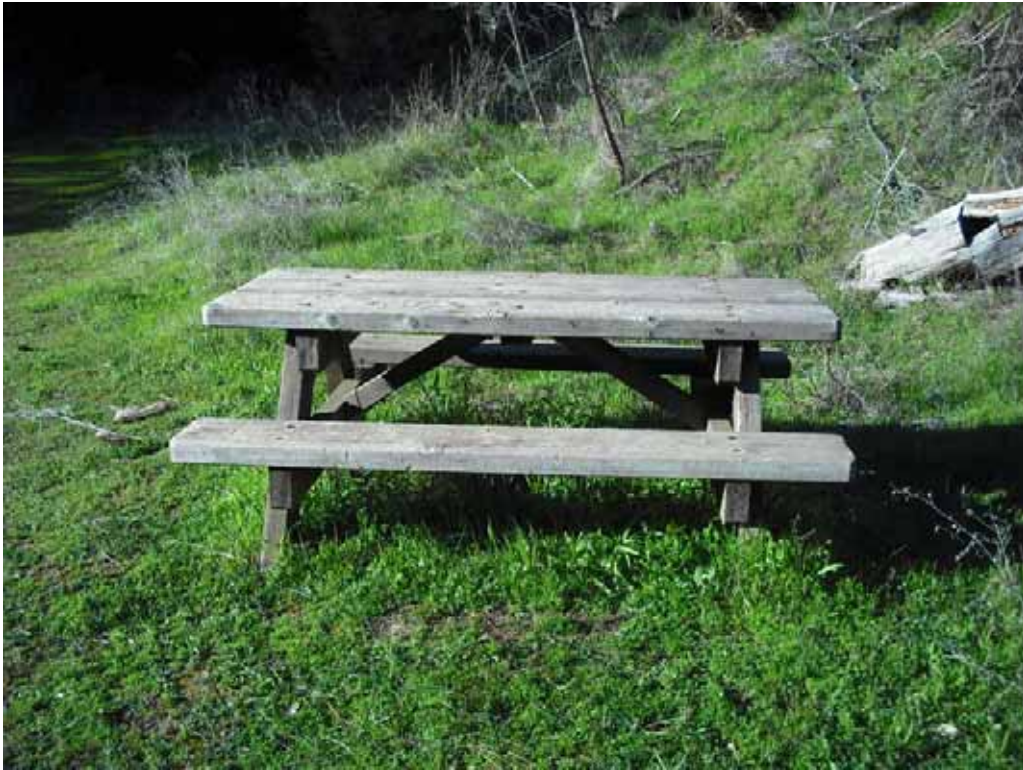
| Feature | Quantity or Dimensions | Location or Description | Material | Type | Cond | Accessibility | | | | | | Comments |
|---|---|---|---|---|---|---|---|---|---|---|---|---|
| <b>Picnic Table</b> | 1 table, seats approx. 8-10 people | Located on northwest upper end of facility in parking area | Treated wood | Heavy | Fair | N | | | X | | X | Picnic table is not accessible design. In fair condition due to lack of use but is covered in old graffiti. Difficult to access and use due to vegetation along pathway and under table. |

**Photo U-2-3. Picnic table located on the east side of the parking/turnaround area. (3/12/09)**

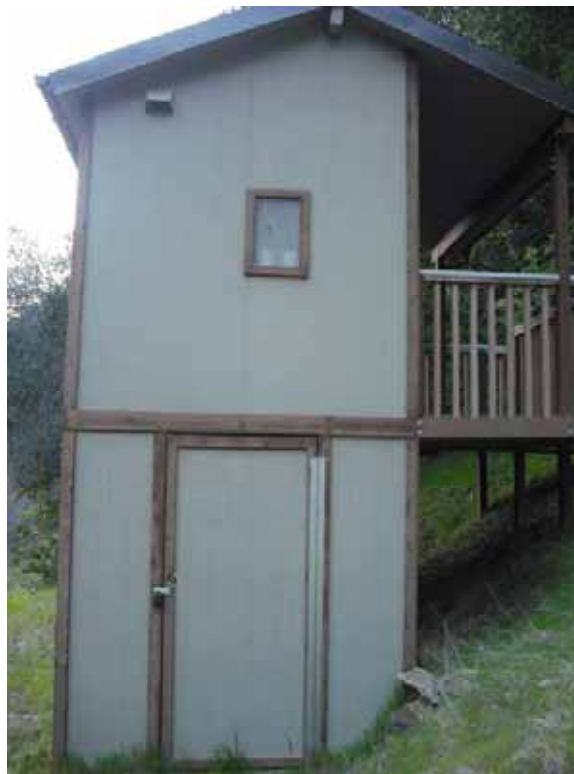
| Feature | Quantity or Dimensions | Location or Description | Material | Type | Cond | Accessibility | | | | | | Comments |
|---|---|---|---|---|---|---|---|---|---|---|---|---|
| <b>Bathroom</b> | Two unit | On east side of facility near beach area. Includes 1 toilet, and 1 toilet paper roll dispenser. | Painted wood exterior | Compost | Good | N | X | | X | X | | Good overall condition not accessible due to location. |

**Photo U-2-6. Compost toilet located on the east side of the facility. (3/12/09)**

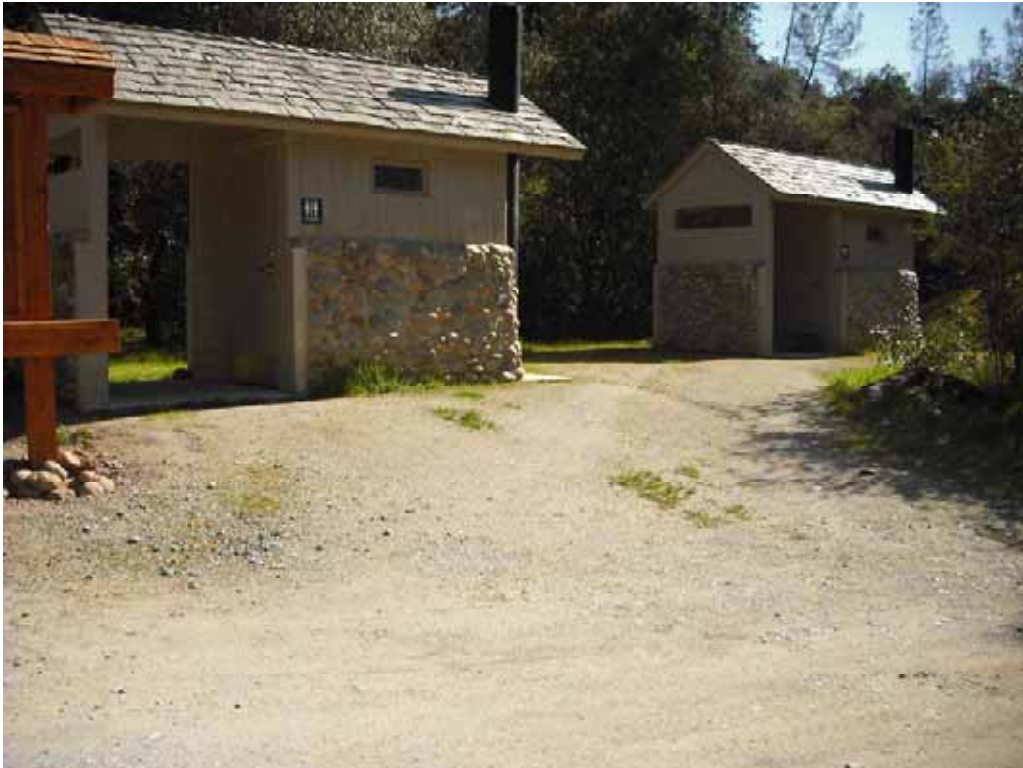
| Feature | Quantity or Dimensions | Location or Description | Material | Type | Cond | Accessibility | | | | | | Comments |
|---|---|---|---|---|---|---|---|---|---|---|---|---|
| <b>Bathroom</b> | Single unit | On east side of NW parking area, adjacent to garbage containers. | Wood and cobble exterior, cement foundation | Vault | Good | Y | | | | | | Includes 1 toilet, 1 toilet paper roll dispenser, and 2 support rails. Good overall condition but in need of cleaning. |

| Feature | Quantity or Dimensions | Location or Description | Material | Type | Cond | Accessibility | | | | | | Comments |
|---|---|---|---|---|---|---|---|---|---|---|---|---|
| <b>Bathroom</b> | Single unit | On east side of NW parking area, adjacent to first bathroom. | Wood and cobble exterior, cement foundation | Vault | Good | Y | | | | | | Includes 1 toilet, 1 toilet paper roll dispenser, and 2 support rails.<br>Good overall condition but in need of cleaning. |

**Photo V-2-3. Two coed bathrooms located in Northwest Parking Area. Disabled accessible and in good condition. (3/12/09)**

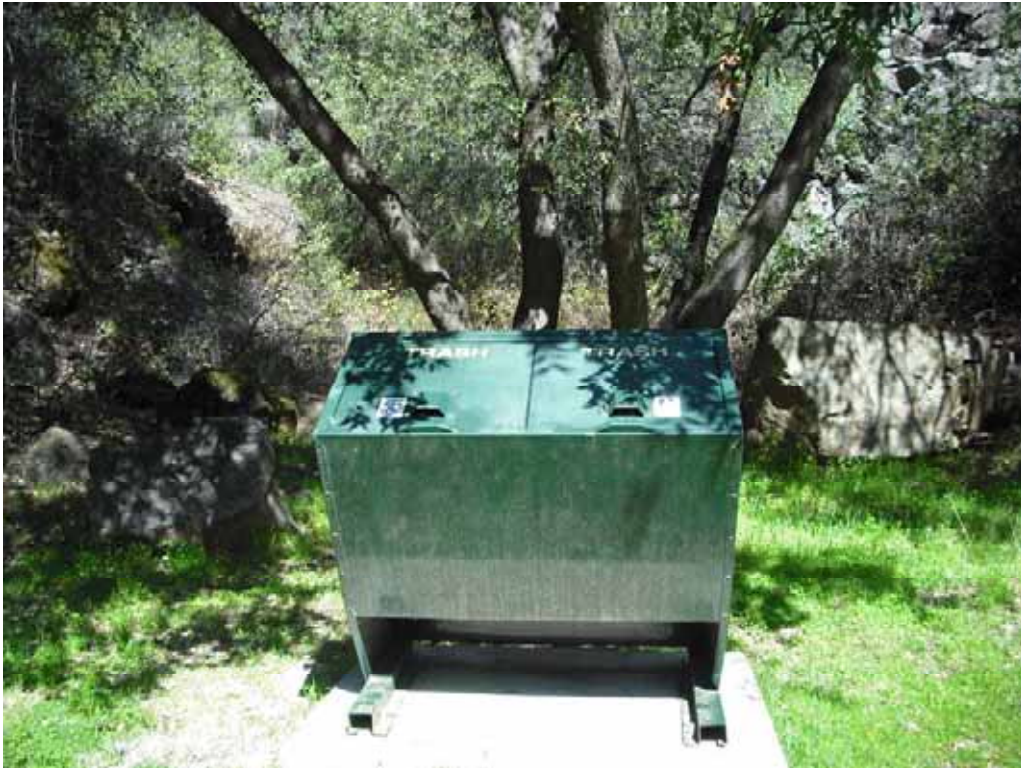
**Photo V-2-11. Bear-proof garbage container in good condition located in the Southeast Parking Area. (3/12/09)**

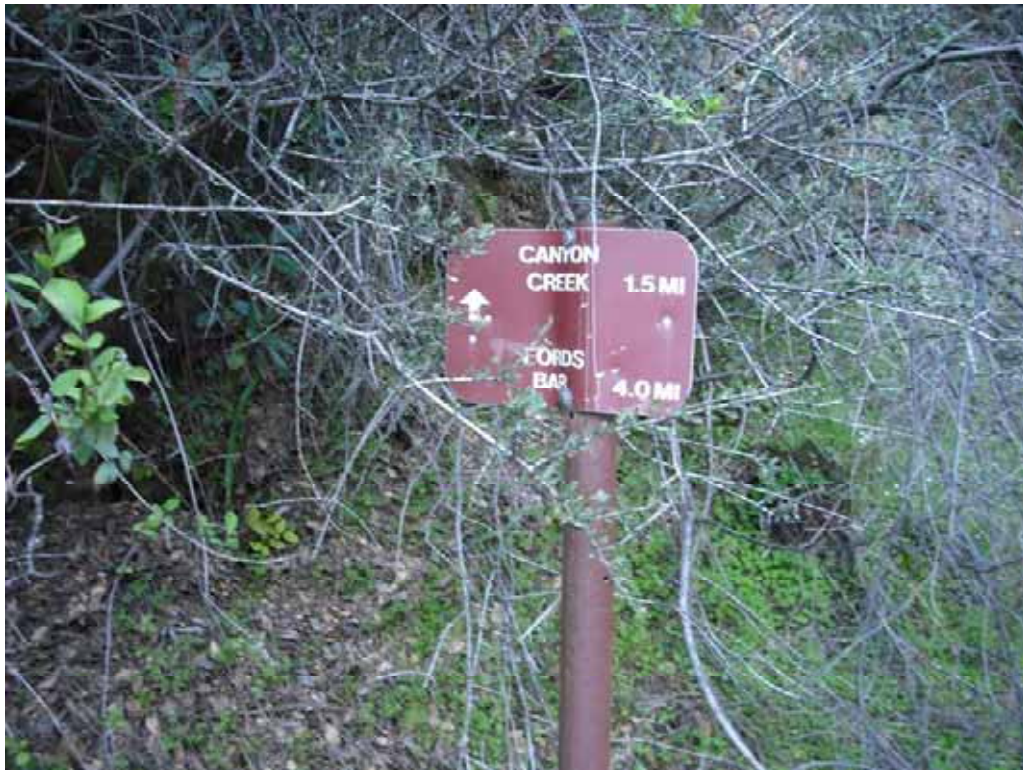
| Type of Sign | Location | Qt | Material | Cond | Wording/Graphics | Remarks | Accessibility Notes |
|---|---|---|---|---|---|---|---|
| Directional | Adjacent to garbage container along road from Ruck-a-Chucky to Canyon Creek | 1 | Painted aluminum on steel post. | Poor | CANYON CREEK 1.5 MI<br>FORDS BAR 4.0 MI (with arrow showing direction) | Aluminum is slightly bent and worn with a few bullet holes, steel pole is rusted | Poor contrast due to condition of sign |

**Photo V-2-35. A directional sign located adjacent to the locked gate. (3/12/09)**
