**Placer County Water Agency
Middle Fork American River Project
(FERC No. 2079)**

**REC 3 – RESERVOIR RECREATION OPPORTUNITIES
TECHNICAL STUDY REPORT**

Placer County Water Agency
P.O. Box 6570
Auburn, CA 95604

March 2010

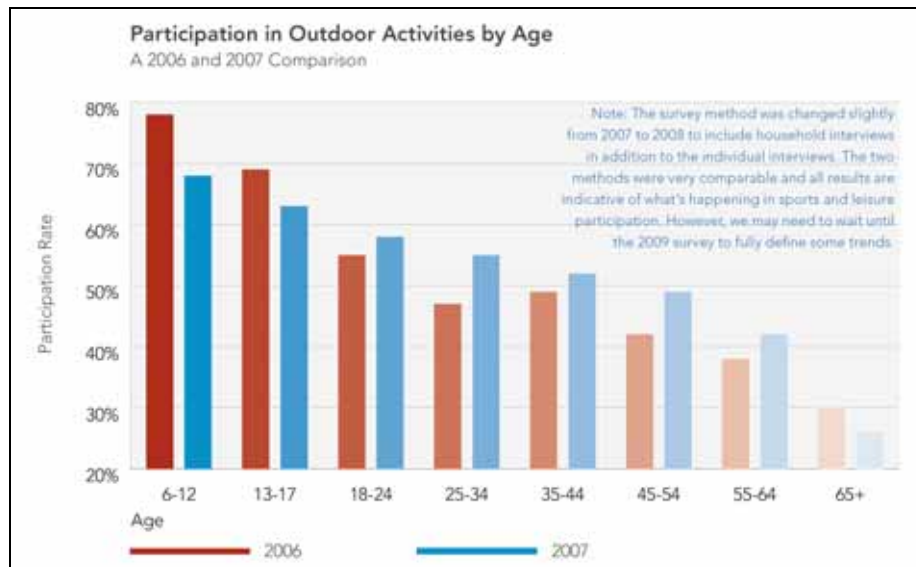
The article includes the following graphic showing outdoor recreation activity participation rates by age group.

As indicated, participation in outdoor activities steadily declines with age. According to the REC 2 – Recreation Visitor Survey results, the ratio of adults to youths in the groups intercepted in the Project area is about 4 to 1.

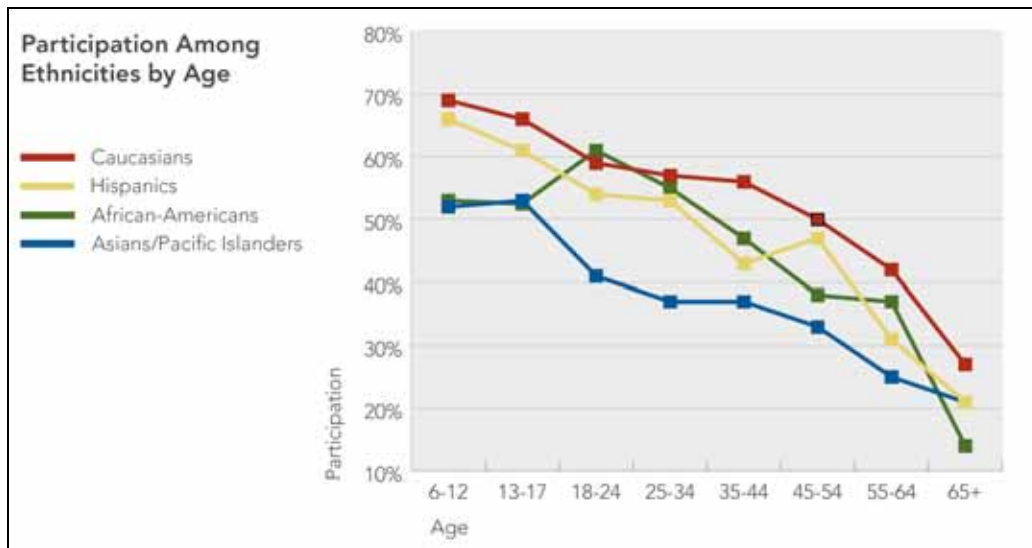
This Outdoor Education Foundation report also includes the following graph showing outdoor participation rates among different ethnic groups by age:

As indicated, participation in outdoor activities is highest for Caucasians in all age groups and lowest for Asians, particularly among children.

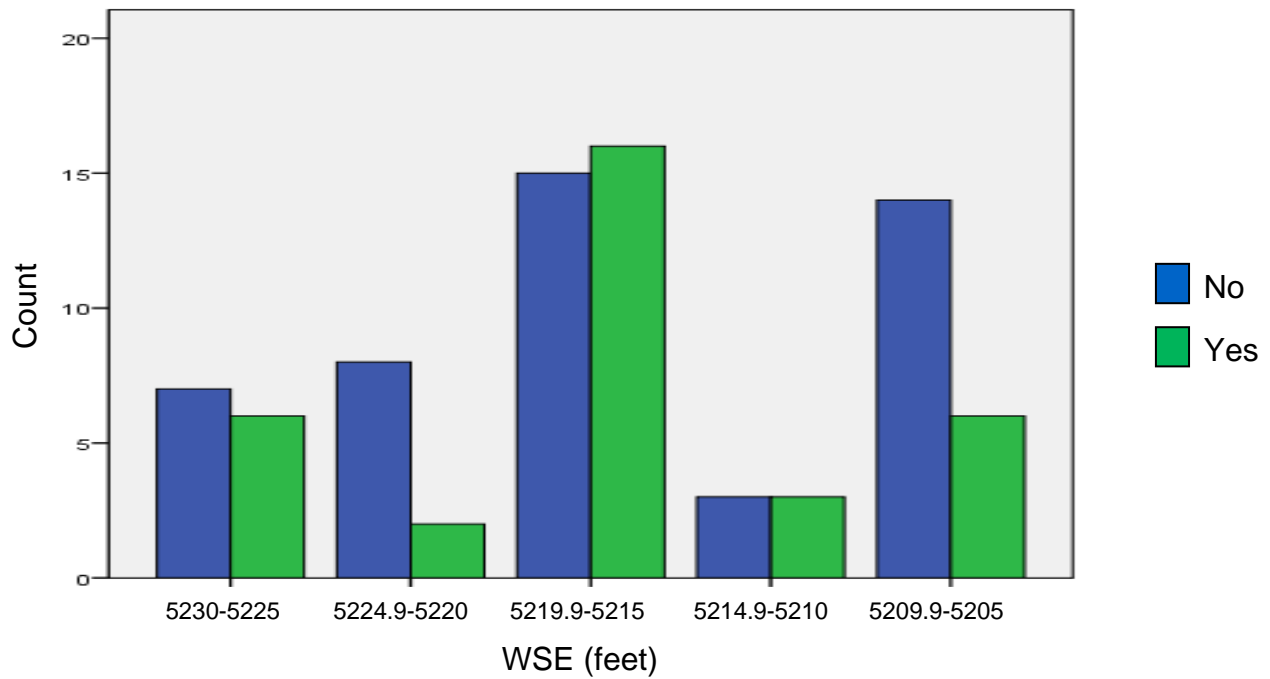
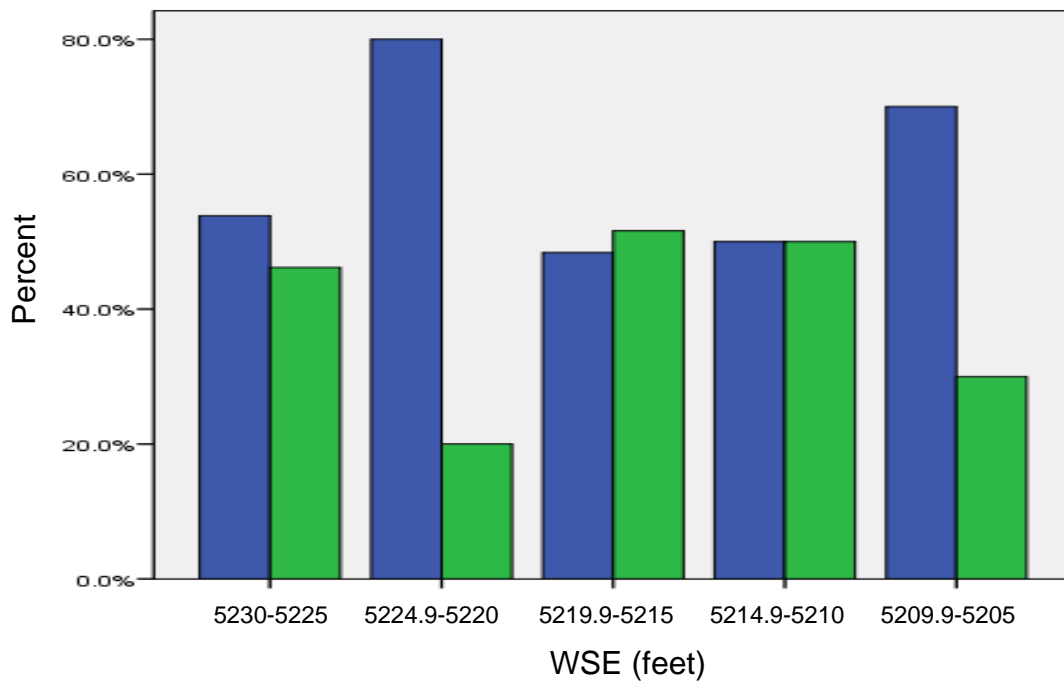
Figure REC 3-4. Recreation Experience Responses Relative to WSE at French Meadows Reservoir.

Was your recreation experience negatively affected by reservoir water surface level?

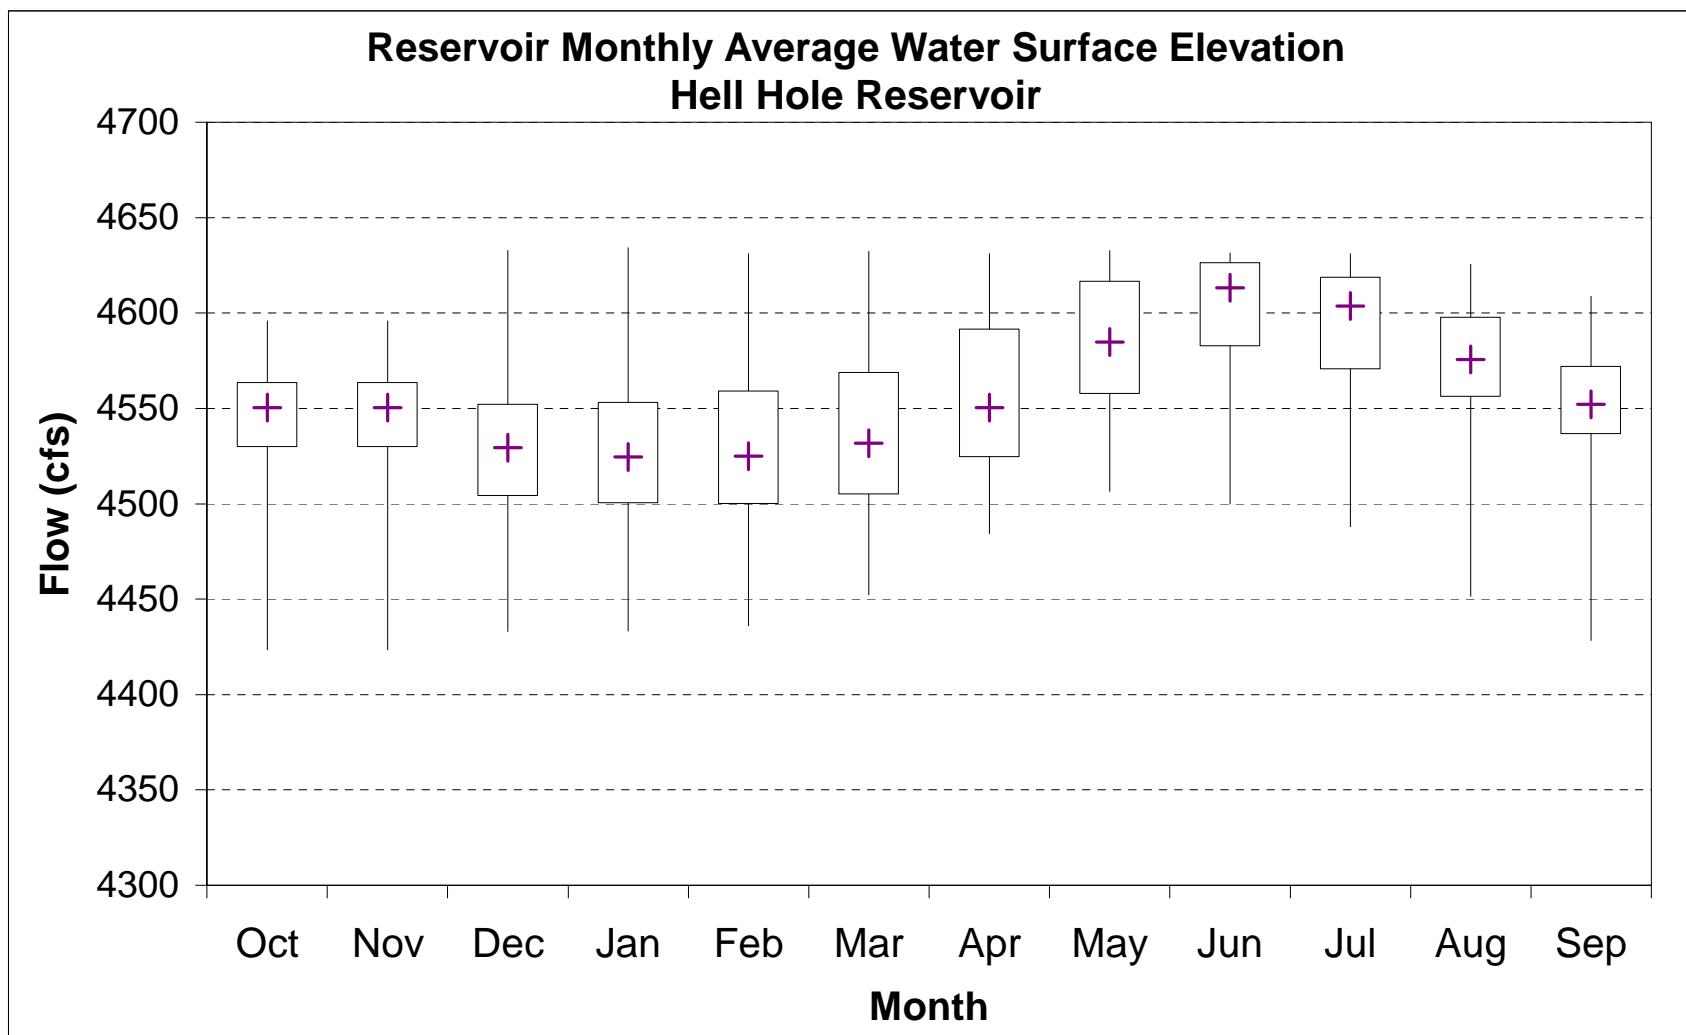
Figure A-1. Box and Whisker Plot showing Median, Quartile, Minimum, and Maximum WSEs by Month (WYs 1975–2007).

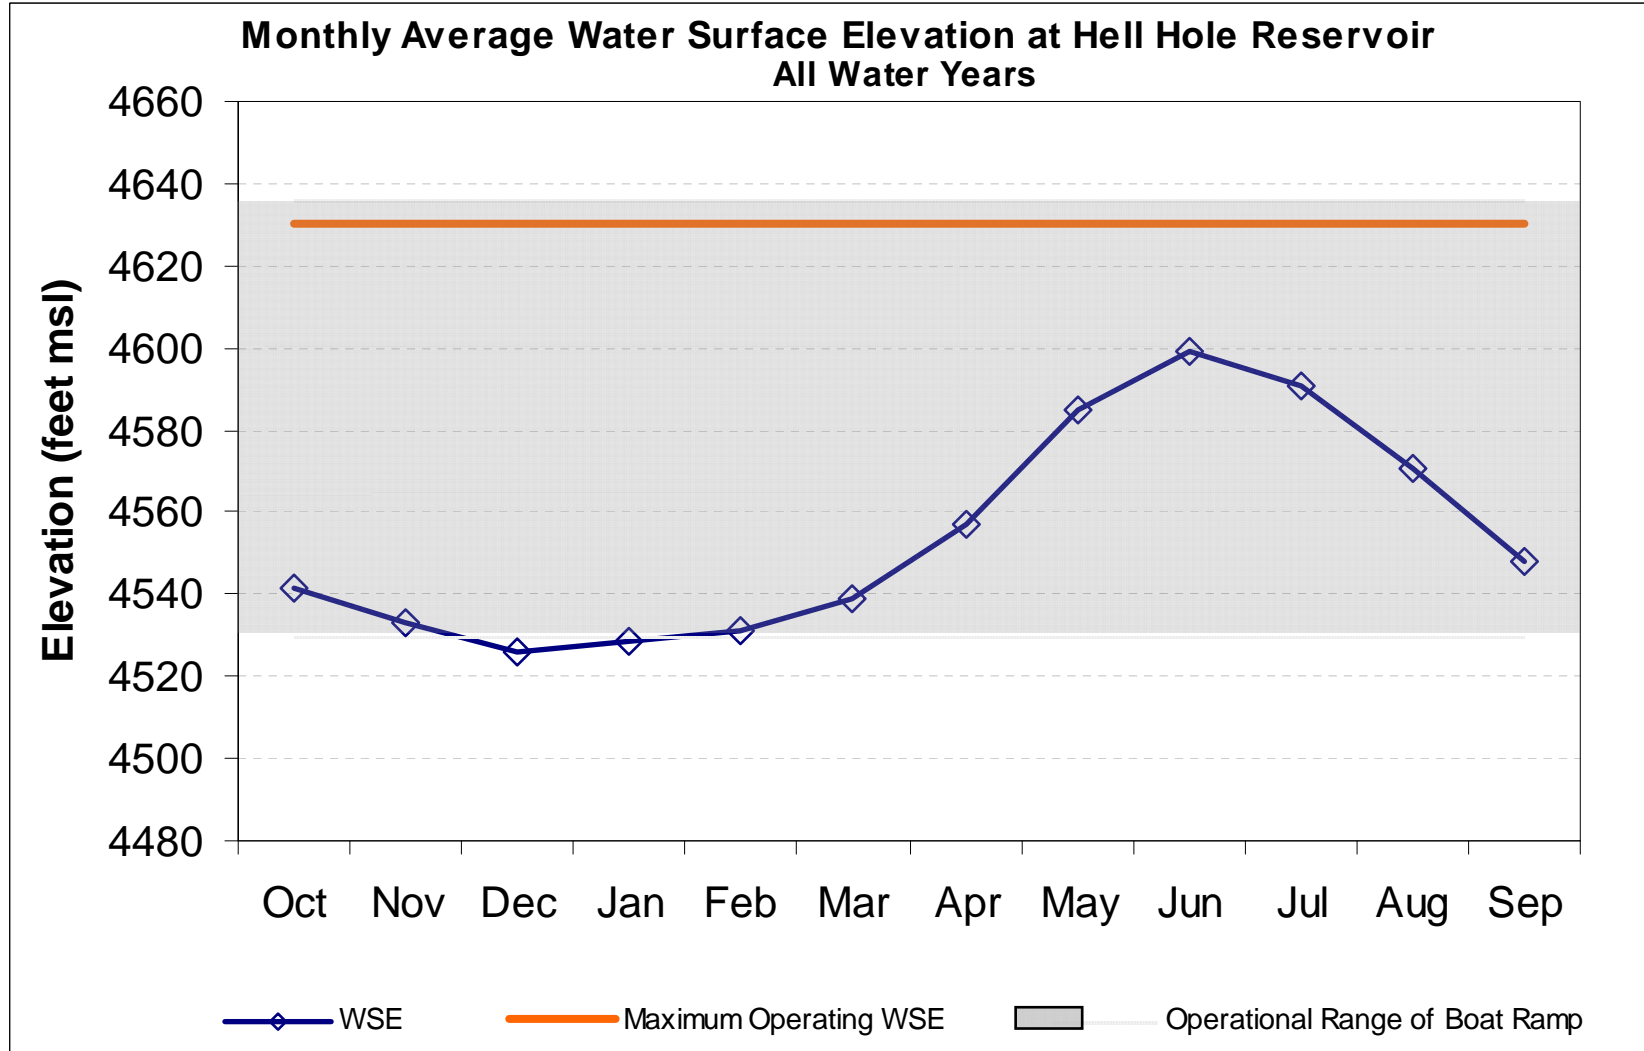
Figure A-2. Monthly Average WSE at Hell Hole Reservoir for all Water Year Types (WYs 1975–2007).

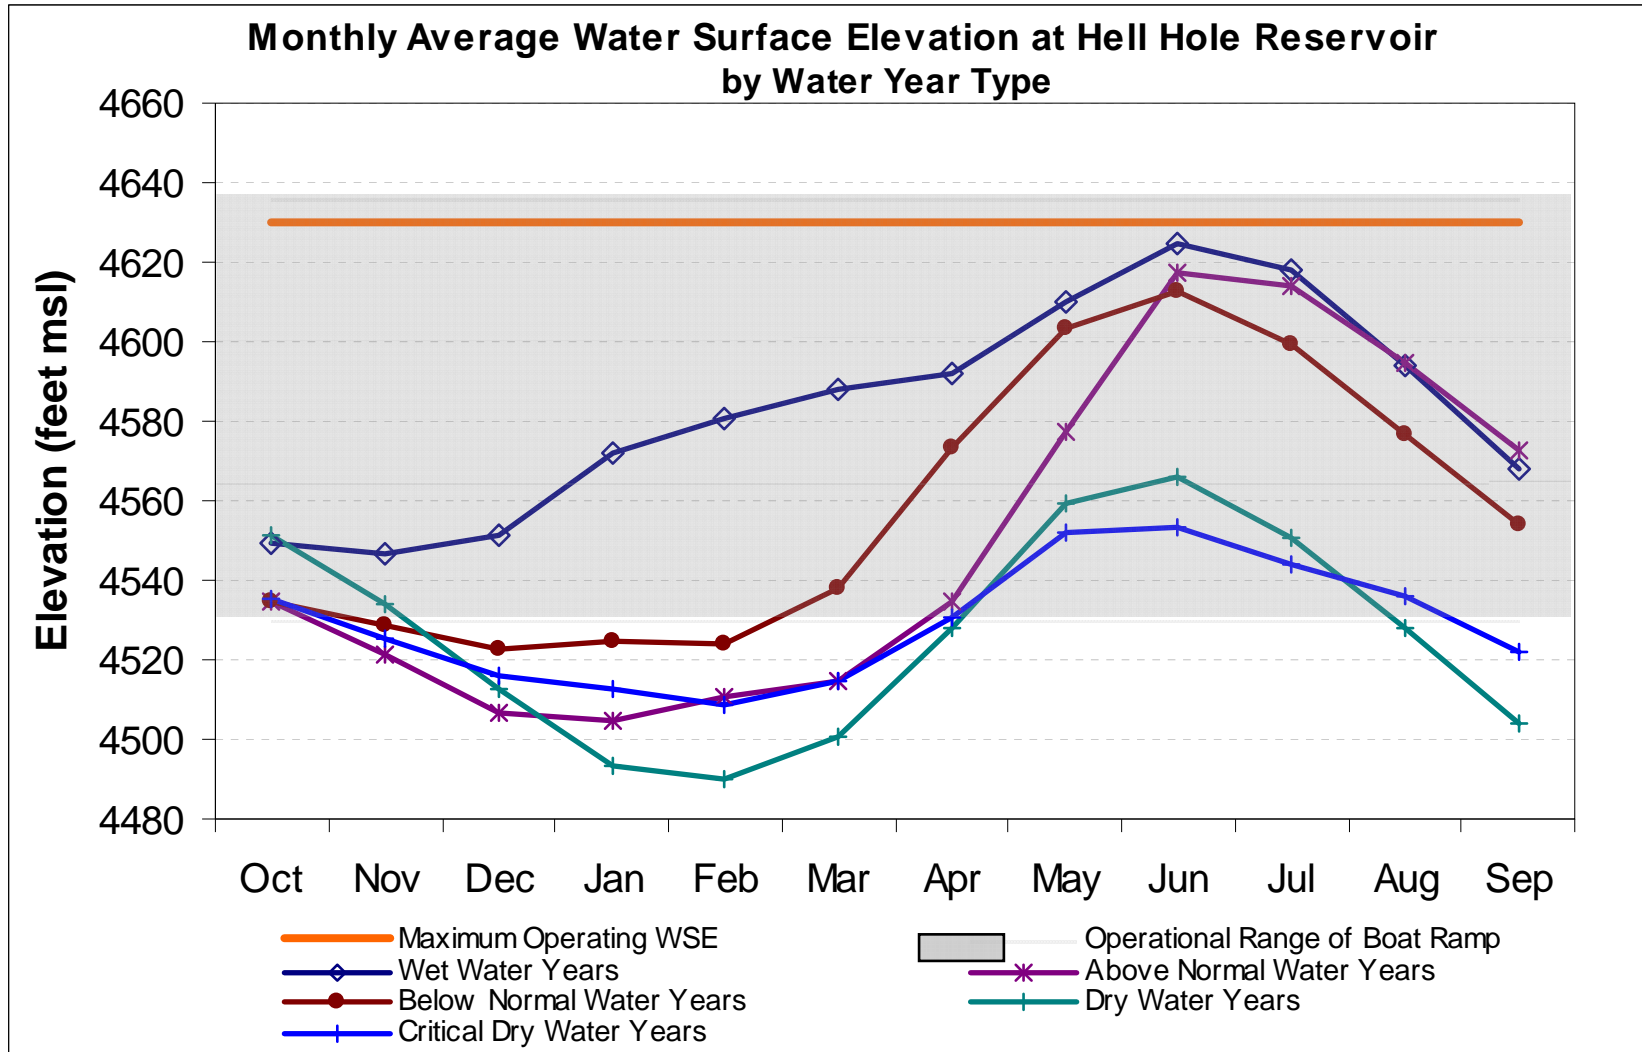
Figure A-3. Monthly Average WSE at Hell Hole Reservoir by Water Year Type.

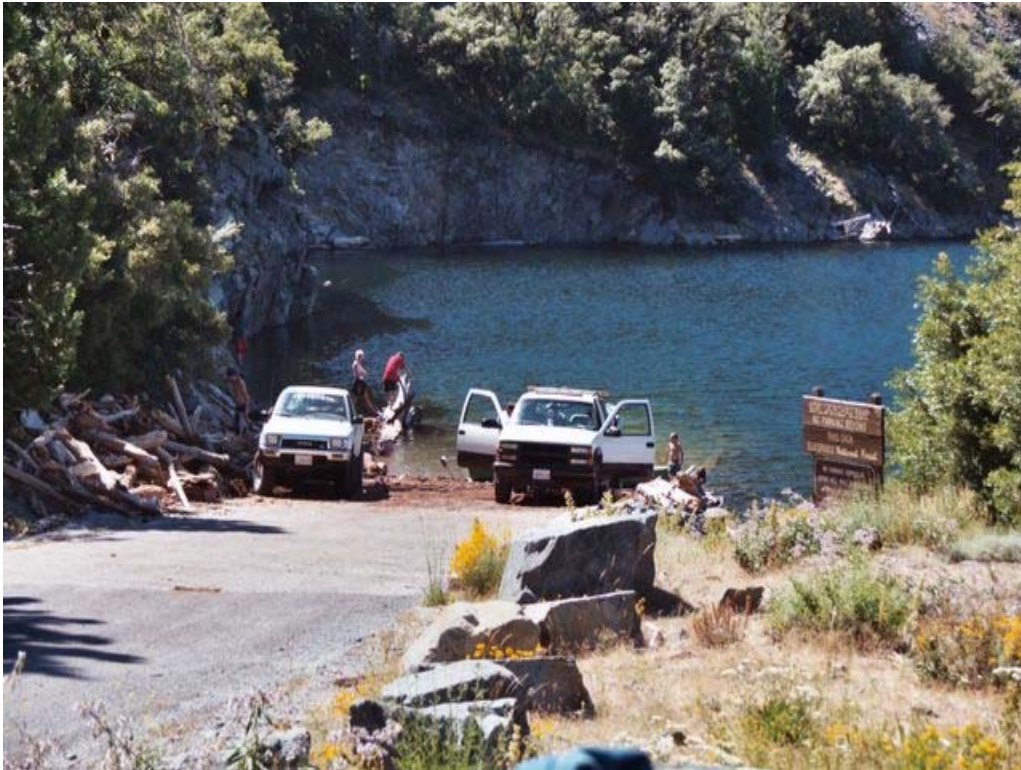
Photo B-1. Top of Hell Hole Boat Ramp as viewed from near Hell Hole Boat Ramp Parking Area. Reservoir is almost at maximum operating WSE of 4,630 feet. Note transition from top of concrete ramp to asphalt pavement (date of photo unknown, WSE ~ 4,628).

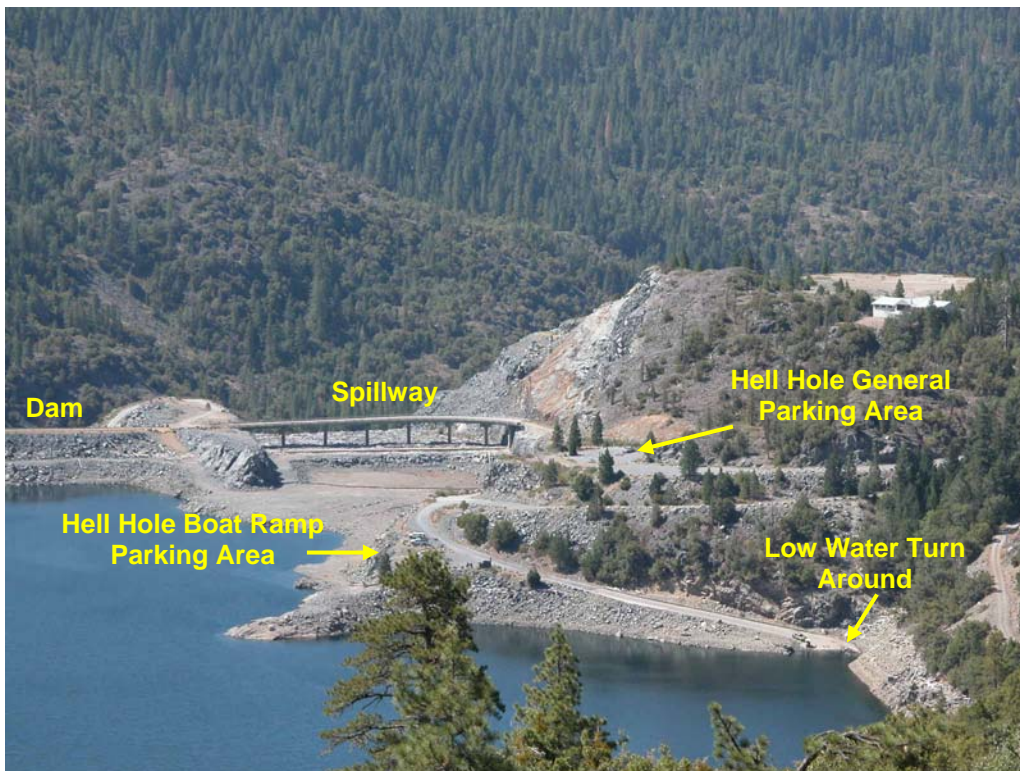
Photo B-2. Hell Hole Boat Ramp with dam and spillway in background. (July 20, 2004, WSE = 4,596).

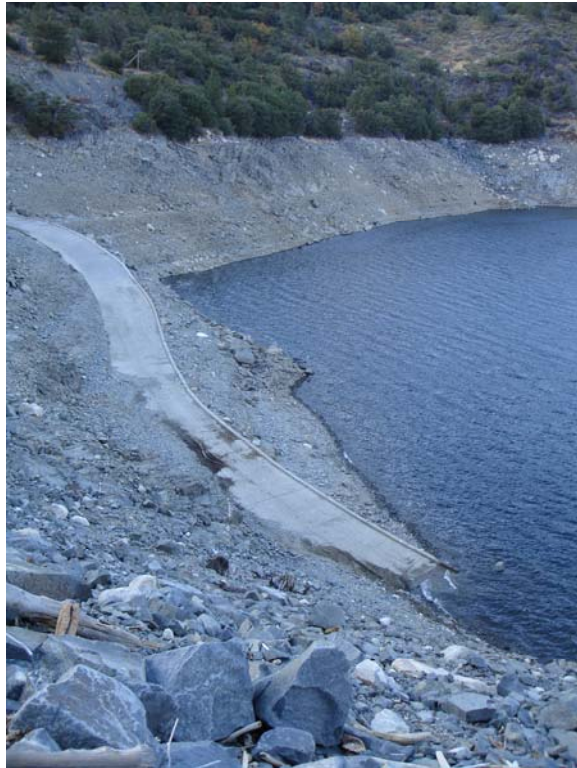
Photo B-5. View of Hell Hole Boat Ramp as viewed from edge of Hell Hole Boat Ramp Parking Area (October 5, 2009, WSE = 4,547 ft)

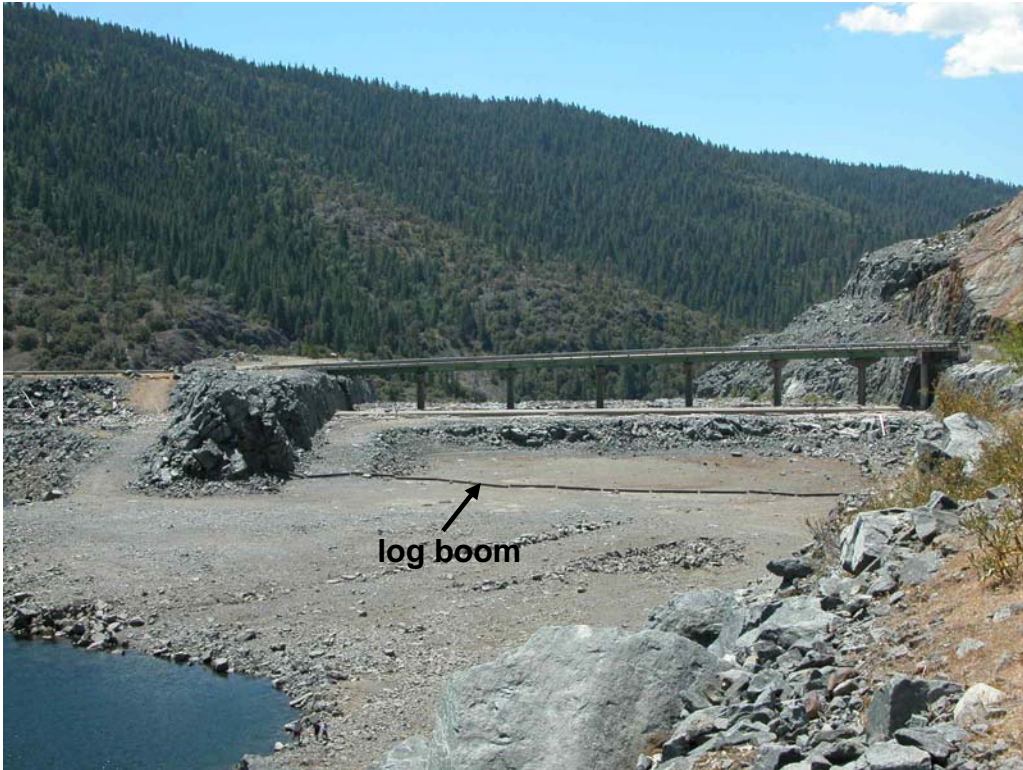
Photo E-1. View of log boom near spillway at Hell Hole Reservoir.

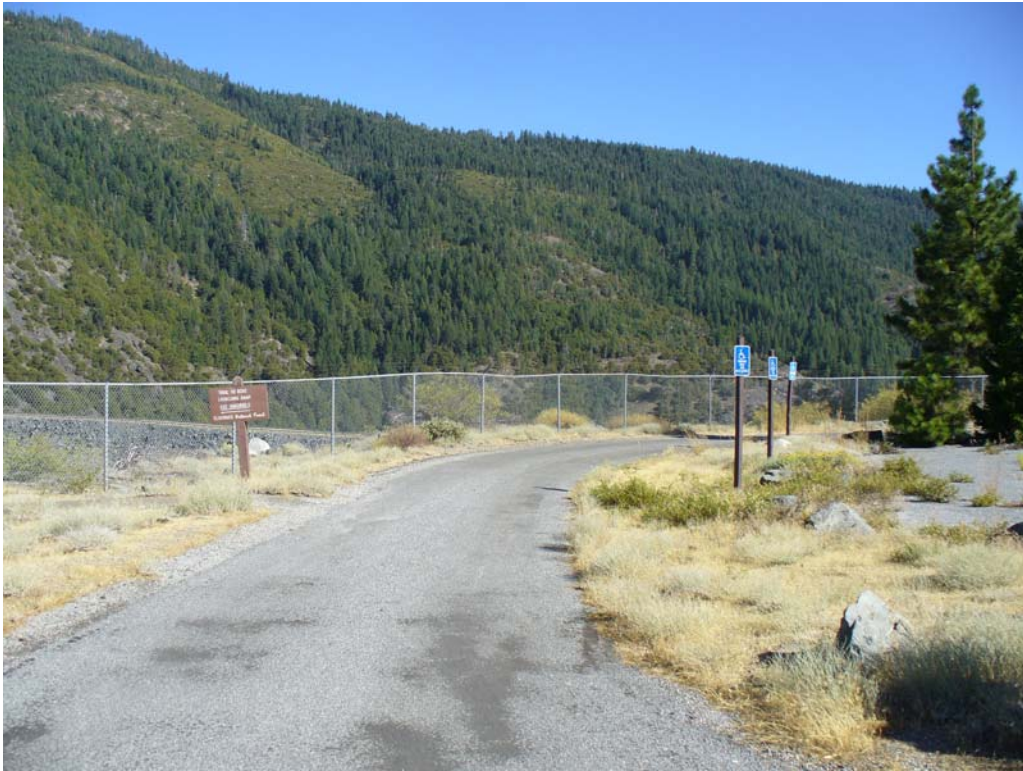
Photo E-2. View of barrier fence surrounding Hell Hole General Parking Area.

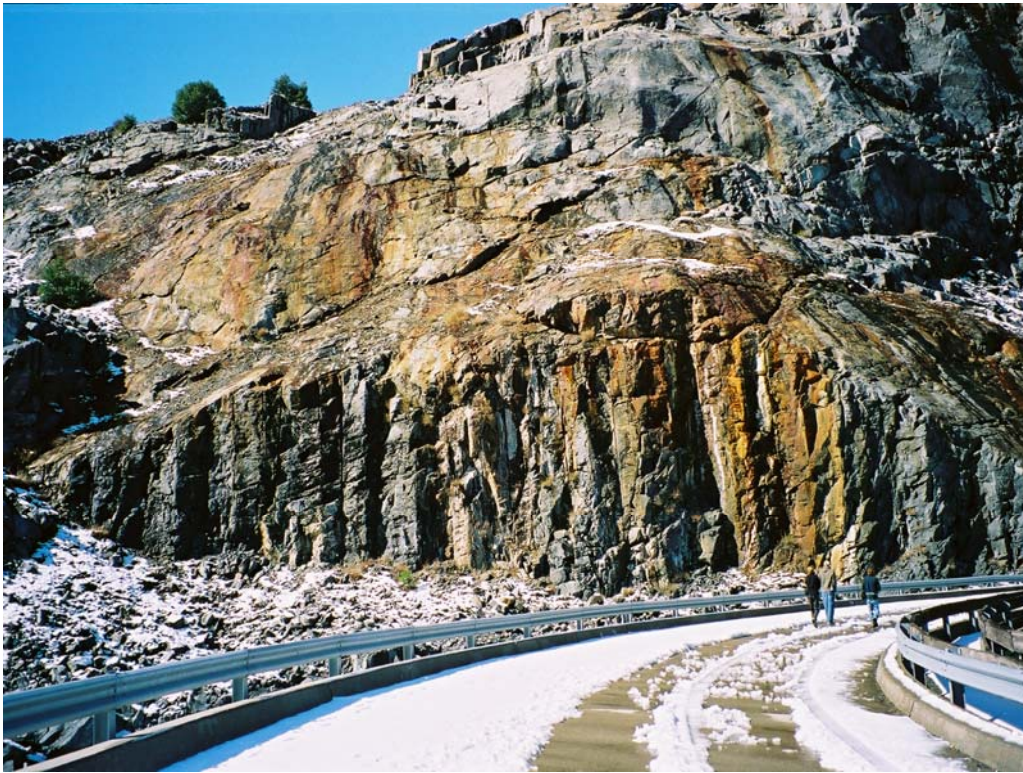
Photo E-4. View of guard rails along top of Hell Hole Dam.

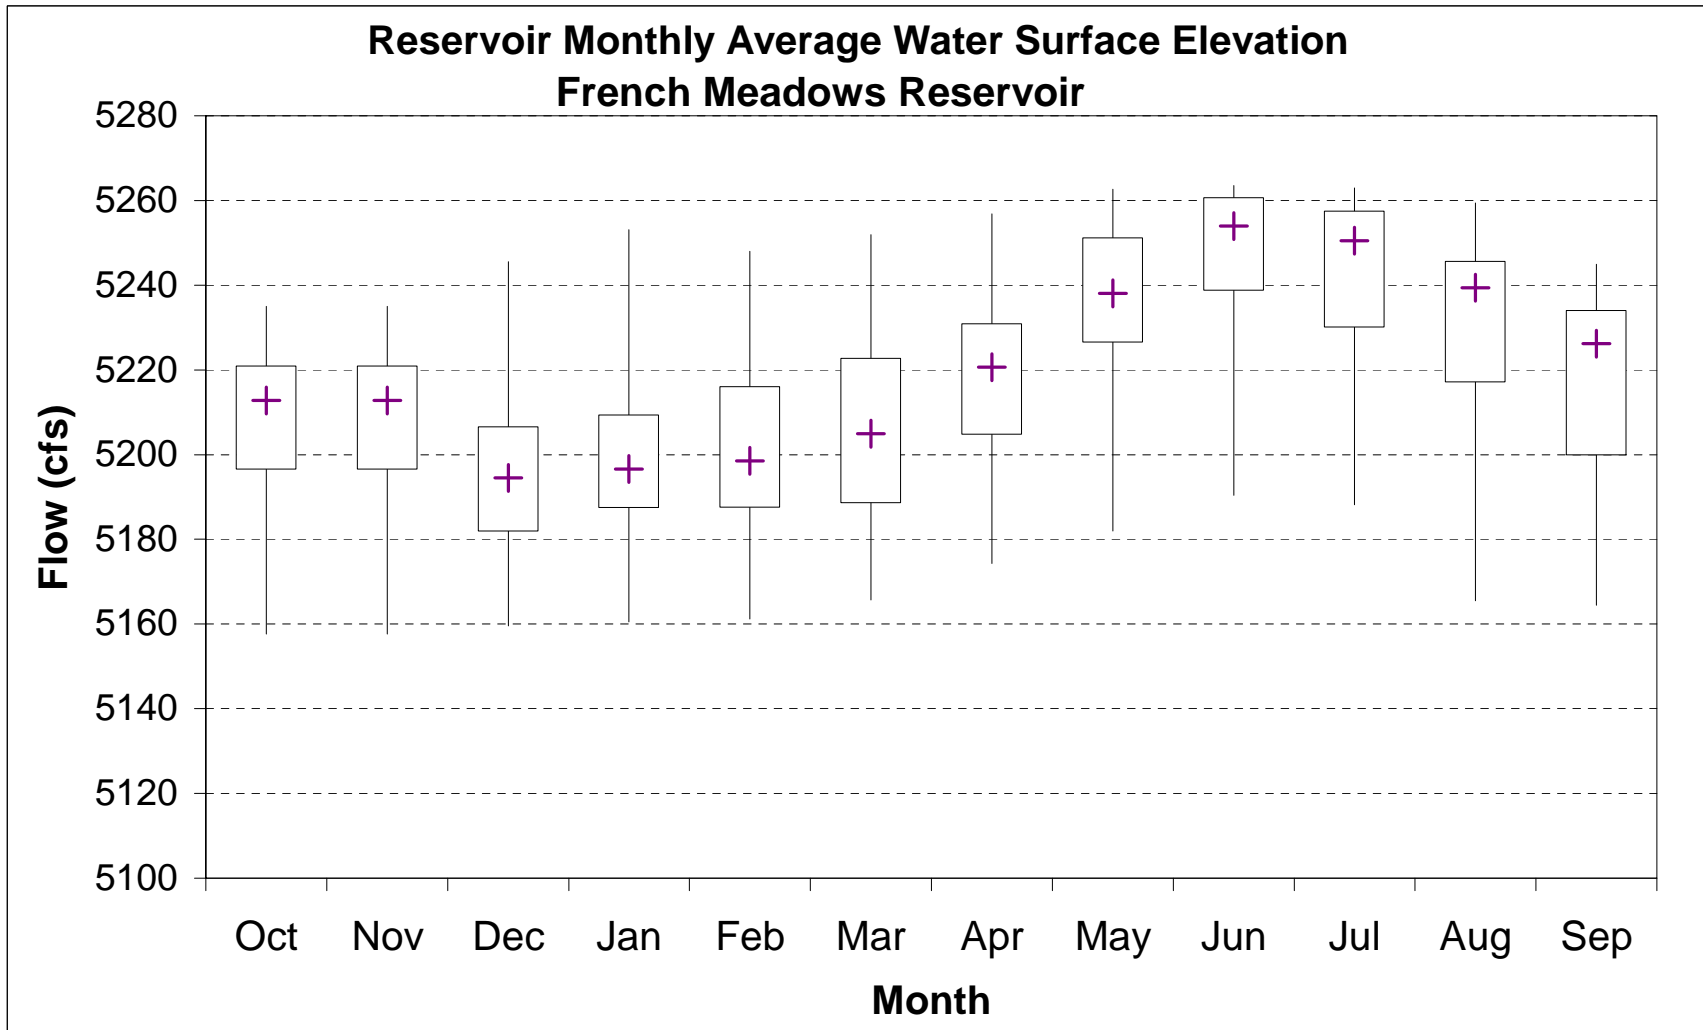
Figure F-1. Box and Whisker Plot showing Median, Quartile, Minimum, and Maximum WSEs by Month (WYs 1975–2007).

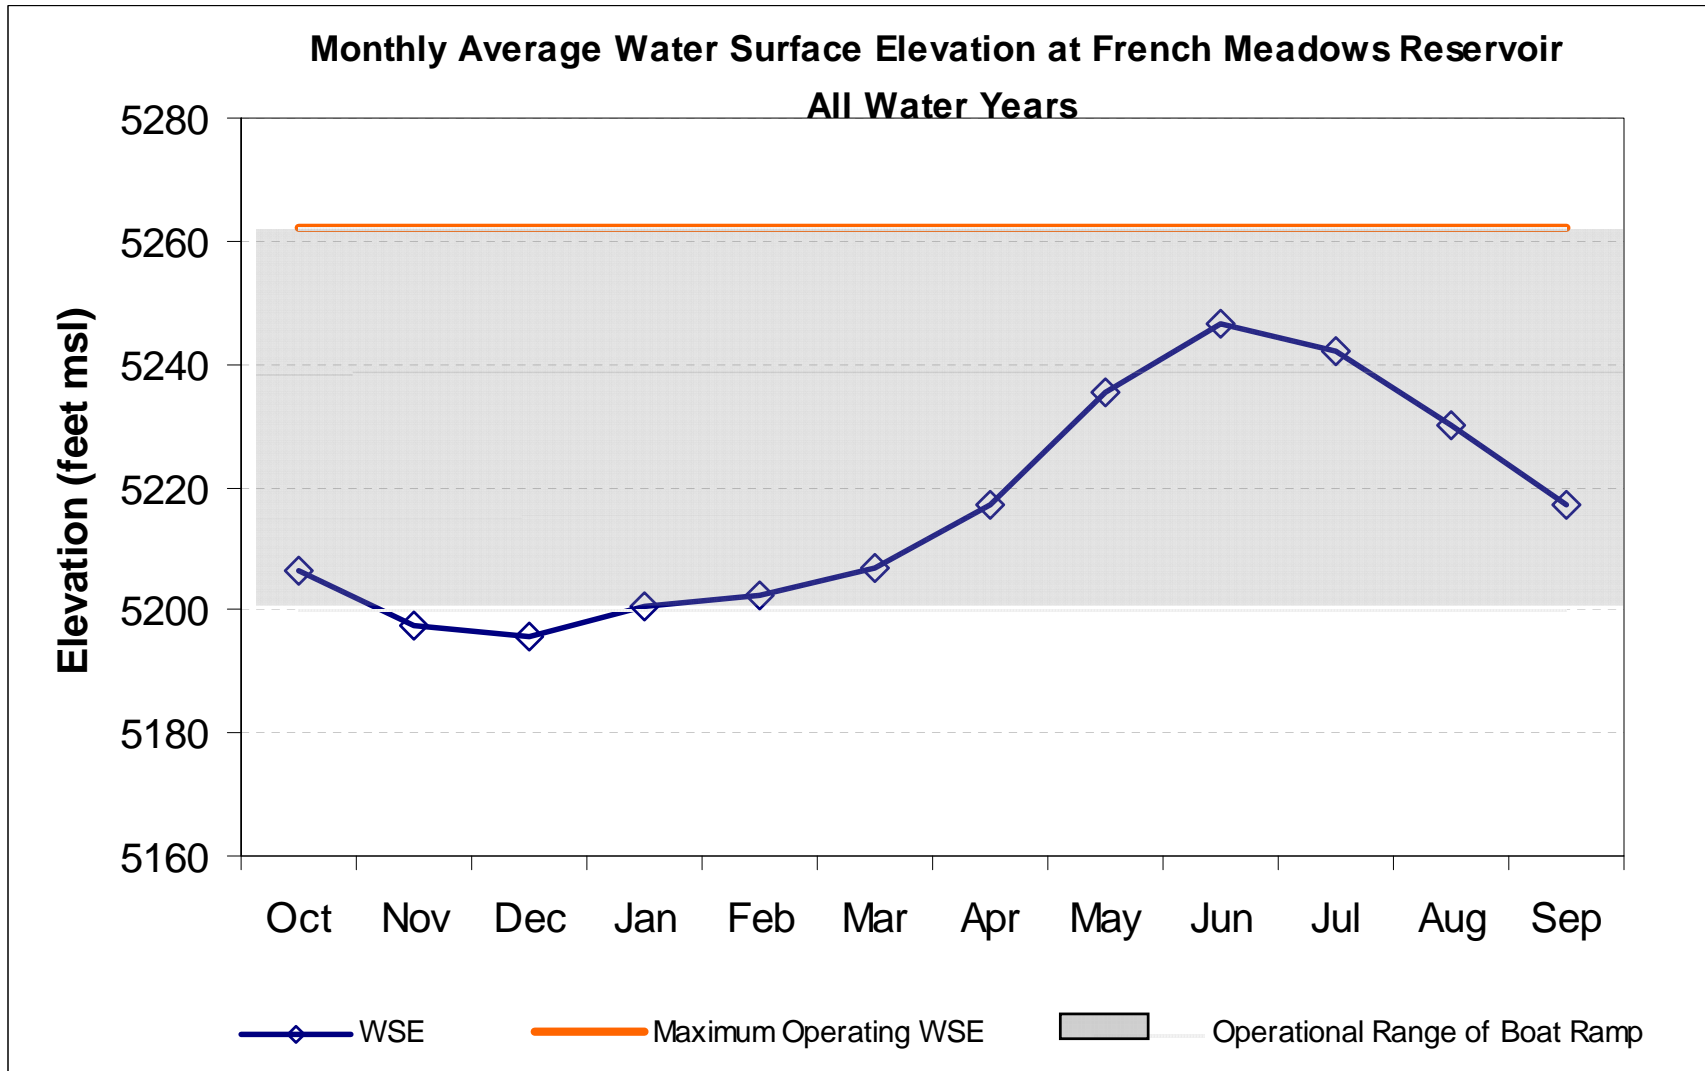
Figure F-2. Monthly Average WSE at French Meadows Reservoir for all Water Year Types (WYs 1975–2007).

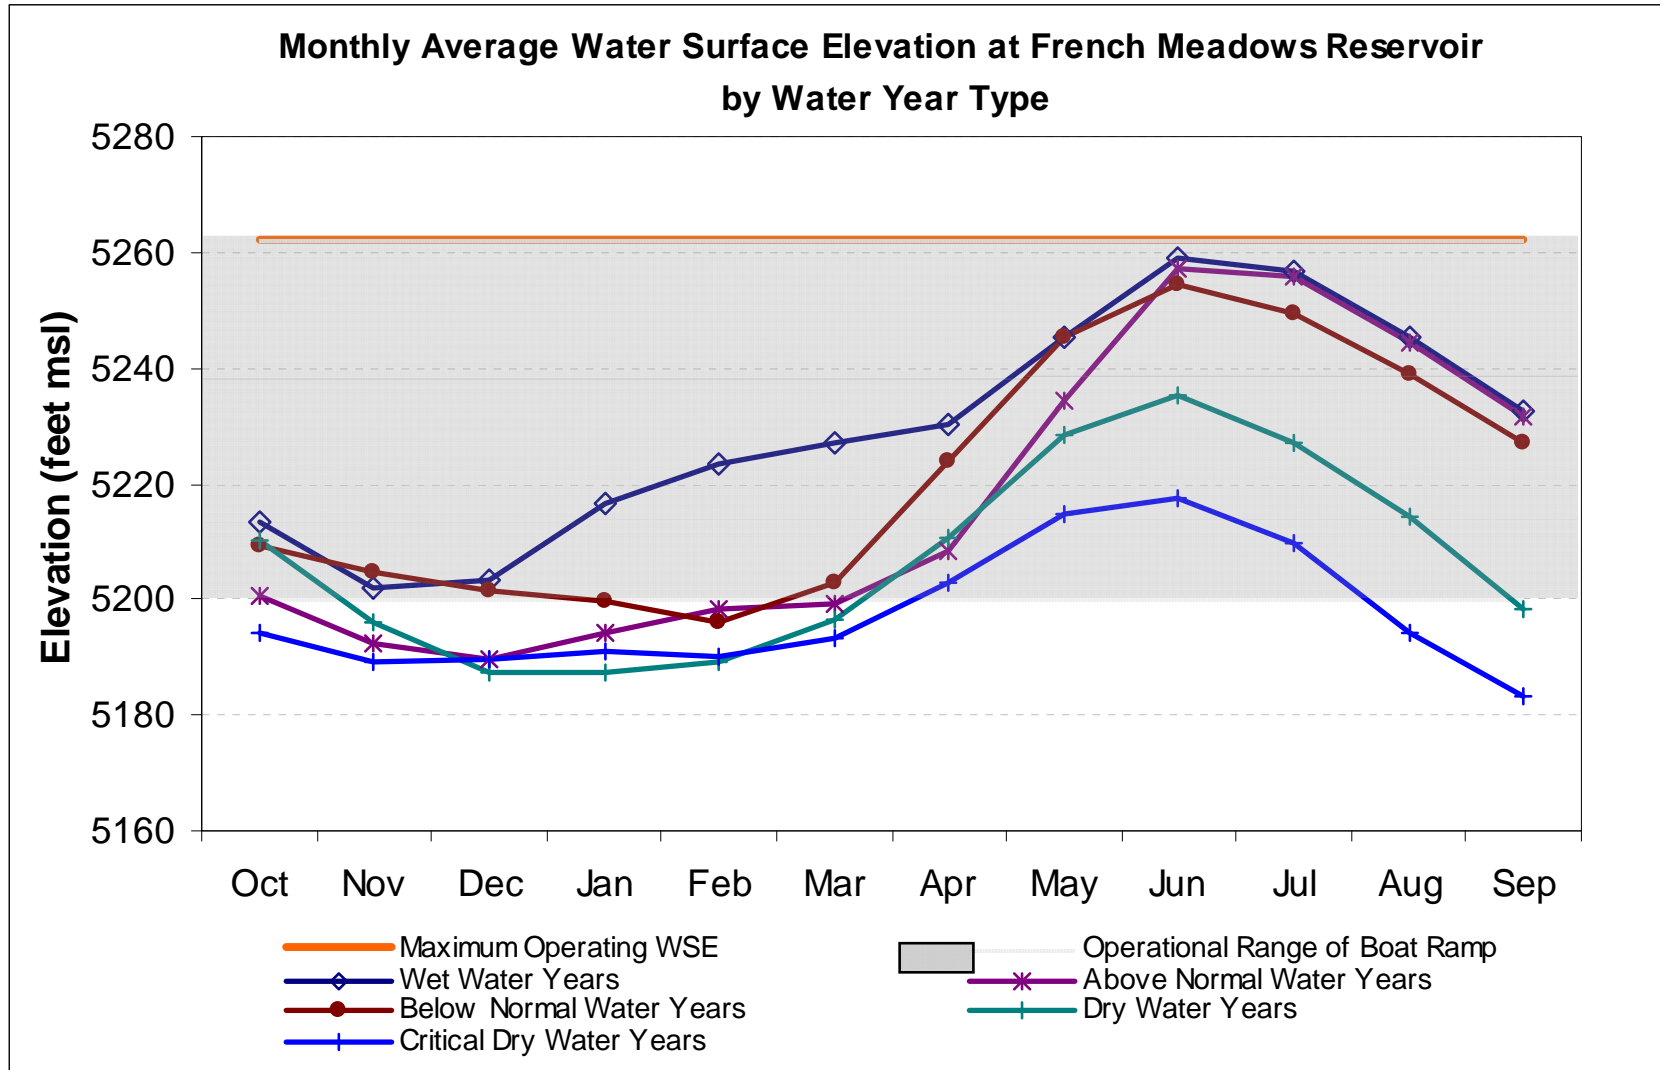
Figure F-3. Monthly Average WSE at French Meadows Reservoir by Water Year Type.

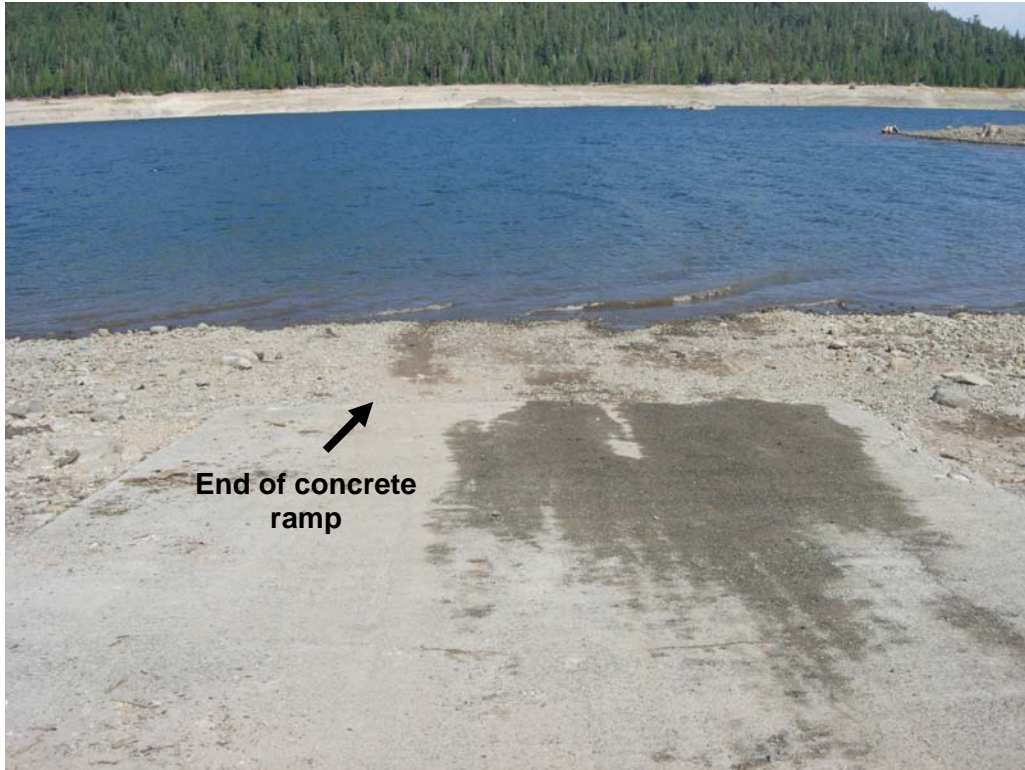
Photo G-5. French Meadows Boat Ramp on September 24, 2008 (WSE = 5,198 ft). The concrete ramp terminates at 5,200 feet.

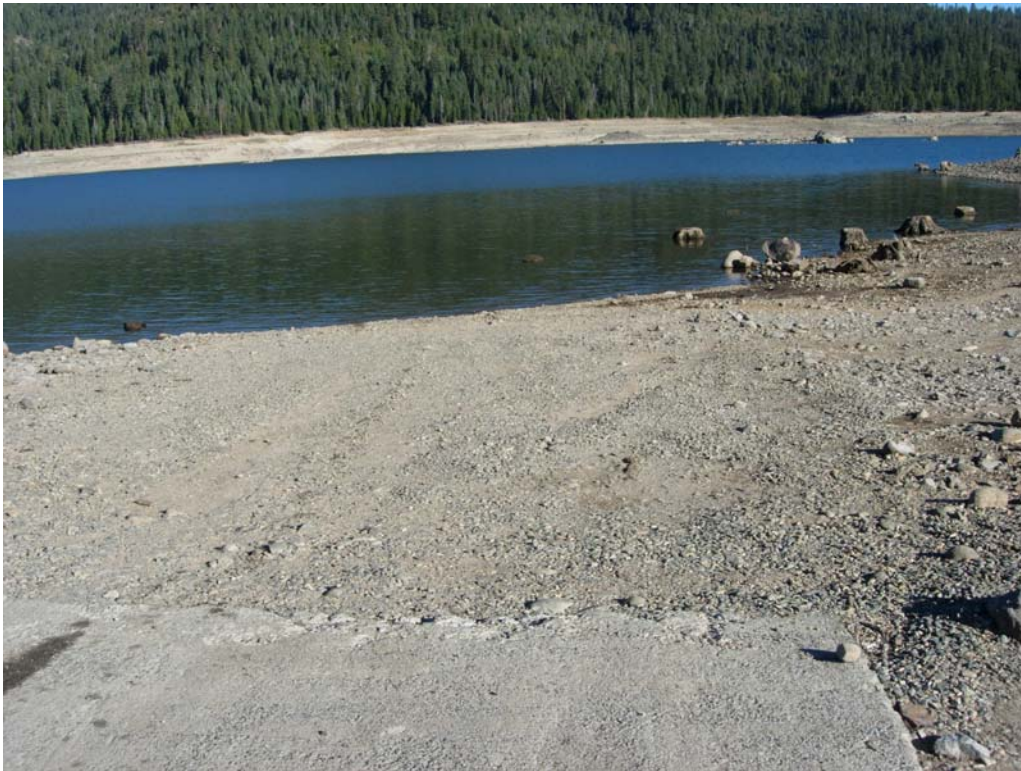
Photo G-8. French Meadows Boat Ramp on October 14, 2008 (WSE = 5,193 ft). Note that boat launching is still possible after the WSE declines below the end of the concrete ramp due to the compacted substrate and shallow slope of shoreline.

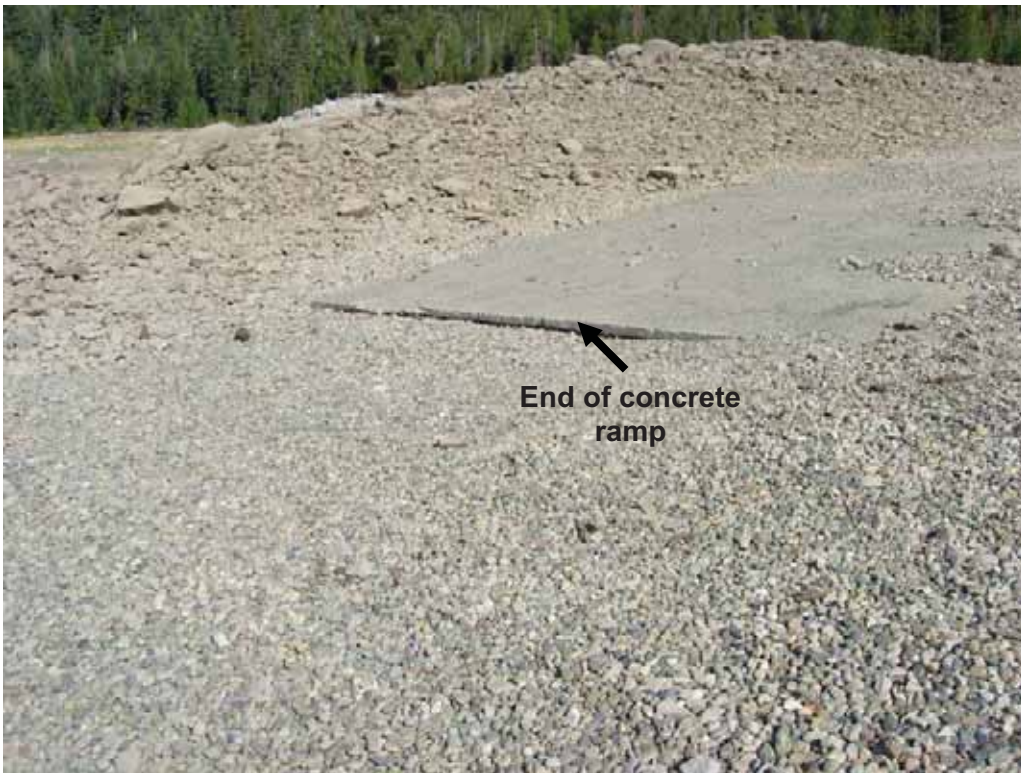
Photo H-8. McGuire Boat Ramp on September 24, 2008 (WSE = 5,198 ft). Note that end of concrete ramp is at 5,200 feet.

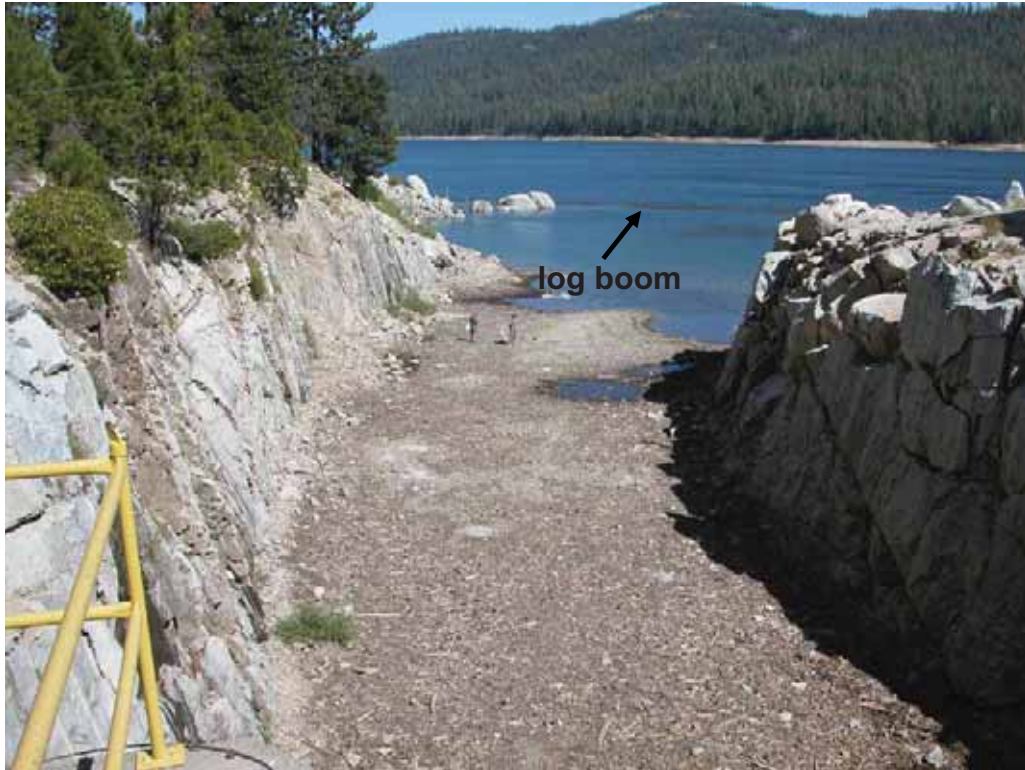
Photo J-1. View of log boom near spillway at French Meadows Reservoir.

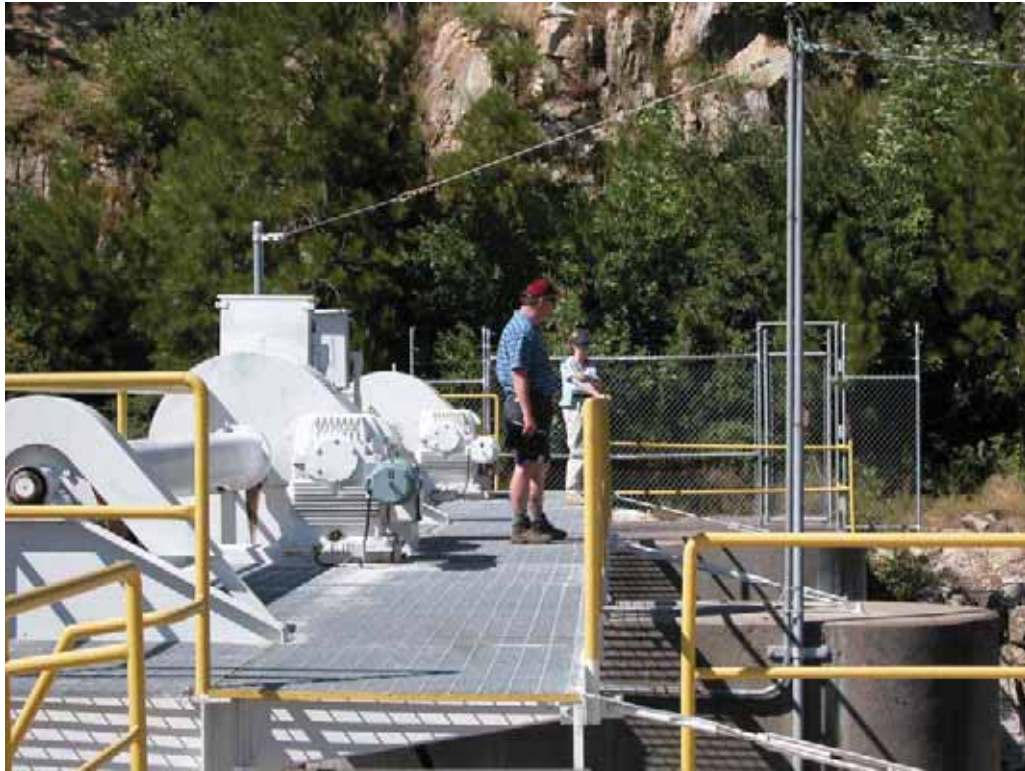
Photo J-2. View of public safety fence and railing surrounding French Meadows Spillway Gates area.

- *Public Safety Fences.* PCWA has erected fences around potentially hazardous areas. A gated fence prohibits access to the French Meadows Spillway Gates area. Similarly, a public safety fence surrounds the French Meadows-Hell Hole Tunnel Gatehouse. These fences are shown in Photos J-2 and J-3, respectively.

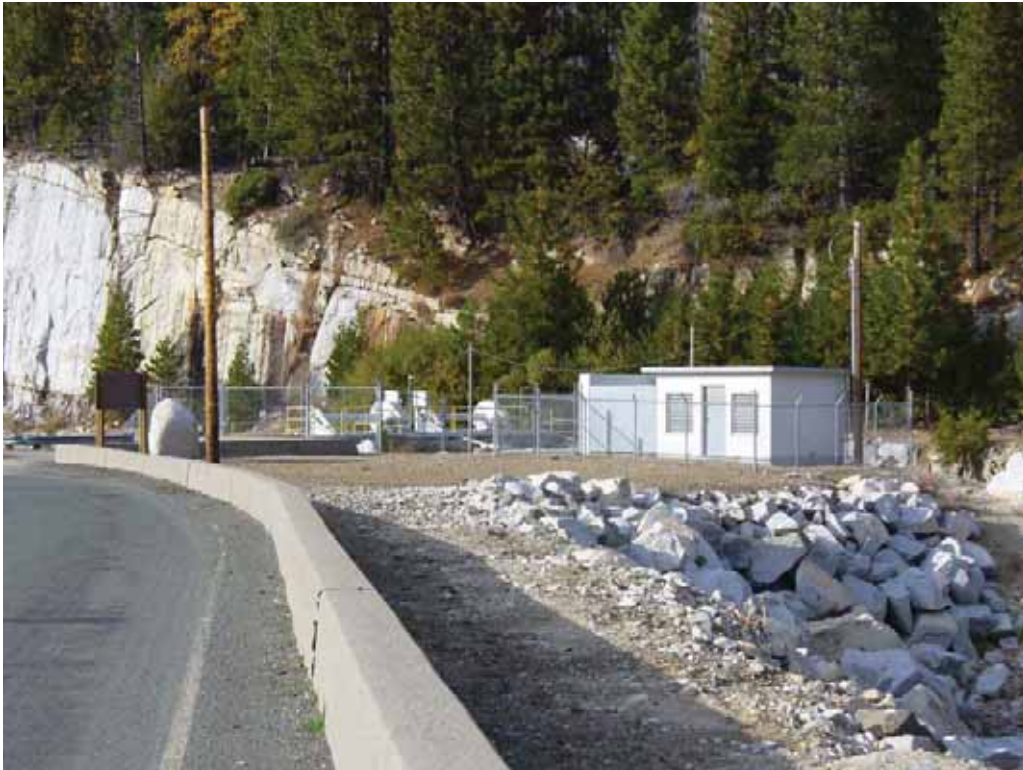
Photo J-3. View of safety fence surrounding the French Meadows Dam Generator Building.
