**Placer County Water Agency
Middle Fork American River Project
(FERC No. 2079)**

**REC 3 – RESERVOIR RECREATION OPPORTUNITIES
TECHNICAL STUDY REPORT**

Placer County Water Agency
P.O. Box 6570
Auburn, CA 95604

March 2010

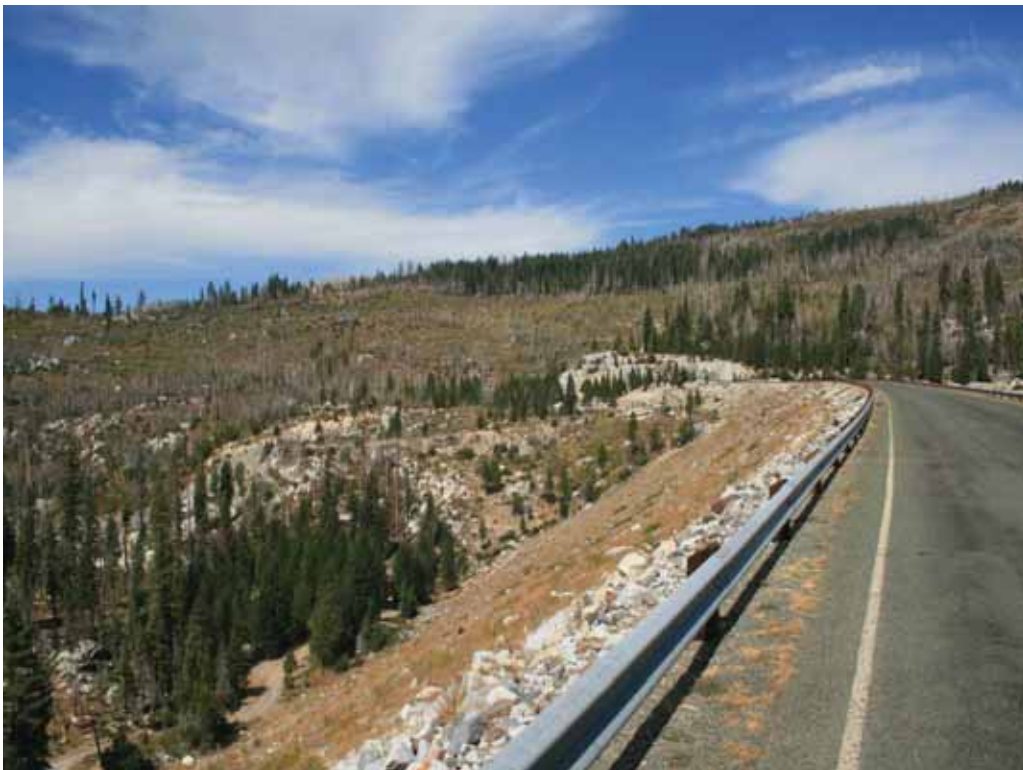
Photo J-4. View of guard rail along top of French Meadows Dam.

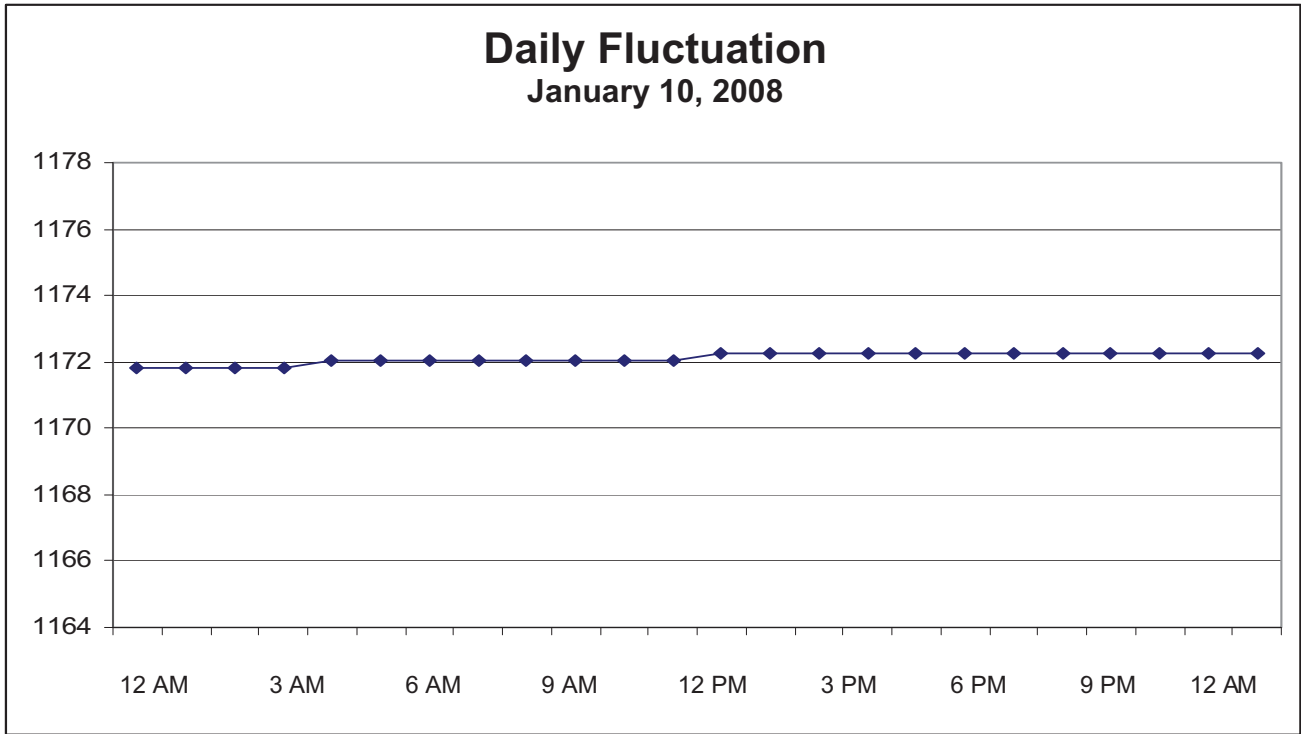
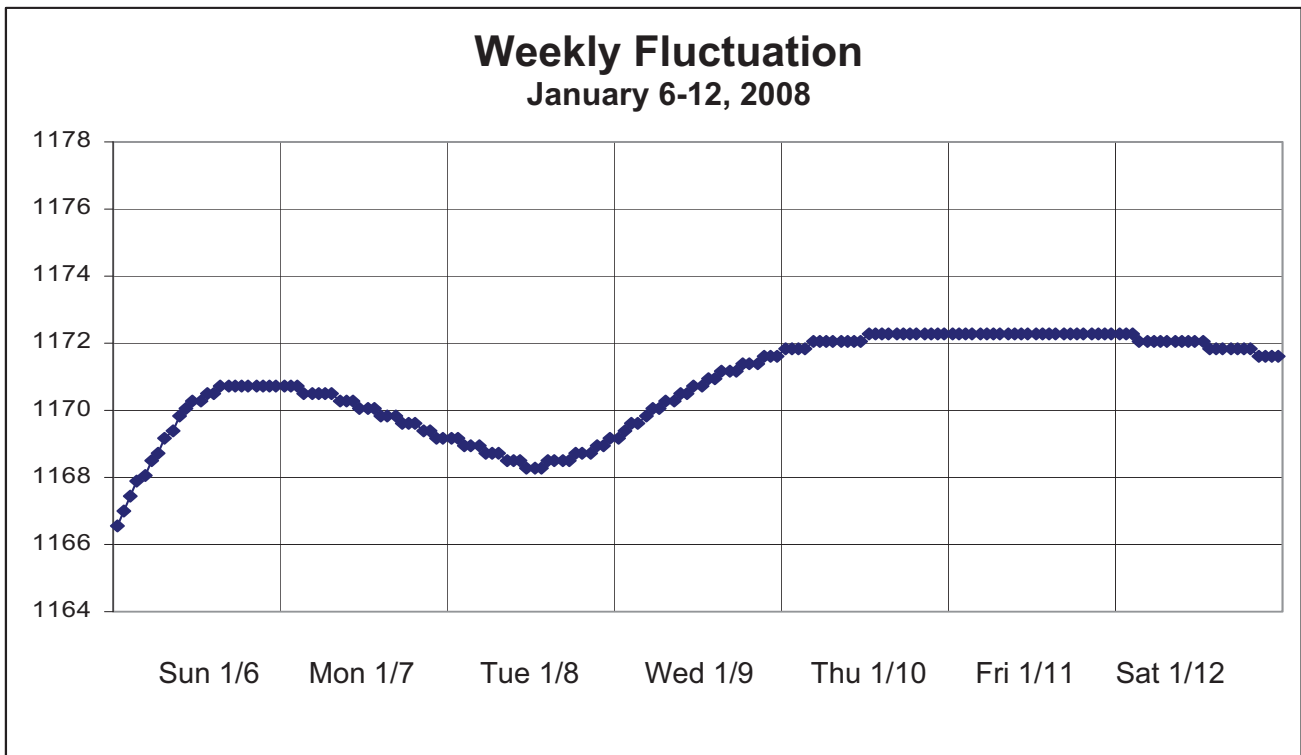
Figure K-1. Water Surface Elevations at Ralston Afterbay – Winter.

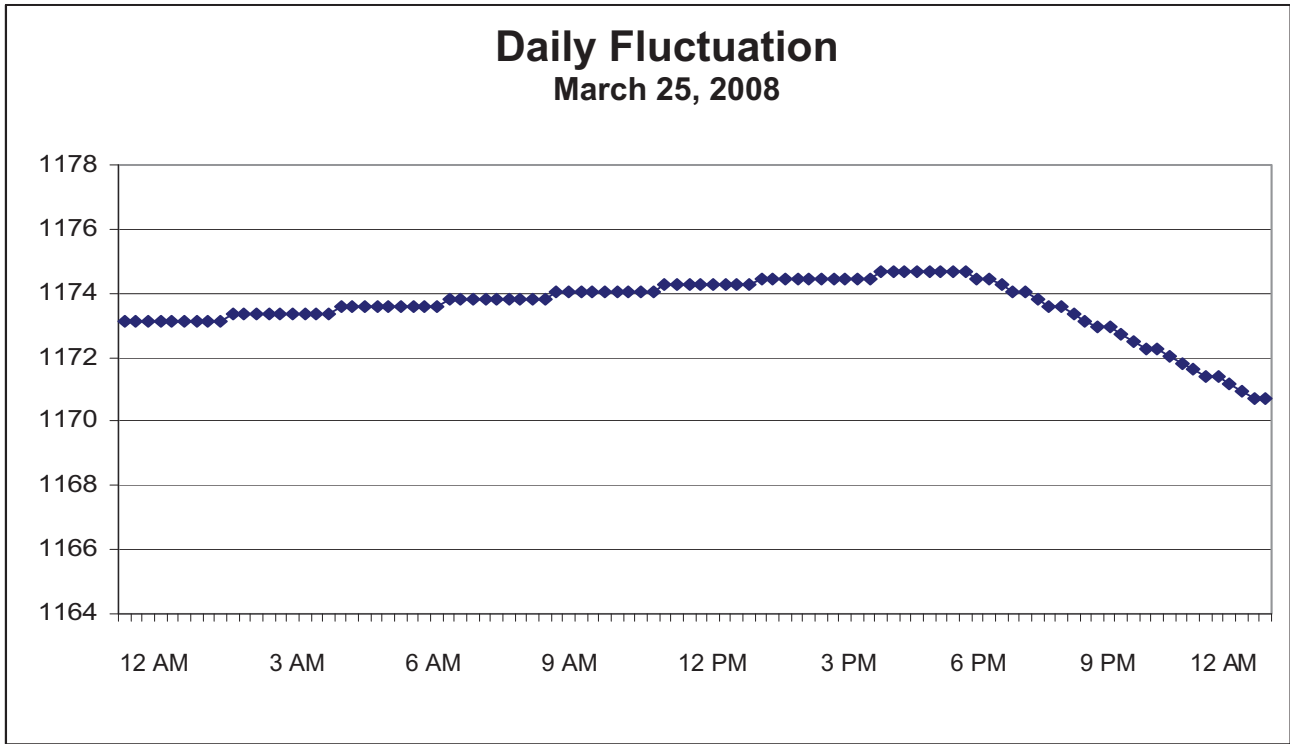
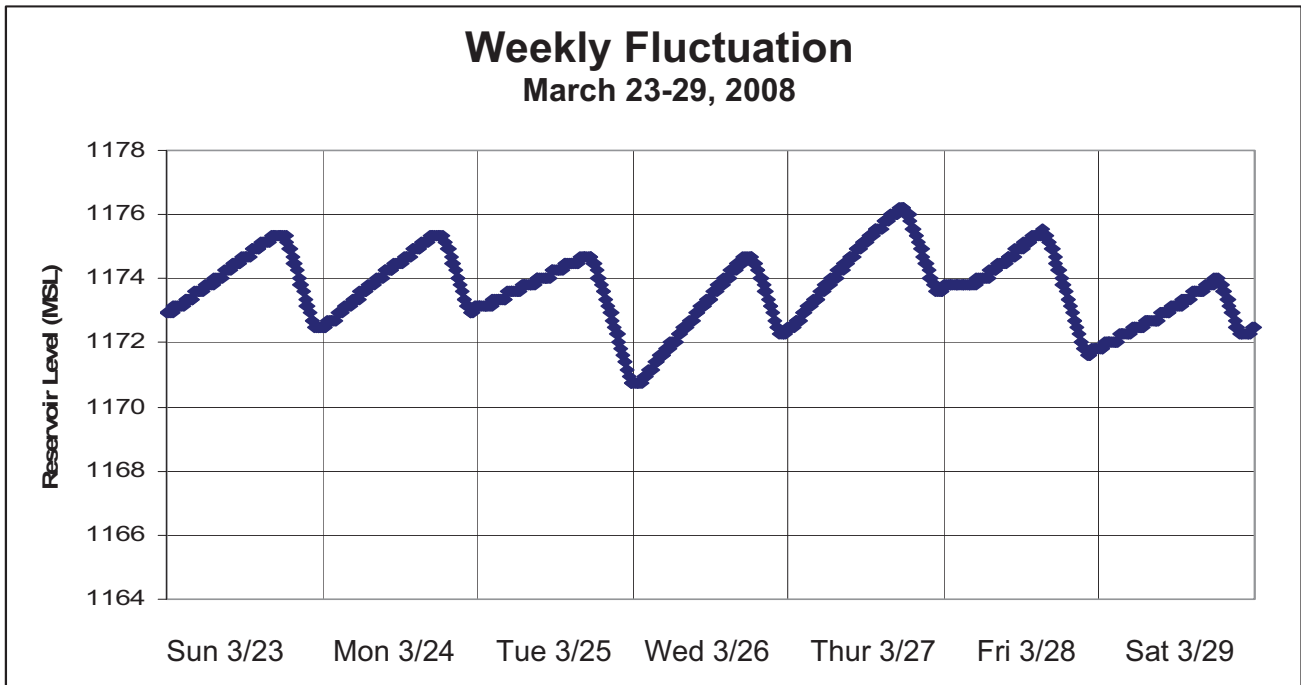
Figure K-2. Water Surface Elevations at Ralston Afterbay – Spring.

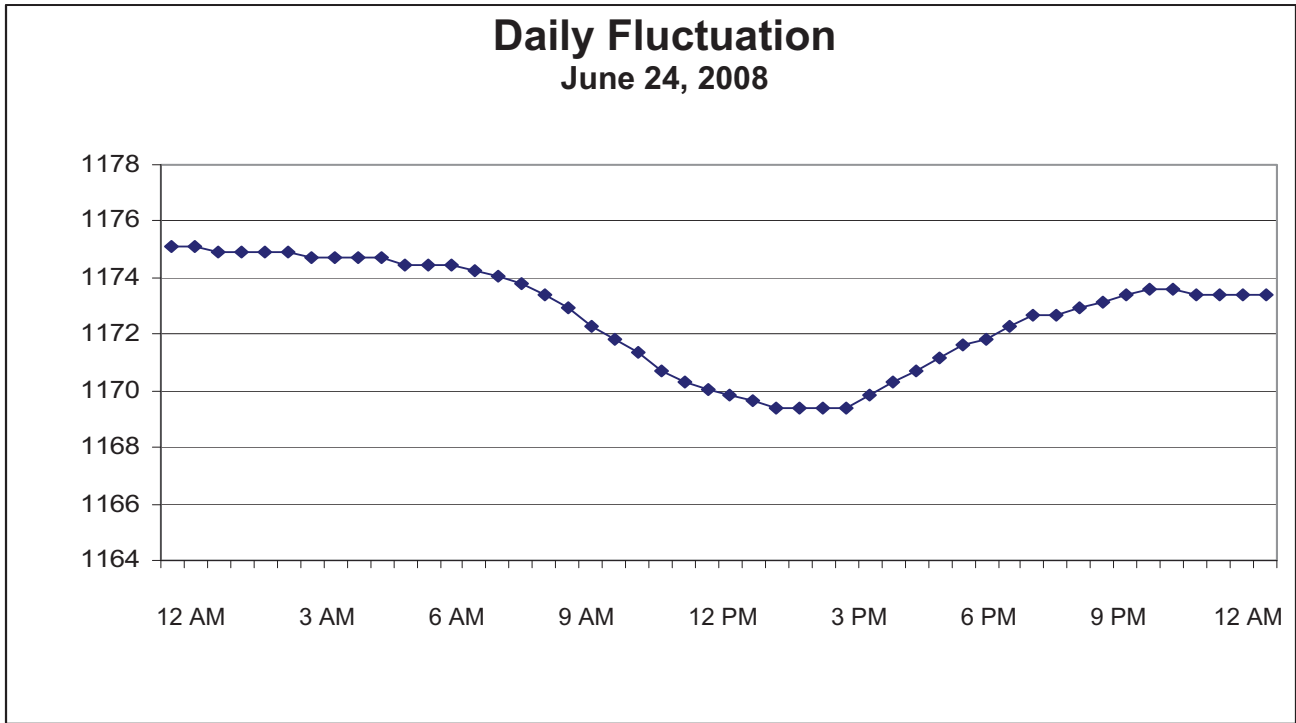
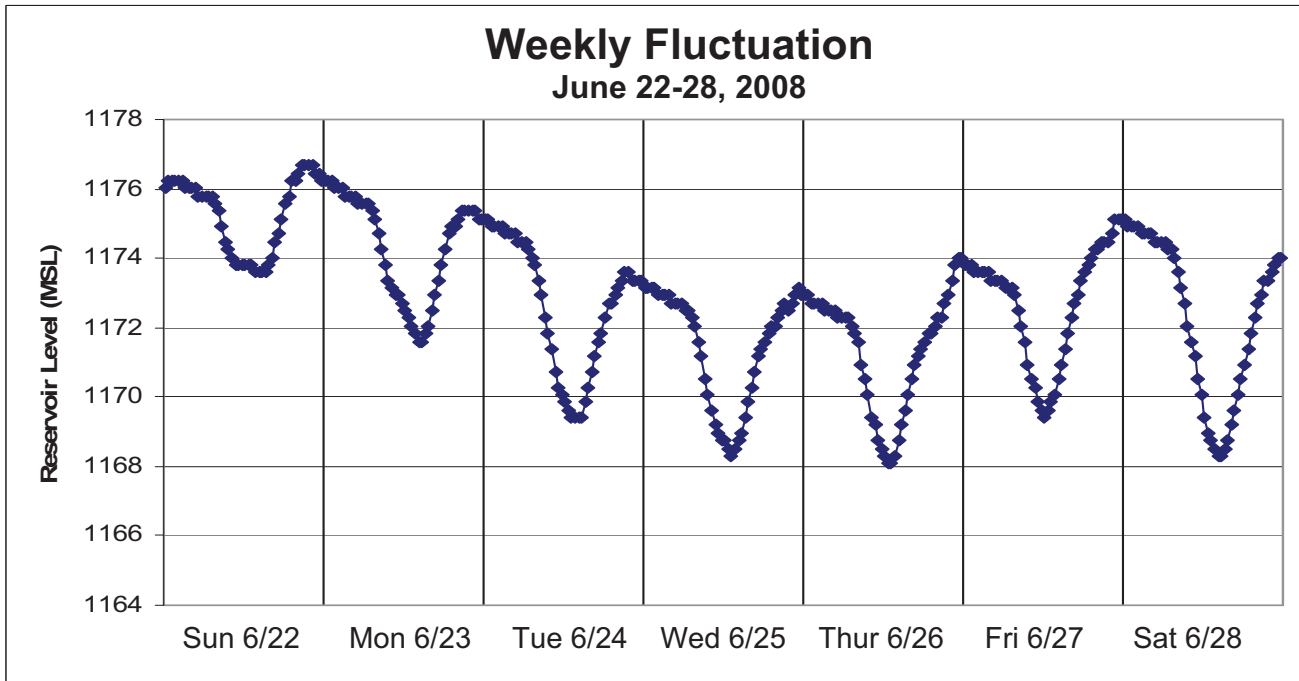
Figure K-3. Water Surface Elevations at Ralston Afterbay – Summer.

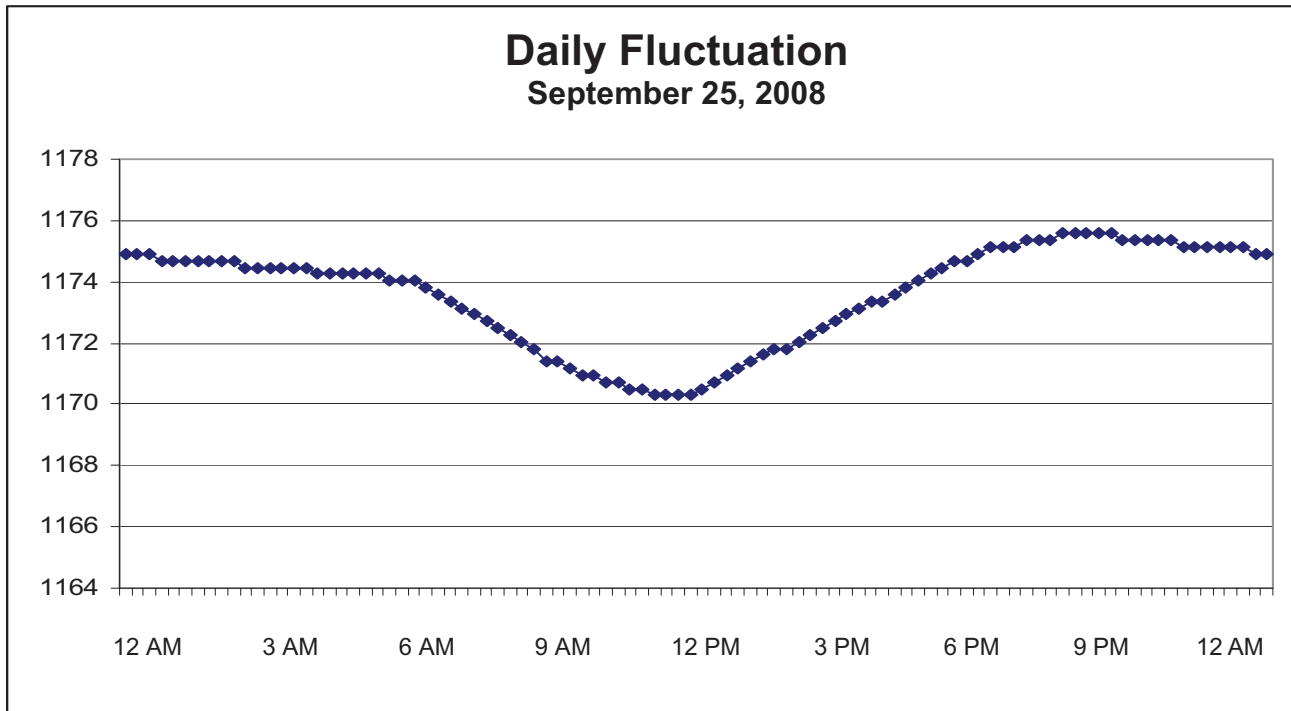
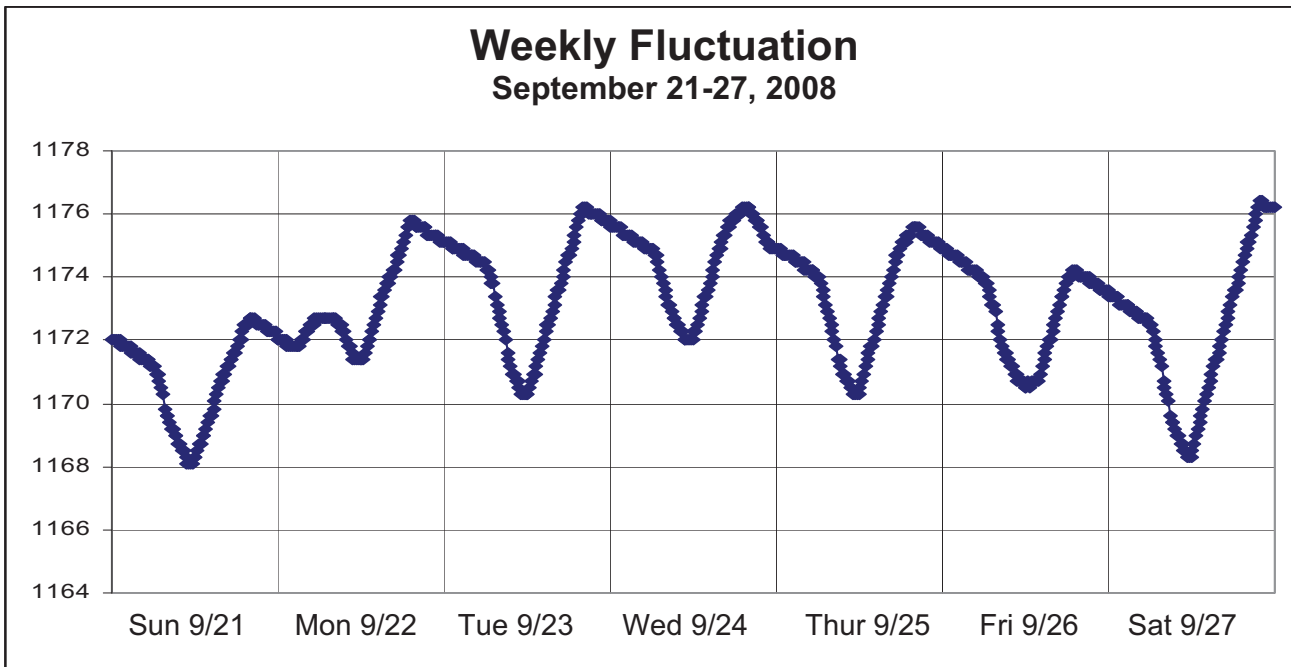
Figure K-4. Water Surface Elevations at Ralston Afterbay – Fall.

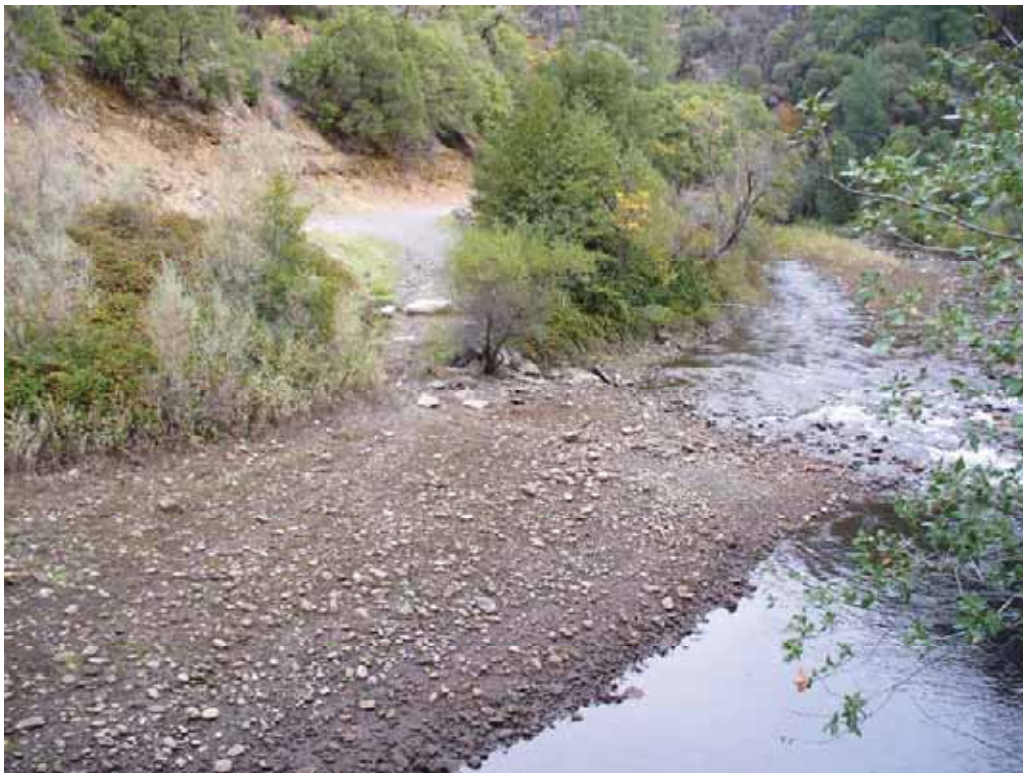
Photo L-4. Ralston Car Top Boat Ramp on November 12, 2008. This photograph was taken during PCWA's annual maintenance outage when the reservoir WSE was about 1,155 feet. Note the large rock in center of ramp.

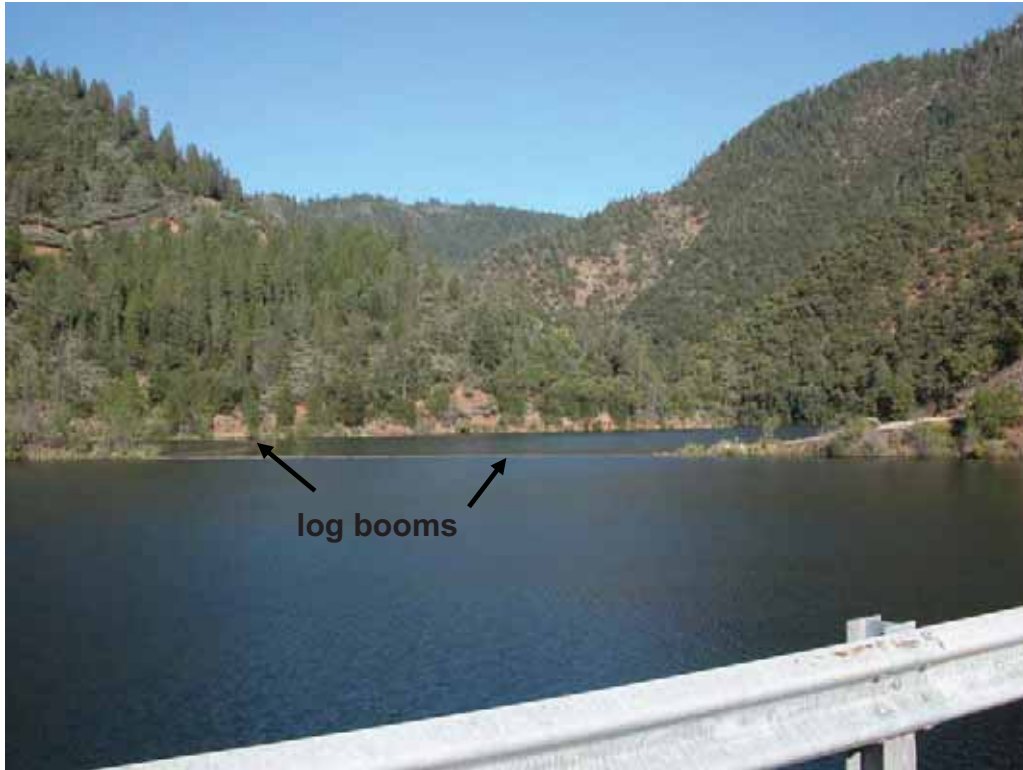
Photo M-1. View of log booms as viewed from Ralston Afterbay Dam

- *Audible Warning Devices.* PCWA maintains security alarms at all powerhouses, including Ralston Powerhouse located on Ralston Afterbay. The security alarm sounds in the event of an unauthorized entry into the powerhouse.
- *Signage* – PCWA and the USDA-FS maintain signs of various types to provide Project-related information to the public and to warn the public about potentially hazardous conditions or areas. Public safety signs were inventoried during field survey conducted in 2008 and are described in detail in the Land 3 – Emergency Action and Public Safety TSR. All of the signs located in the Ralston Afterbay area are summarized in Appendix D.
- *Log Booms.* PCWA maintains log booms across the spillway at Ralston Afterbay. The purpose of the log boom is to prohibit access to the dam area from the reservoir. A photograph of the log boom is provided in Appendix M (Photo M-1).

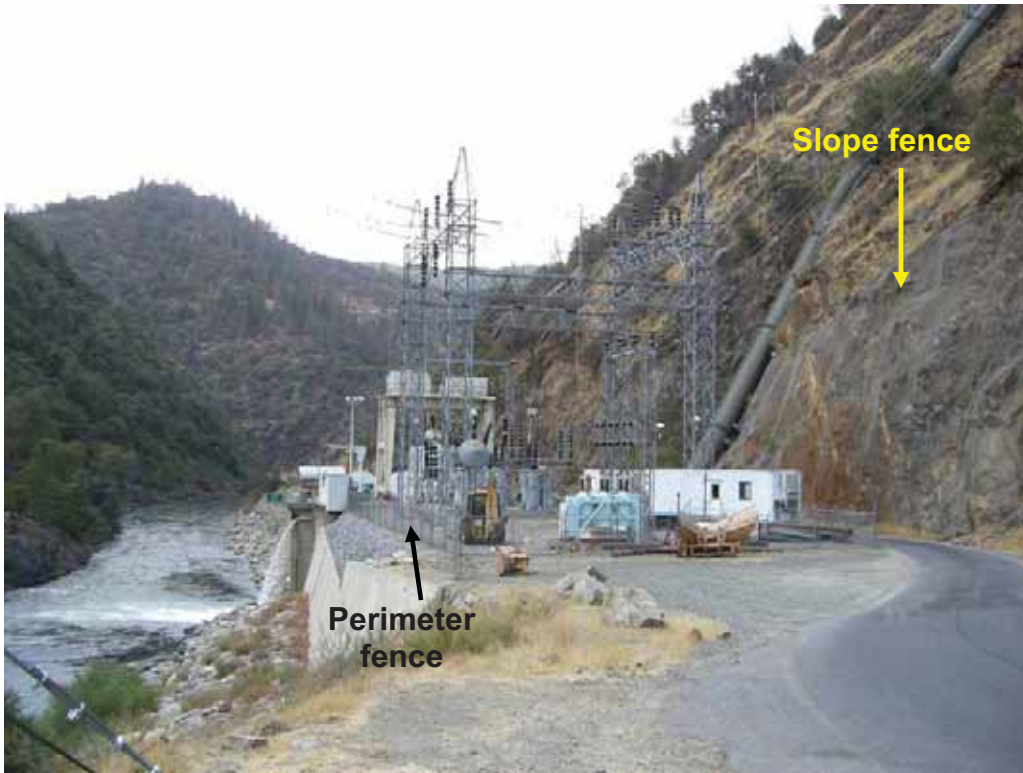
Photo M-2. View of public safety fence (perimeter fence) surrounding Ralston Powerhouse. Also note slope fence along road way. The slope fence is prevents rocks from falling on to the roadway.

- *Public Safety Fences.* PCWA has erected fences around potentially hazardous areas. A fence with a locked gate prohibits access to the Ralston Afterbay Dam and a perimeter fence prohibits access to the adjacent Ralston Afterbay Dam Generator Building (Photo M-3). In addition, the Ralston Powerhouse is surrounded by a perimeter fence (Photo M-2).

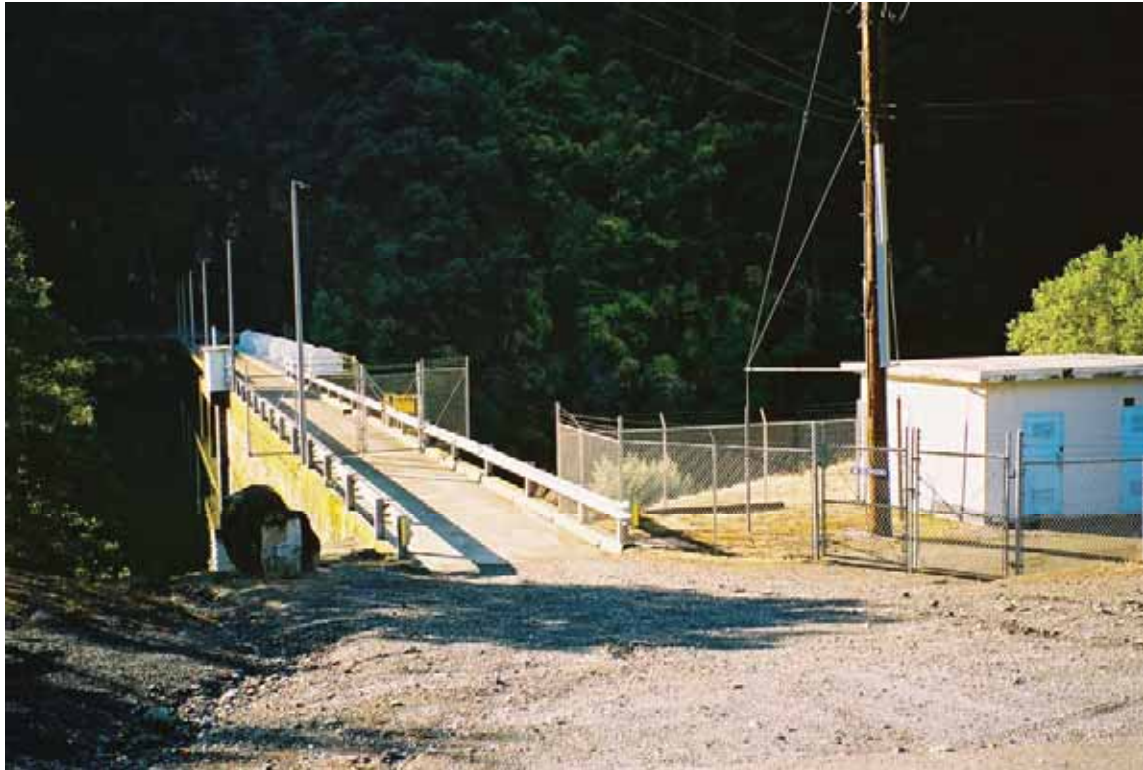
Photo M-3. View of safety railing across Ralston Afterbay Dam and perimeter fencing around the Ralston Afterbay Dam Generator Building. Also note locked fence and gate to prohibit access to dam.
